**Re: Mrs N Vincent, The Coach House, 32 Daleham Gardens, NW3 5DE -
REQUEST FOR TREE REMOVAL**

SITE INVESTIGATION REPORT

We have been asked by J R Clare Underwriting Agencies Limited to comment on movement that has taken place to the above property. We are required to briefly describe the damage, identify the probable cause and describe appropriate remedial measures.

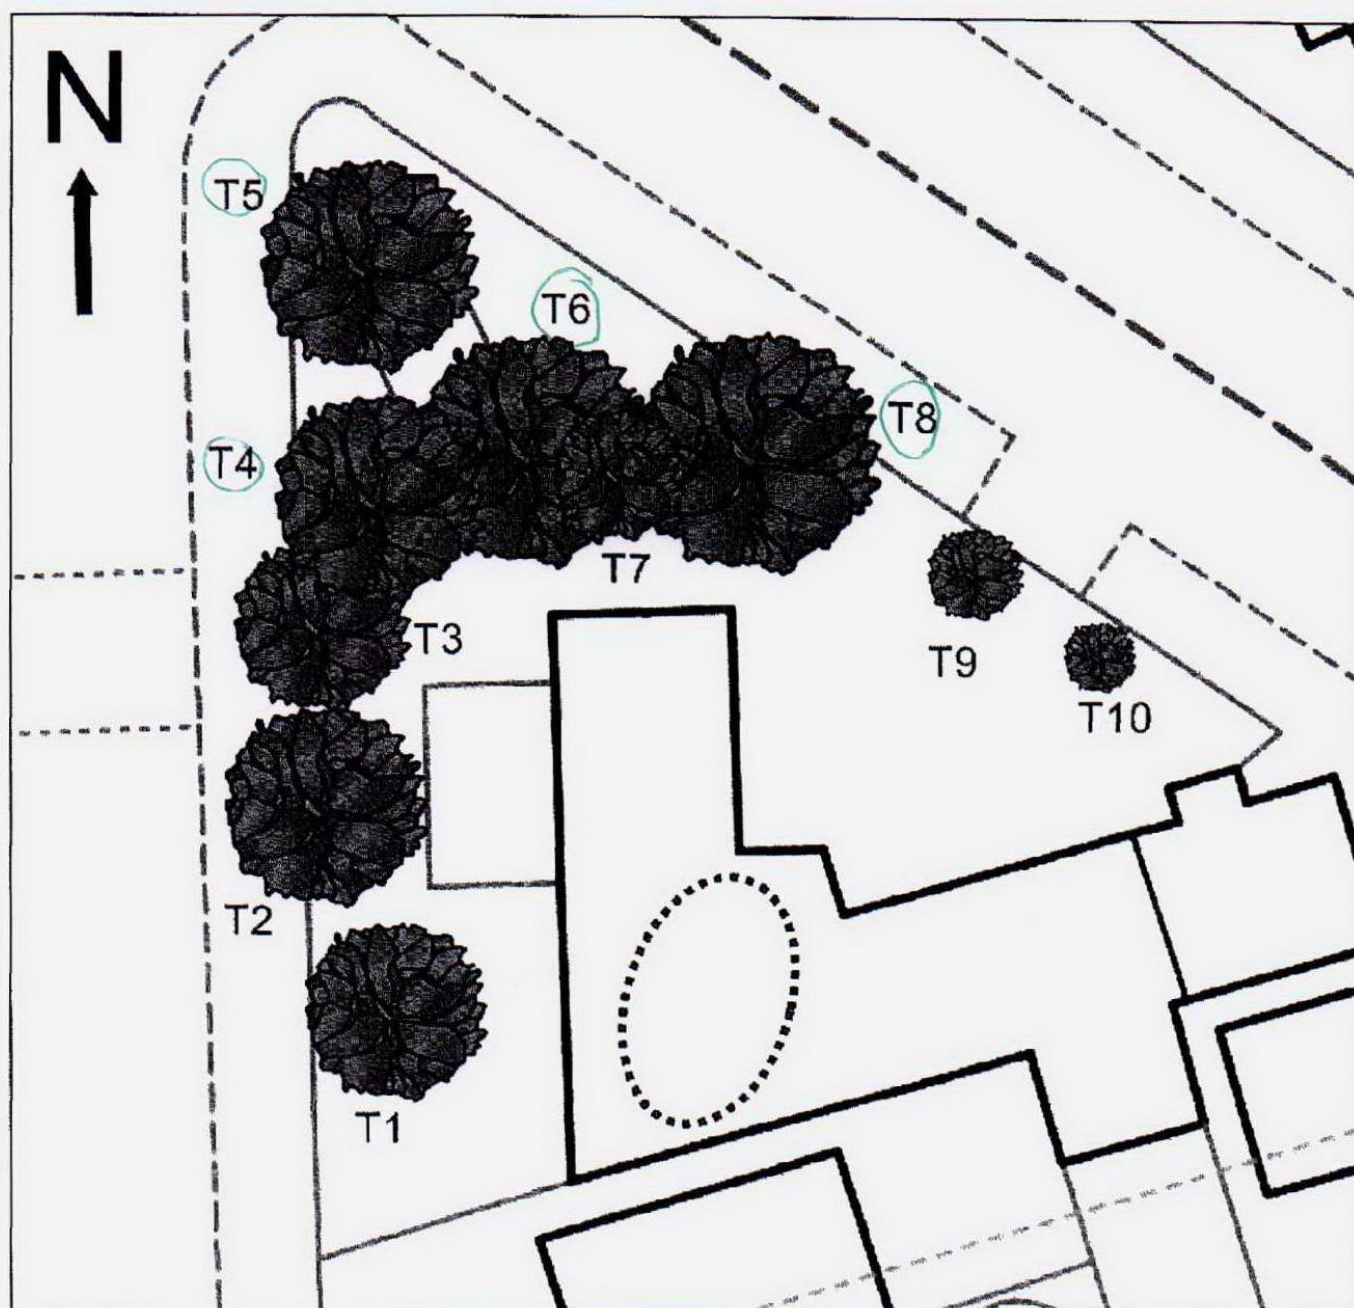
The footings of the subject property fall within the anticipated rooting range of a significant number of trees, many with the capacity to be influencing soil moisture values below foundation level. Felling of all the vegetation noted on the site plan would be necessary to fully eliminate the influence of trees within the garden. It is most unlikely that such extensive removals will be sanctioned and based on current circumstances such an approach is considered disproportionate.

It is therefore recommended that trees marked as T4 (Birch (Silver)), T5 (Birch (Silver)) and T8 (Birch (Silver)) be removed.
