PHOTOGRAPHIC RECORD OF ARCHITECTURAL FEATURES AT 61 MARCHMONT STREET

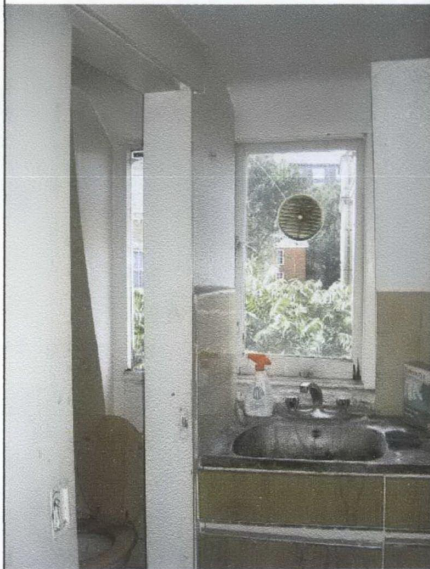
7

1	F/f Lounge arch to be retained. Investigate cleaning of coving
2	Stairs painted s/w to be cleaned and repainted.
3.	2/f kitchen no features
4.	F/f coving as 1 Moulding around windows to be cleaned and repainted
5.	Panel doors to be repainted investigate method of fireproofing
6.	3/f window. No coving. Moulding to be cleaned and repainted.
7.	4f flat kitchen. No features
8.	4f front door to be removed
9.	3/f bed woodwork to be cleaned and repainted
10.	4f no features
11.	3f lounge. Overhaul w/work
12.	As 10
13.	Ff lounge arch and full height window w/work to be overhauled
14.	Moulding around door to be overhauled and made good where necessary
15.	Ff Fireplace to be removed and opened
16.	Ff fireplace to be opened
17.	2f fireplace to be opened
18.	Entrance hall. Meters to e boxed in 1/2hr FR
19.	Rear view.
