Custom Cutters Tree Specialists
5 day Notice

West Hill Court
Millfield Lane
London
N6 6JJ

TREE INSPECTION REPORT

Client: Faraday Property Management Limited, for Clients
Location: West Hill Court, Millfield Lane, London N6 6JJ
Date of inspection: 21 January 2010
Inspected by: J.Harraway FArborA, MICFor

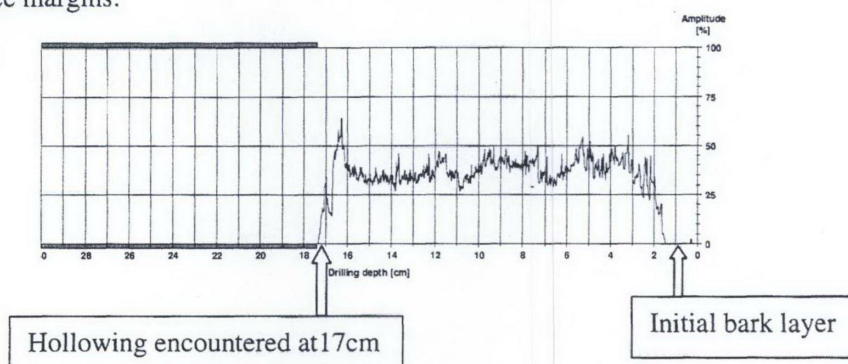
The Resistograph F400 measures the drilling resistance of a very fine drill bit (to a maximum depth of 40cm). Significant drops in drilling resistance are indicative of decay or hollowing. On the example shown below hollowing is indicated at a depth of 17cm and highlighted red in the drill trace margins:

Resistograph in use
at the base of T26

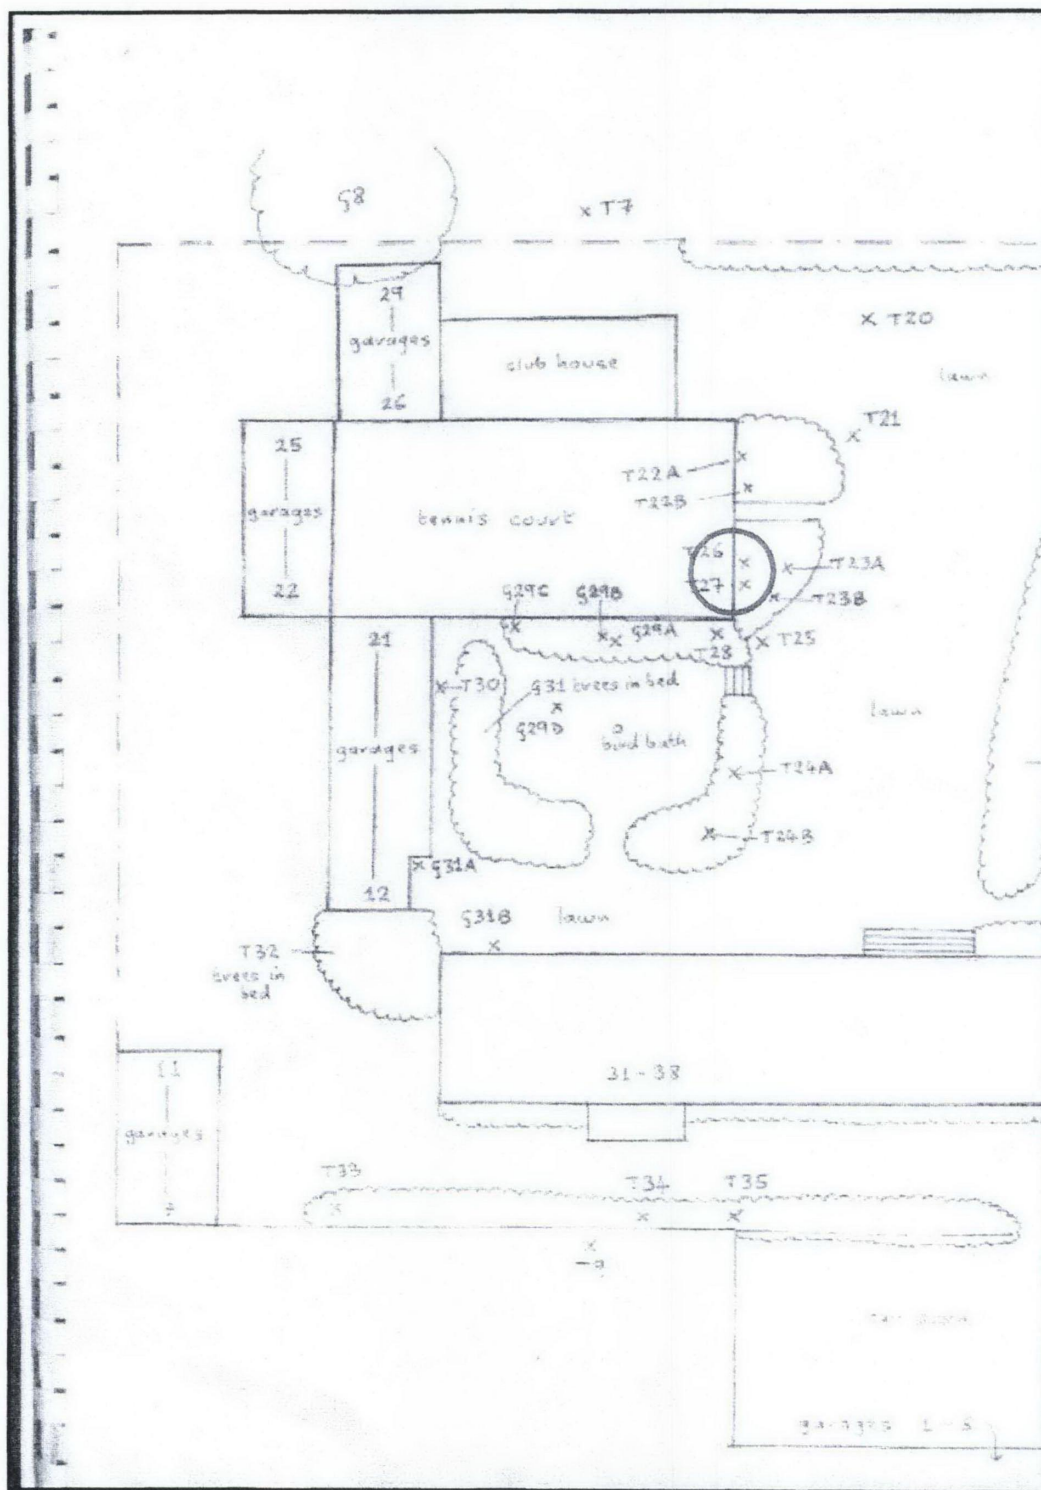
Extract from site plan, showing trees' position, adjacent tennis court:

T26/T27: Lombardy Poplar x 2 – adjacent to tennis court

T44: Black Polar x1 – on boundary of property (north) adjacent to driveway
