**Kings Cross Station
Redevelopment Programme
Package 2**

**South Facade
Proposed Works**

Job No	Drawing No	Issue
B40234	MSR-CSS-0180	07

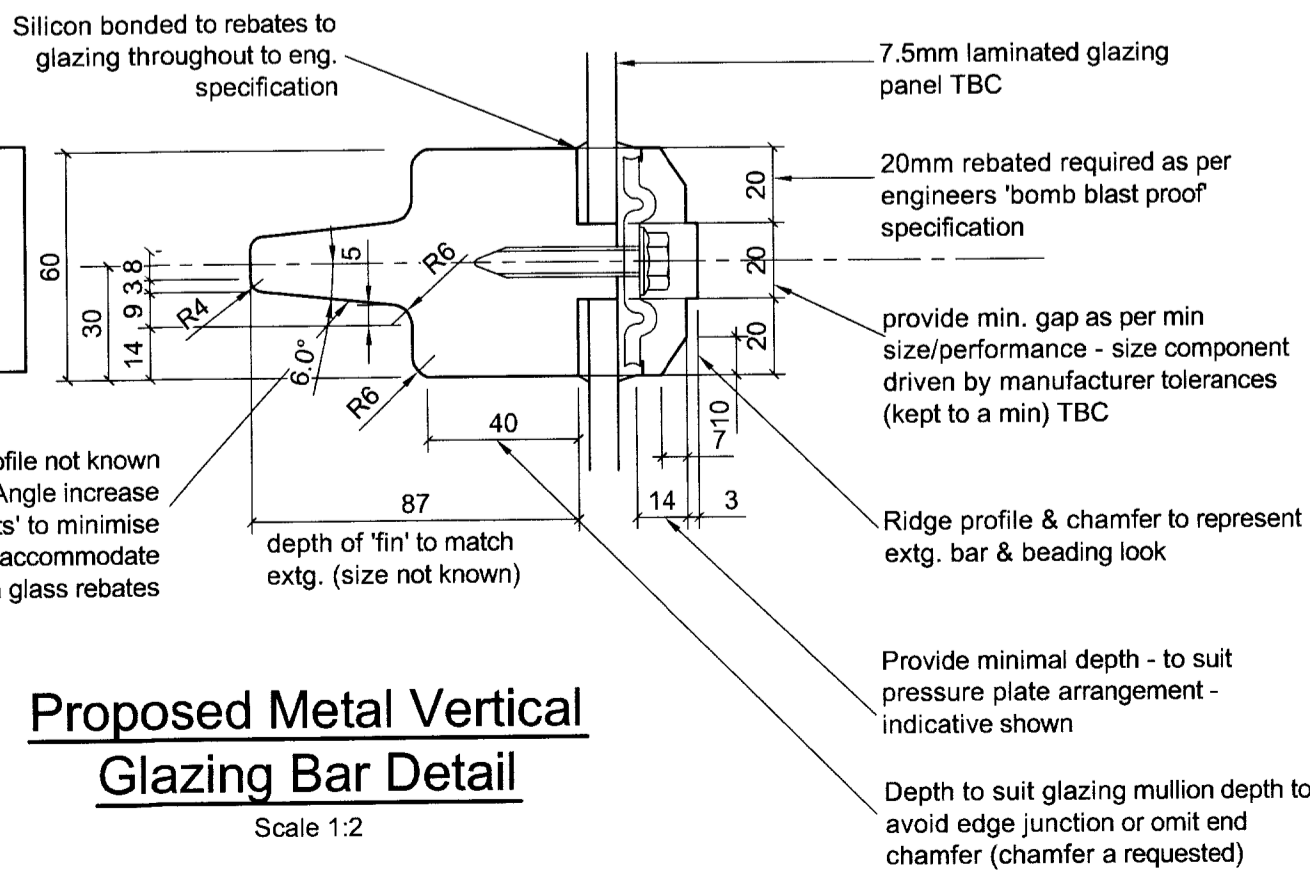
Proposed Metal Vertical Glazing Bar Detail
Scale 1:2

Angle of exiting profile not known (representational only). Angle increase helps retain minimal 'flats' to minimise overall width increase to accommodate bomb blast criteria from glass rebates

Note!
All joints between proposed main glazing bars to be full strength.
