WITANHURST
STRUCTURAL REPORT ON THE GARDEN STRUCTURES
11 MAY 2009 rev 26 May 2009

The following report is the result of a visual inspection of the garden structures made by Michael Barclay Partnership LLP on 29 and 30 April 2009.

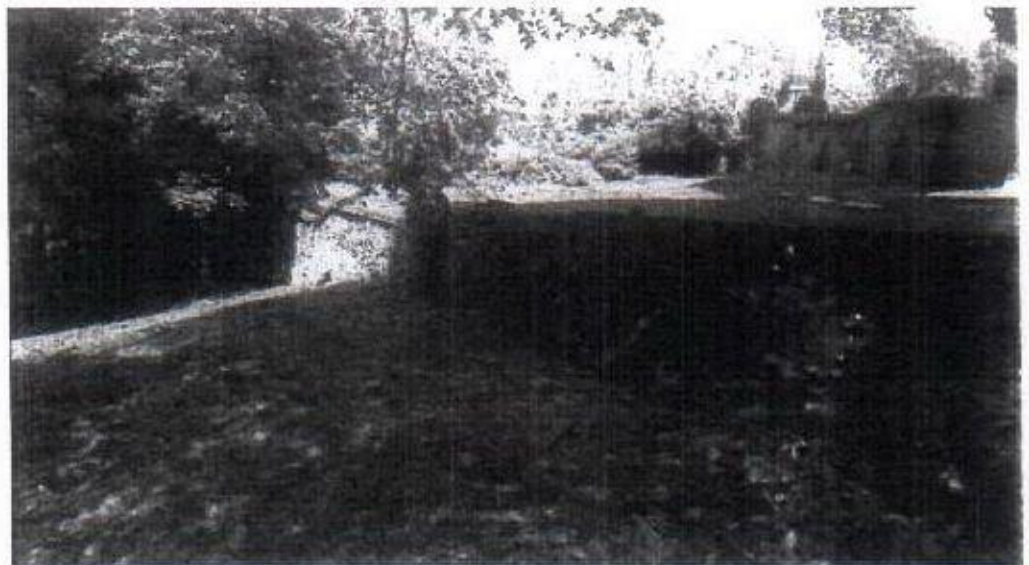
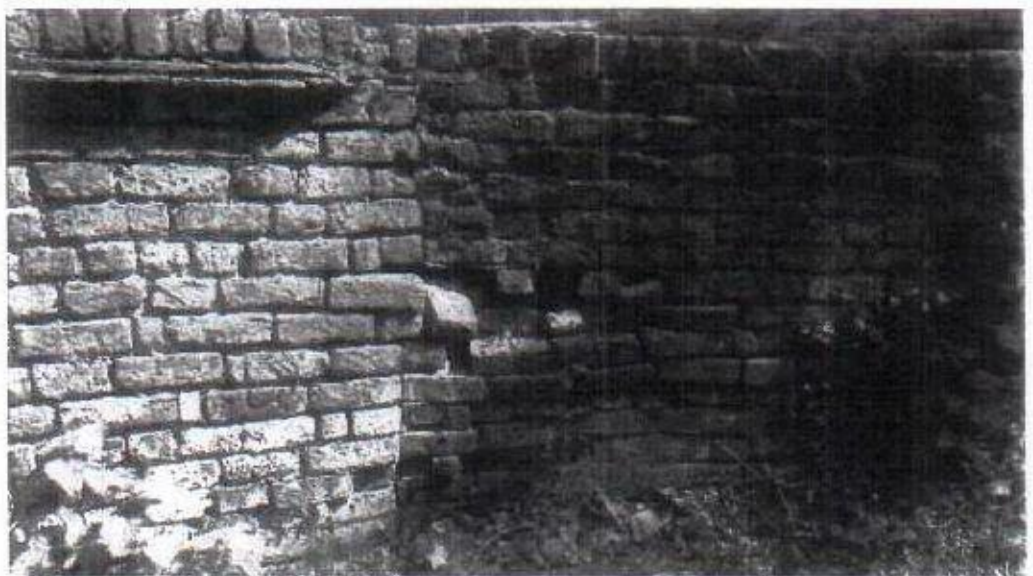
PHOTO 1: TERRACE AND ROCKERY STEPS

PHOTO REF.	LOCATION		CONDITION	RECOMMENDATIONS
1	1	Terrace and rockery steps	The sandstone(?) is of good quality, but both the terrace and steps are very uneven and almost certainly bedded on poor quality subbase material and underlying fill.	The terrace should be taken up and re-laid on compacted material. The steps should be taken up and re-laid on compacted material.
2, 3, 4, 5	2	Garden retaining wall of soft brick construction, retaining up to 1.3m of ground.	Poor, bricks loose, and wall up to 50mm out of plumb.	Take down and rebuild.
5, 5	2a	Brick paving and steps	Poor, bricks badly weathered and uneven. Inadequate subbase material.	Take down and rebuild.
6	3	Garden retaining wall of soft brick construction.	Poor, bricks loose, parts of the wall have collapsed.	Take down and rebuild.
8	4	Steps and wall.	Later addition in improved brickwork. Retains 1.7m of ground. Approx 30mm out of plumb. Severe deterioration in adjoining wall.	Rebuild required at north end.

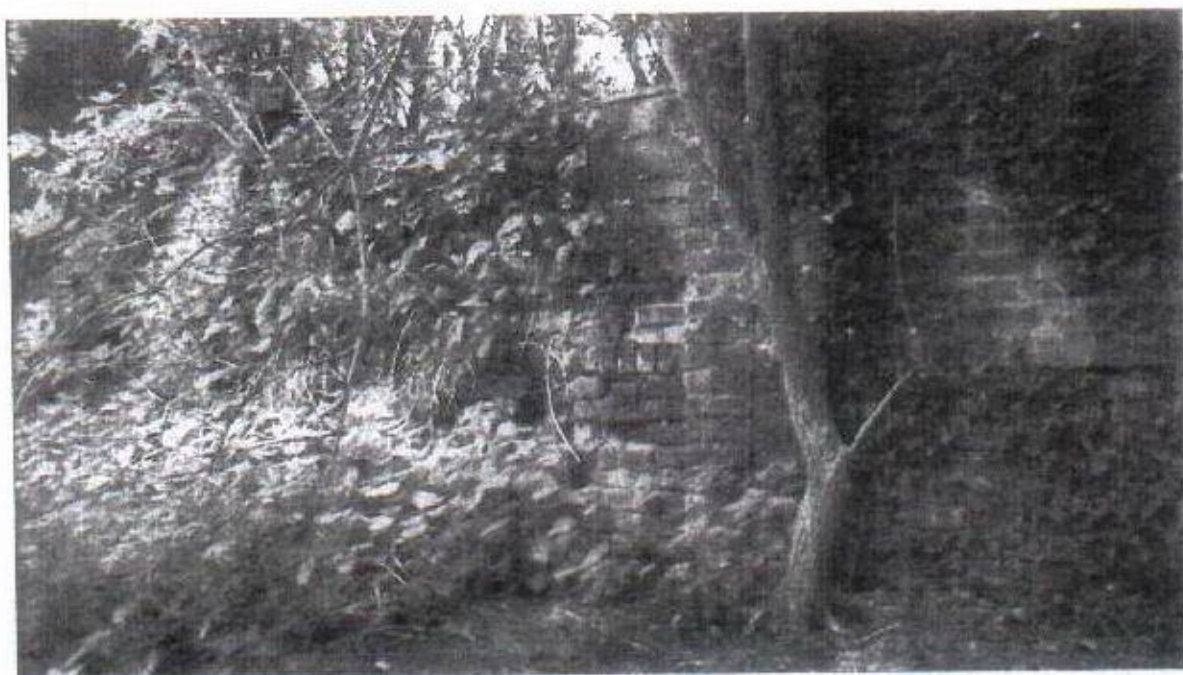
PHOTO 9: BOUNDARY WALL 5

9	5	Boundary wall	Could not be inspected from adjoining property. The wall at the east half has been rebuilt within the last 30/40 years. Brickwork weathered with cracking and severe deterioration at west end close at junction with wall 4.	Repair and partial rebuild required.
12	5, 7 and 8	There are three walls set in terraces leading from the tennis court up to the boundary wall at the top. The total earth retention is more than 3m. There are trees and scrub at the lower levels and a hedge at the top.		
9, 10, 11 and 12	6, 7	The top and middle soft brick walls are the earliest in construction - possibly designed as a composite system. The top wall is buttressed and the middle wall batters back.	The top wall could not be fully inspected without access from the adjoining properties. The walls are generally in poor condition. The top of wall 6 has a gap in the brickwork and is at least 100mm out of plumb. Parts may be dangerous.	Further inspection is required. Remedial measures may include partial reconstruction.

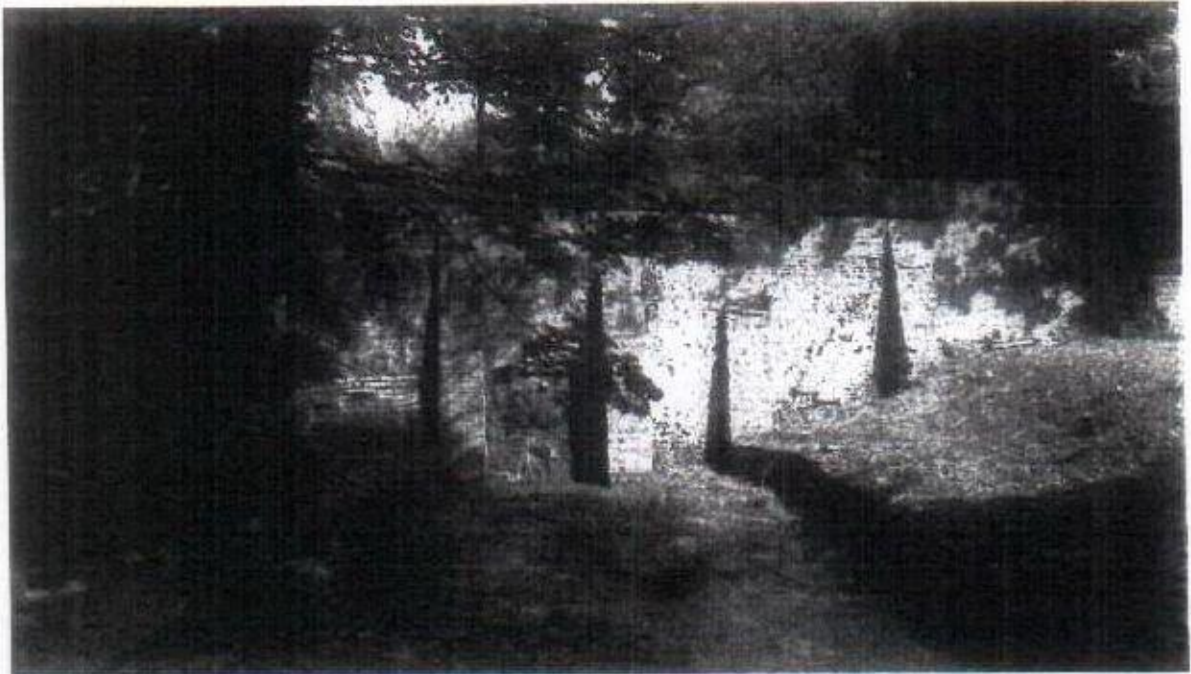
PHOTO 14: BOUNDARY WALL 9

13	8	Tennis court wall. Wall of later construction, possibly 1950's	The bricks themselves are in reasonable condition, but the mortar is poor allowing slipping of the upper courses.	Repair and partial rebuild required.
14	8	Continuation of 1950's tennis court perimeter wall. The bank behind is overhung with decking to adjoining house.	Bricks reasonable, mortar poor.	Repair.
15	10	Buttressed 4.5m high retaining wall to the west side of the tennis court.	Diagonal cracks suggest foundation movement in the area of the pond. It is possible that the part above the pond has more substantial foundations than at the two sides.	Further investigation required including trial pits to assess the foundation. It may be possible to repair this wall.
16	11	Curved random stone wall to the east of the tennis pavilion.	This wall is in very poor condition.	Rebuild.
17, 18	12	Curved stair and square limestone(?) faced wall, backed in brickwork.	Stair steps uneven. Many of the limestone facings are weathered.	The steps require attention, but it may be possible to repair the wall.

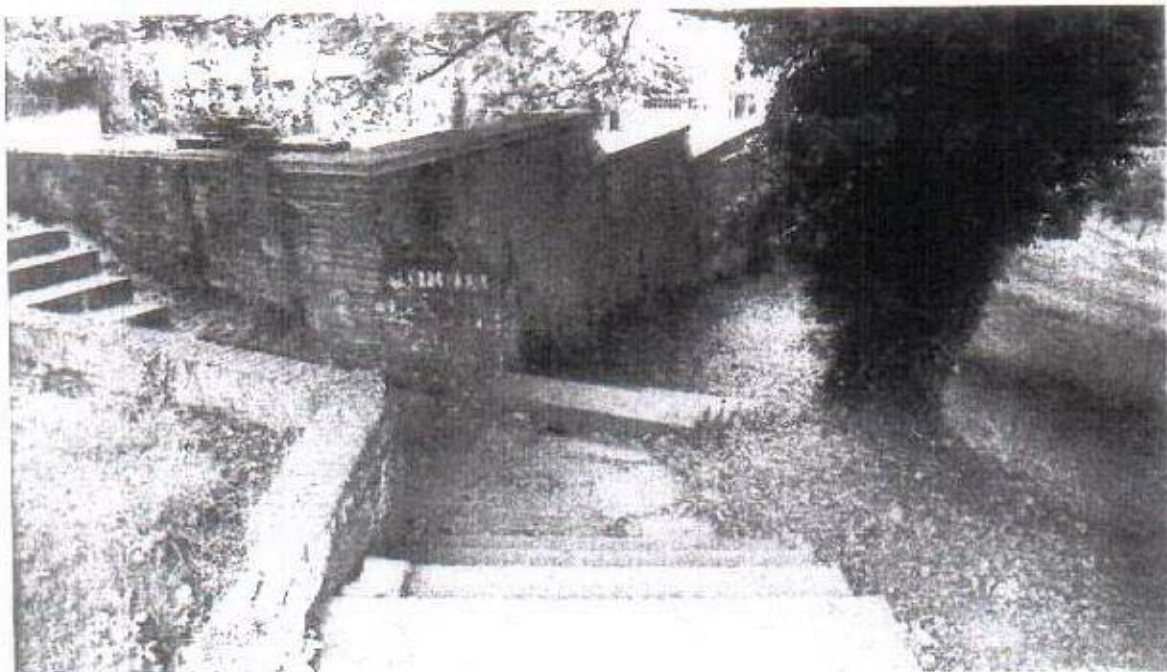
PHOTO 29: WALL AND TERRACE 15

PHOTO REF.	LOCATION	CONDITION	RECOMMENDATIONS	
27, 28	14	Grand staircase	Similar construction to 13 above.	As 13
29	15	Curved stair and square limestone(?) faced wall, backed in brickwork and terrace	Wall construction similar to 13 above, but less deterioration. Terrace uneven.	Terrace should be re-laid on compacted granular material
30, 31	16	Sandstone (?) steps and low brickwall.	Stone is good, but sloping and uneven. Brick work is damaged.	Flagstones should be re-laid on compacted granular material. Rebuild brick walls.
	17	Sandstone (?) steps and low brickwall.	as 16	as 16
	18 - 23	Terraced Italian gardens	These gardens generally are in poor condition. The limestone copings and columns are all severely weathered and broken and the quality of the original construction poor: much of the construction is thought to have been built off inadequately compacted fill. Detailed comments on each element follow below.

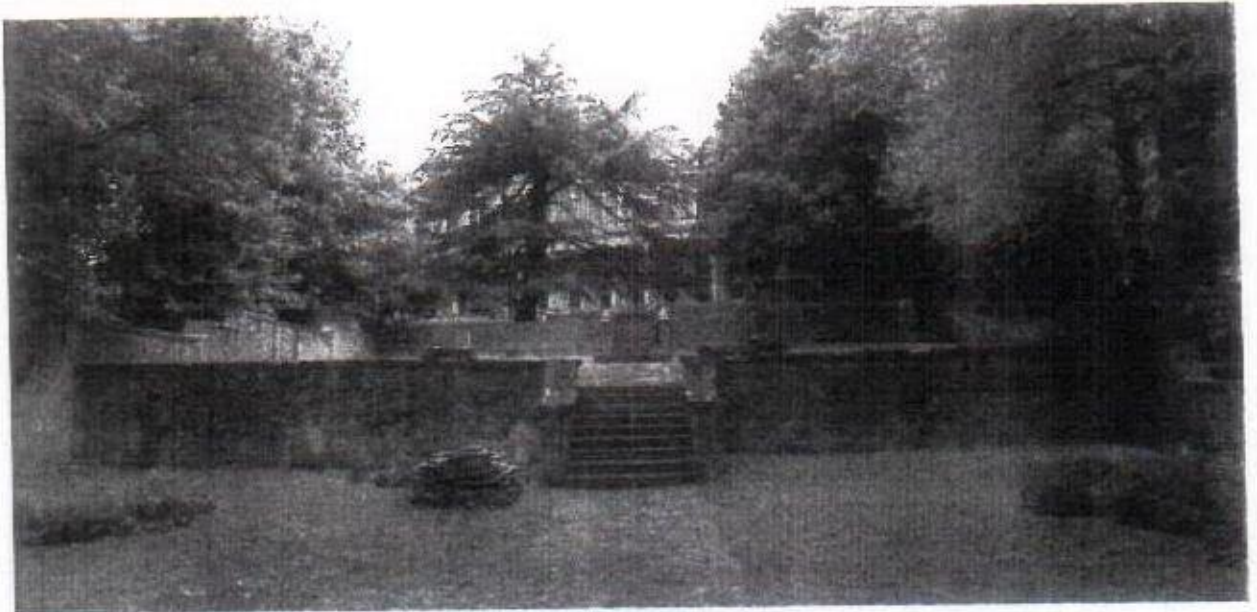
PHOTO 35: ITALIAN TERRACED GRADEN TOP HEAD WALL 18

32, 33, 34, 35	18	Top head wall and central steps.	Brickwork weathered and cracking on both sides. East side 100mm out of plumb, west side 300mm out of plumb and now dangerous. Steps uneven.	Take down and re-build
32	19	Stone paving	Uneven	Re-lay on compacted granular material.
	20	East side walls and steps	Brickwork weathered and out of plumb.	Take down and re-build.
36	21	Middle head wall and steps	Brickwork weathered. Noticeable settlement - the two flanks slope at about 1 in 50 towards central stair	Take down and re-build
37	22	Middle east side wall and steps	Walls severely out of plumb.	Take down and re-build
36	23	Stone paving	Mostly already taken up and stacked.	
	24	Side wall	Severely out of plumb	Take down and re-build
38, 39, 40, 41	25	Bottom head brick wall, stone balustrade, central steps, side openings	Bad weathering to stone balustrade, slipped lintel to left side opening, cracking at junction with west side wall. Brick retaining wall appears to be reasonably robust. Steps uneven, plinths distorted.	Replace severely damaged features. Possibly repair the wall itself.
