The Whitworth Co-Partnership  
18 Hatter Street  
Bury St Edmunds  
Suffolk IP33 1NE

## **THE CAREER OF GEORGE JOHN VULLIAMY (1817-1886) AND HOW THE SWISS CHURCH FITS**

### THE SWISS CHURCH

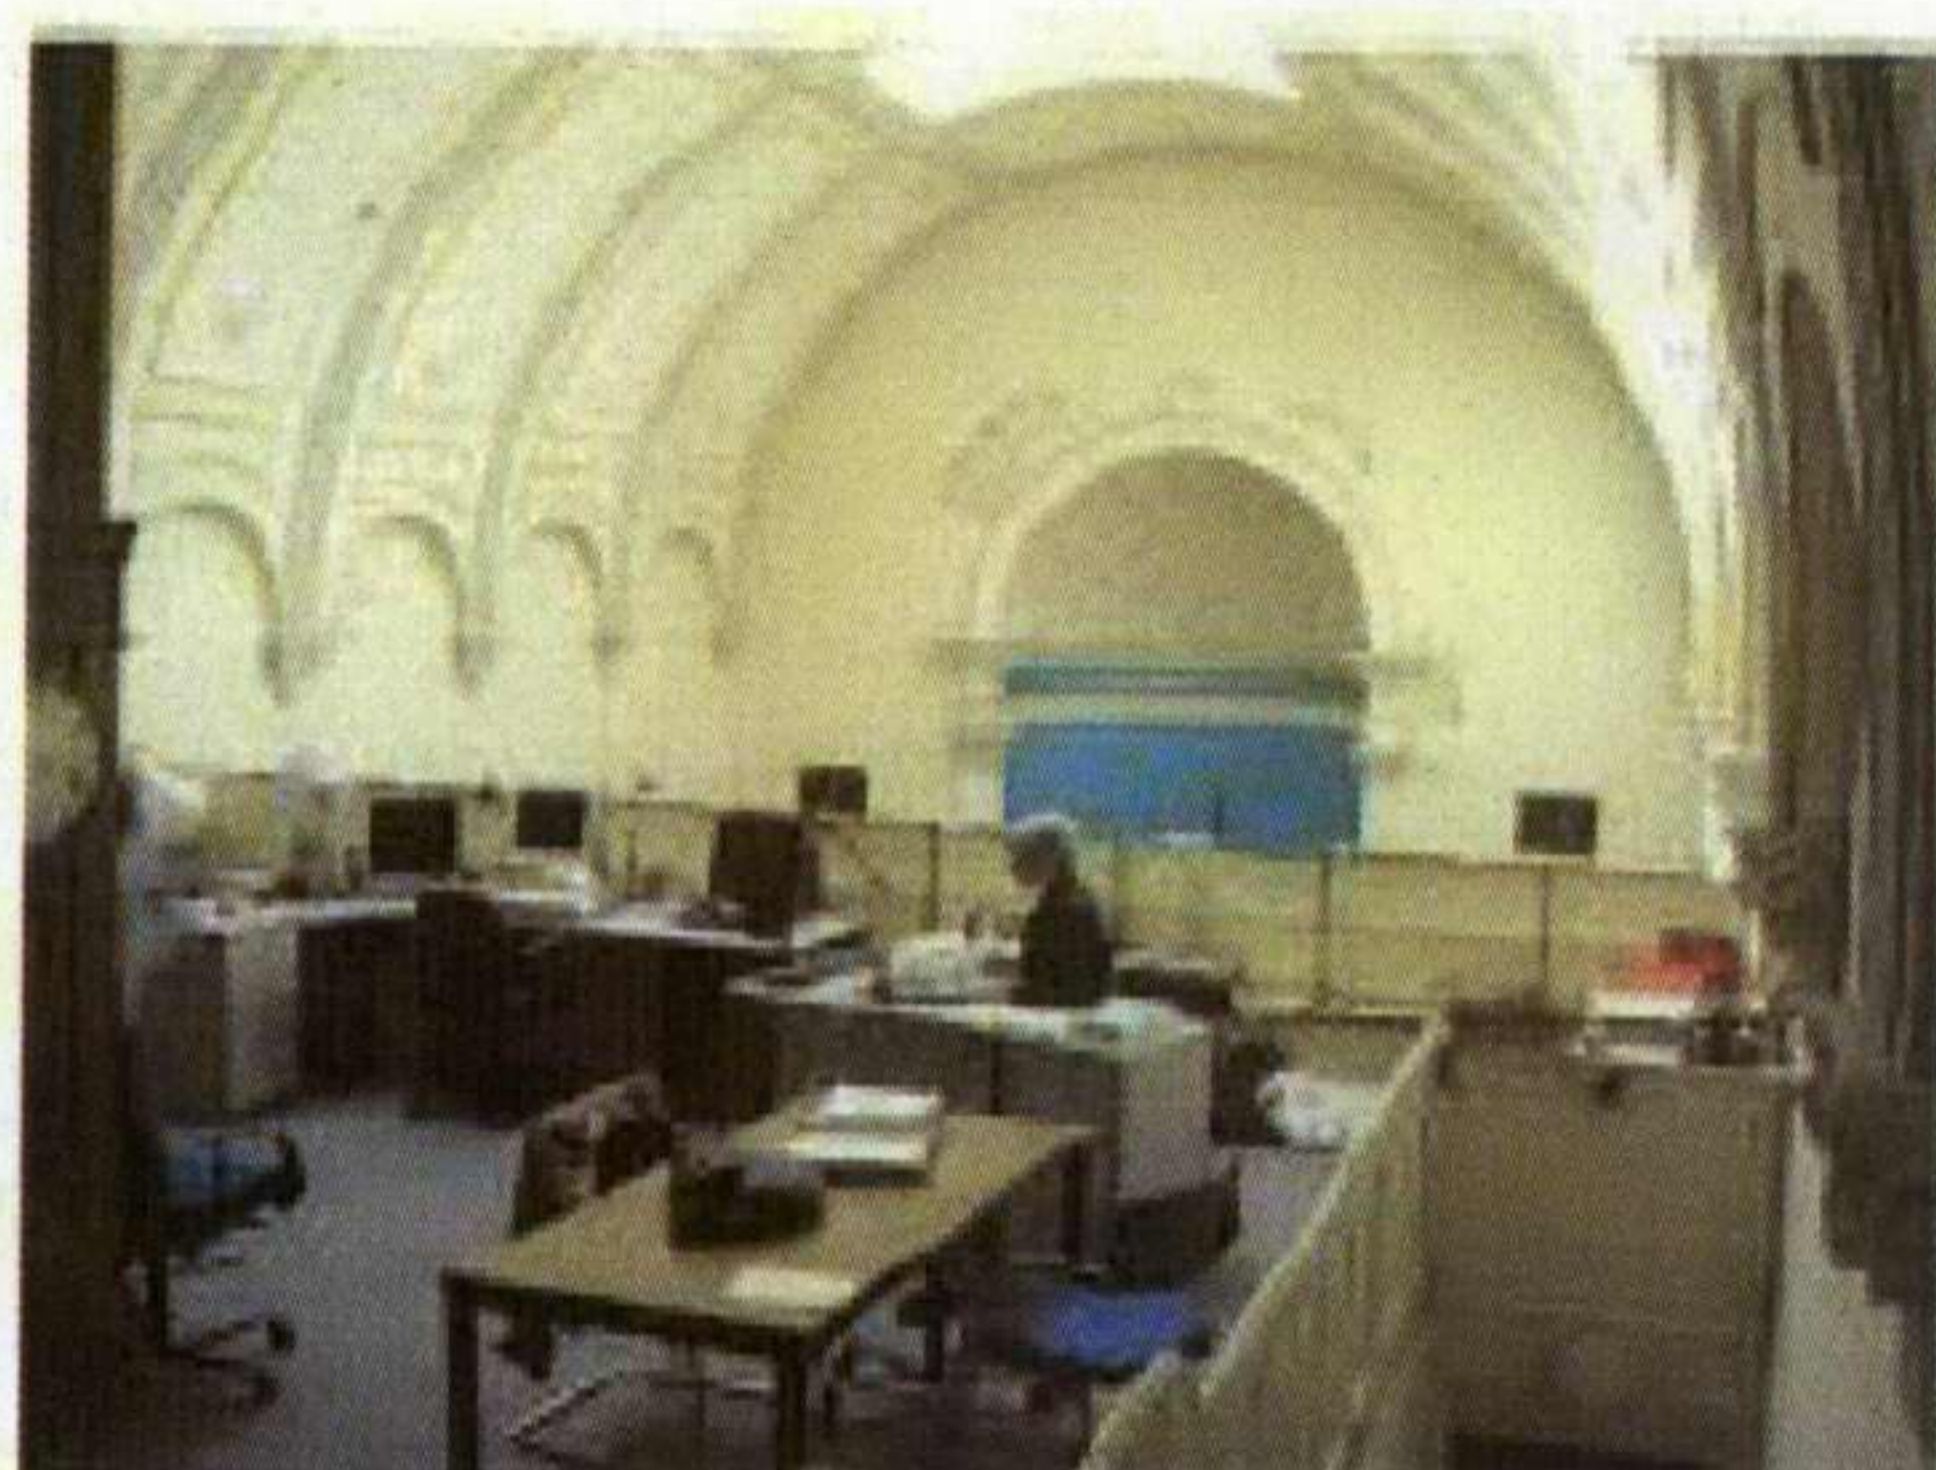
- 5.35 **Gallery front:** a timber upstand, with metalwork above giving the gallery rail height up to 1100mm. There was a fabric covering to this which protects the office people from the worship area, and this appears to be satisfactory.
- 5.36 **Walls to the gallery:** these are covered in the report for the main worship area.

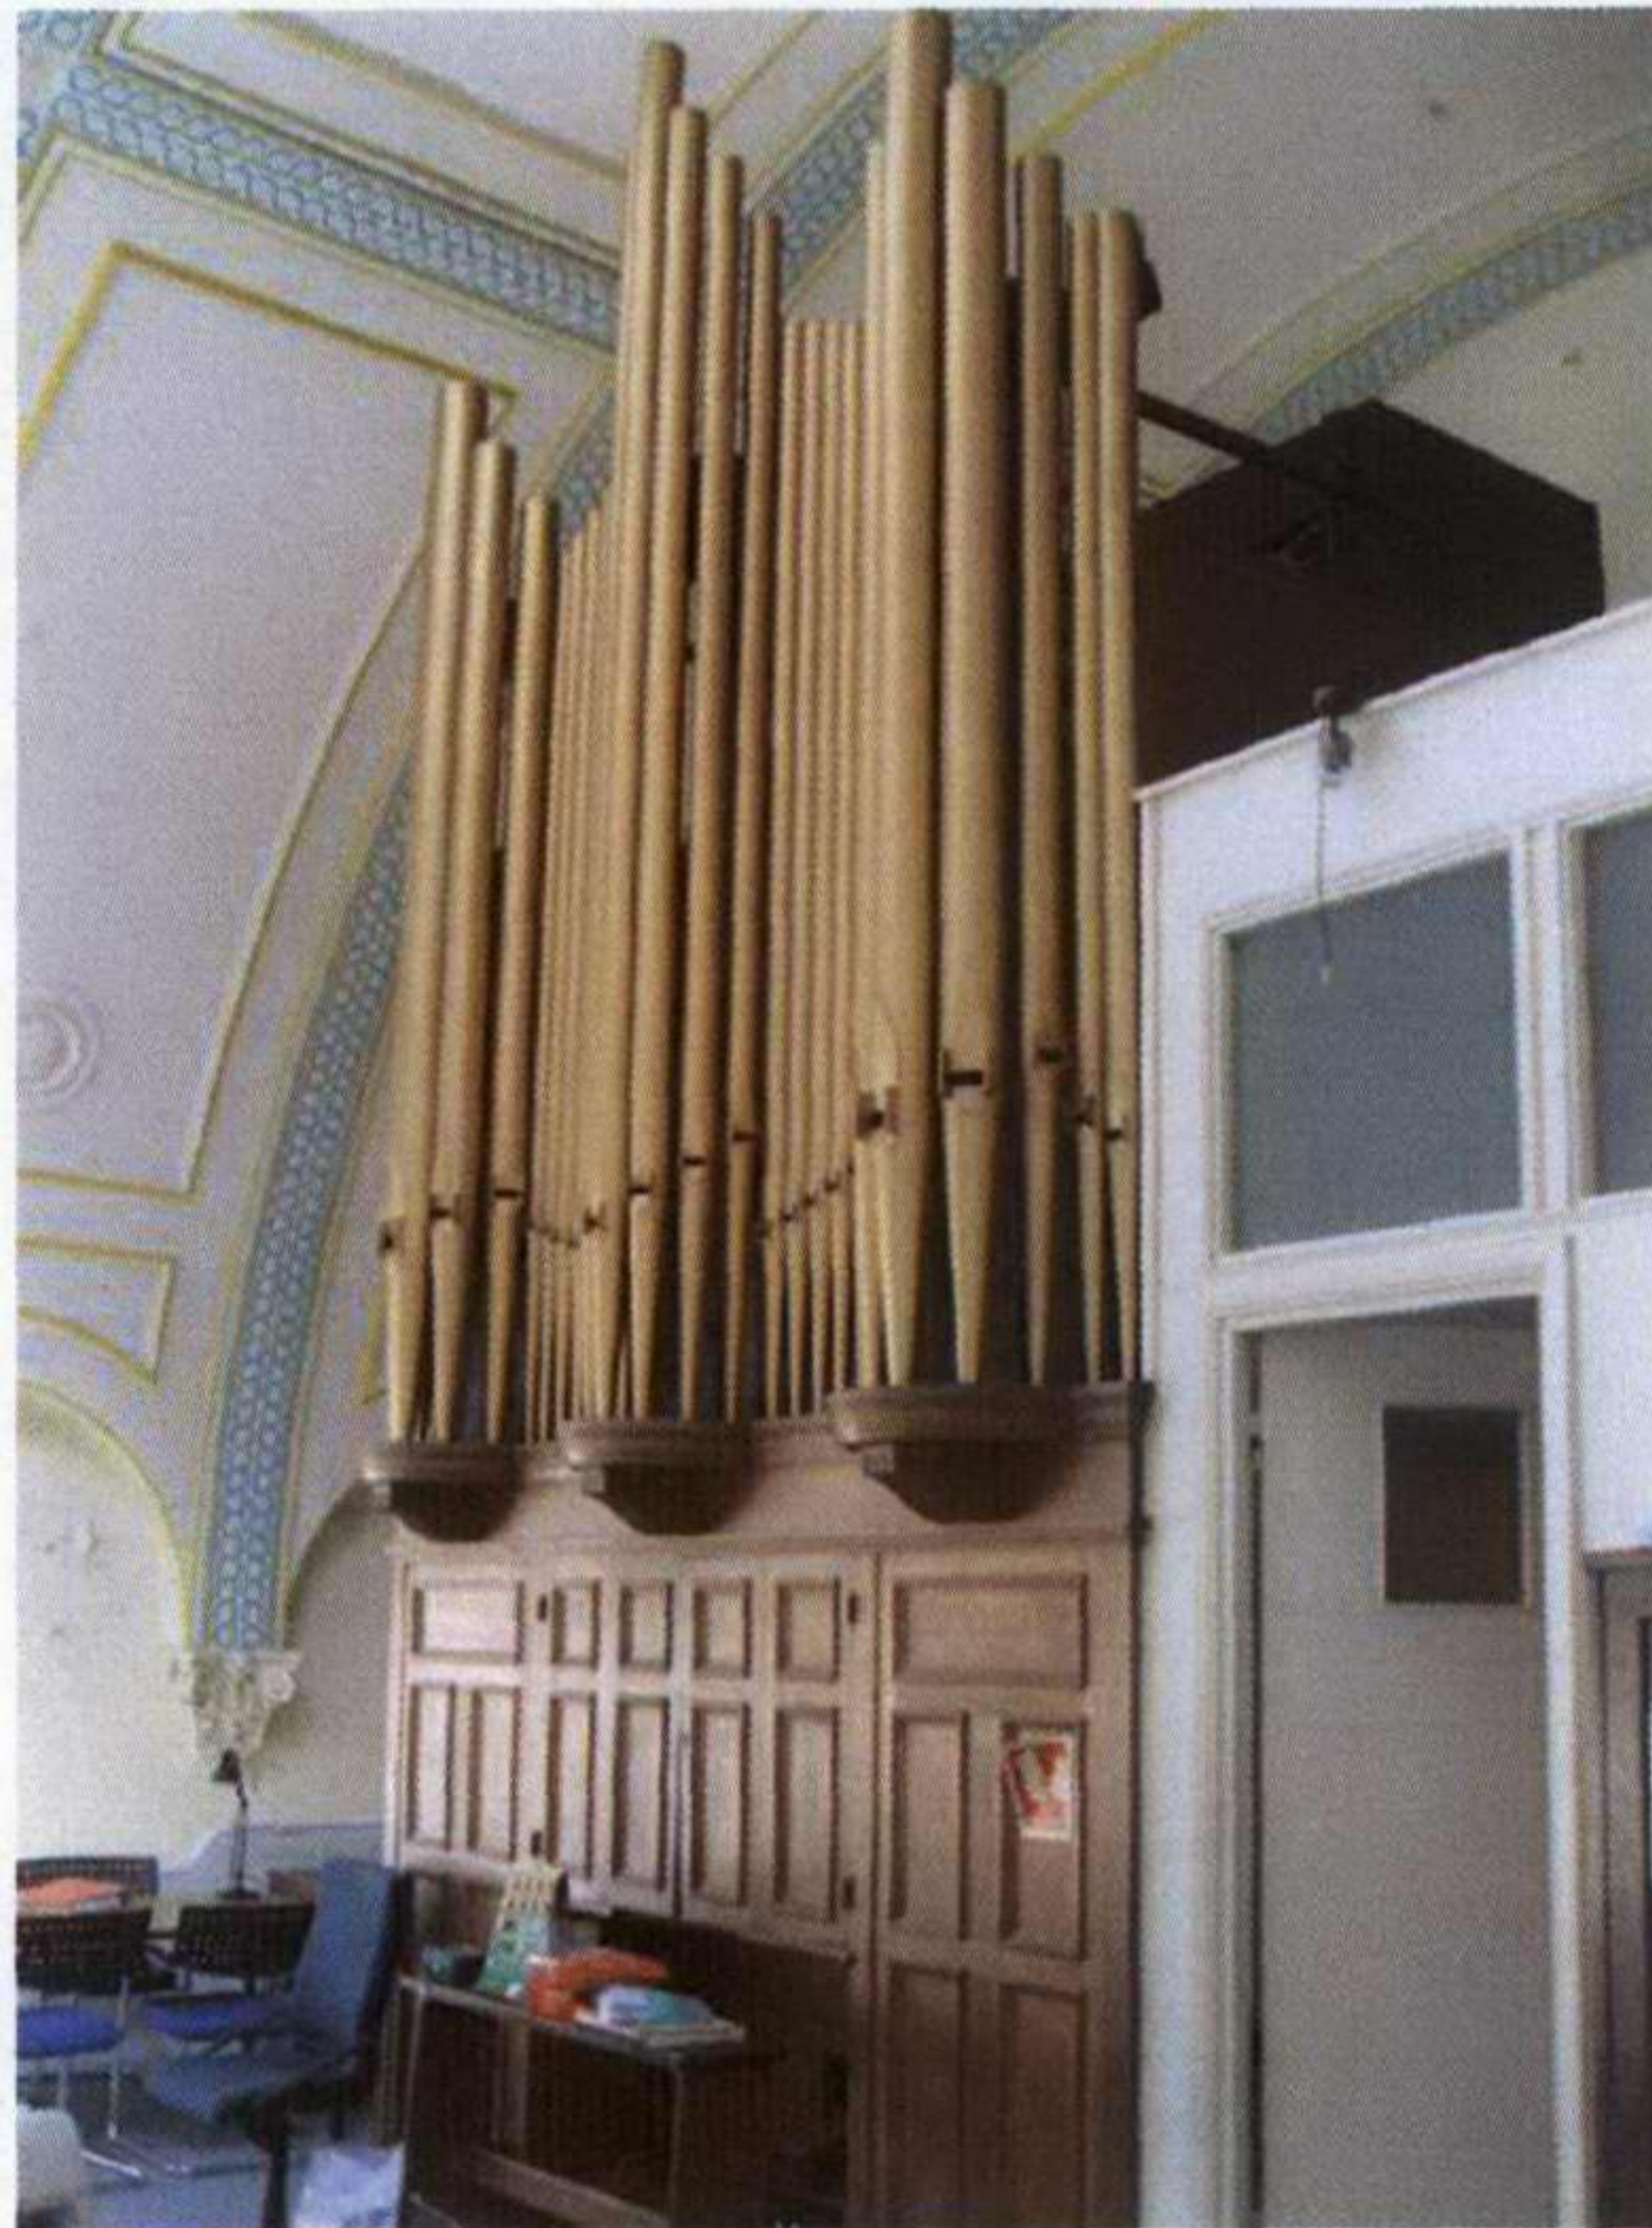
5.37 **Organ:** there is an instrument referred to in previous documentation, we understand this is regularly maintained, the casing and the instrument appear to be in satisfactory order.

5.38 **Rest room:** (beyond the organ) a lightweight timber structure with plasterboard painted walls and suspended ceiling tiles and an inset grid, with a sink unit cupboard. General condition fair. No evidence of structural defect. The plasterwork on the south wall has been encased in hardboard, and was generally not available for inspection. Some panels have been subsequently removed and plaster behind was found to be damaged by old water penetration.
