**Simon Pryce, Arboricultural Consultant**

**Site:** Land at rear of Prime House, Finchley Road, London, NW3

**Subject:** Trees and proposed building work

**Reference:** 07/191

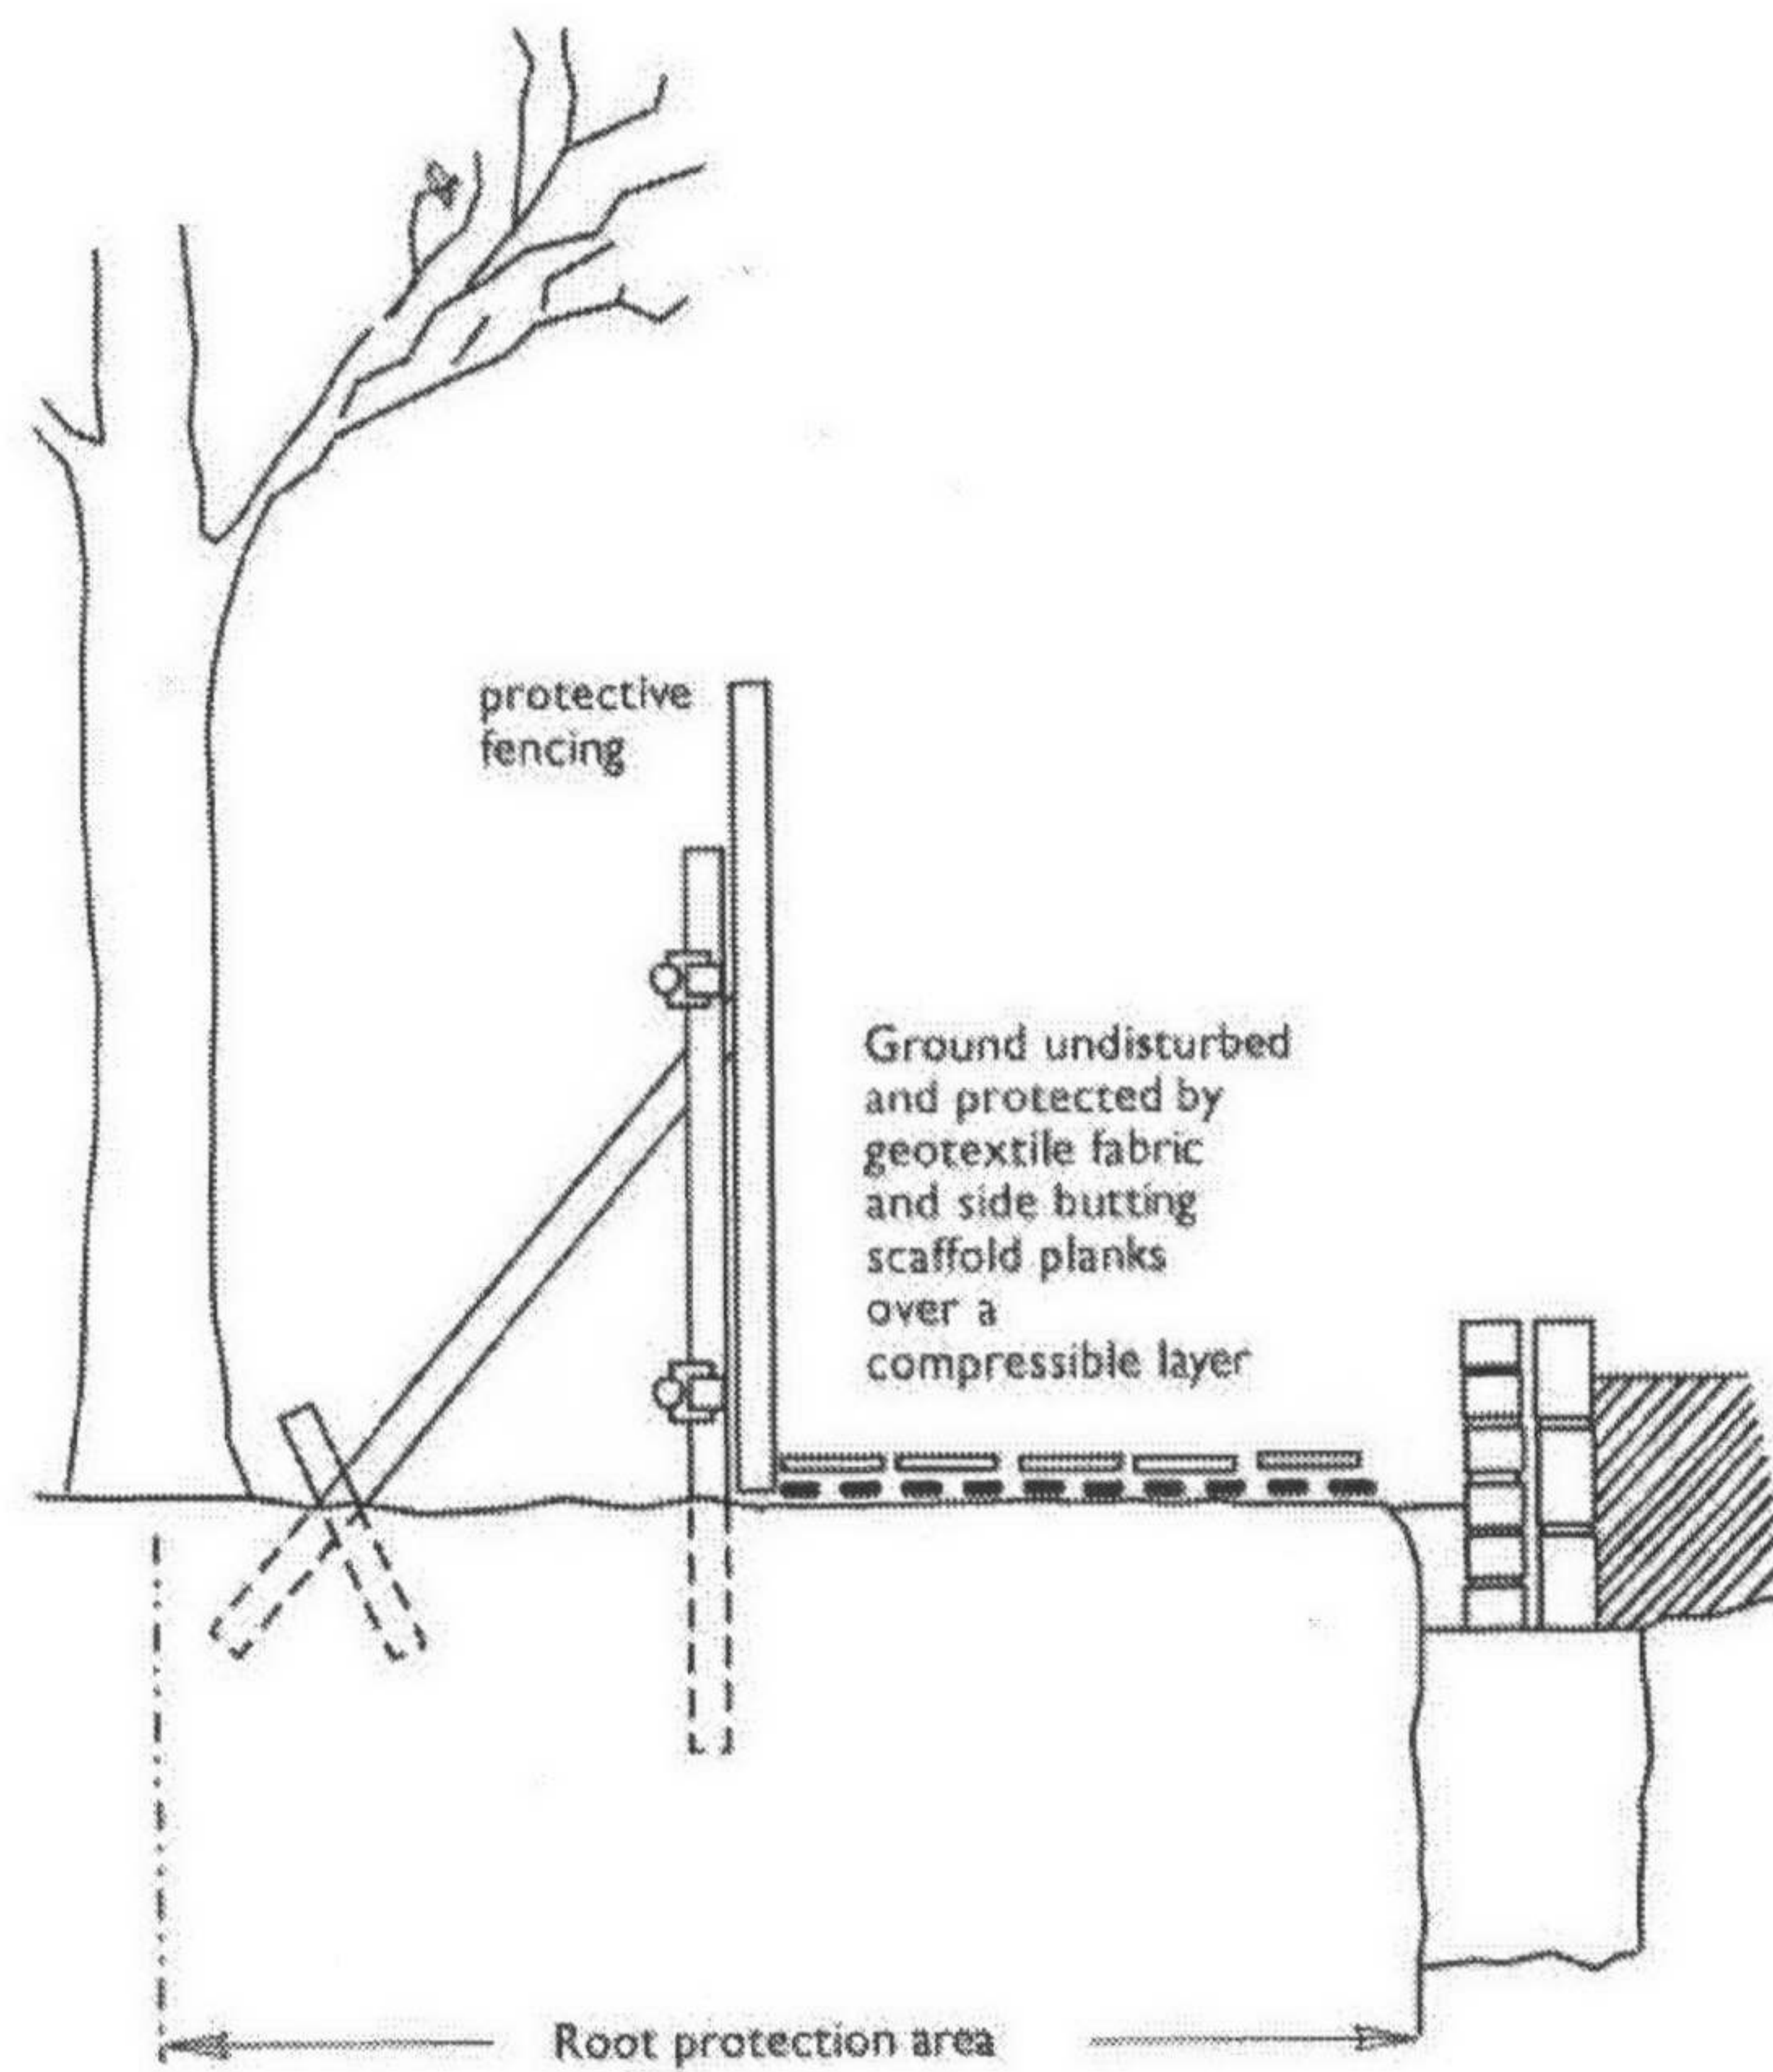
1] Initial stage

Measures for work within the Root protection area - based on BS5837: 2005 Trees in Relation to Construction
