*NHR Joinery Ltd*

**1-2 LINCOLNS INN FIELDS**  
**STAIRCASE CONDITIONS REPORT**  
**(SURVEY DATE 6<sup>th</sup> MAY 2014)**

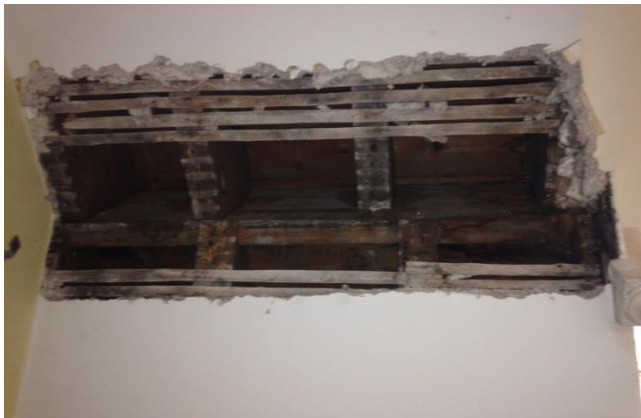
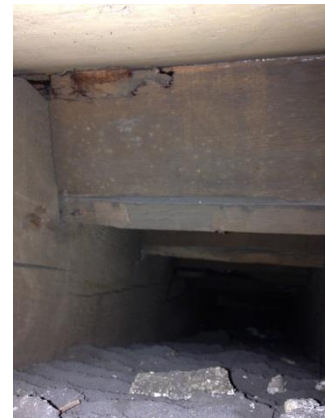
The photograph (below left) shows the exposed underside of the staircase. The 2no sawn softwood carriages are visible. The photograph (below right) shows the wall string with the

treads and risers housed into it. The soffit to the underside of the staircase is of a lathe and plaster construction.

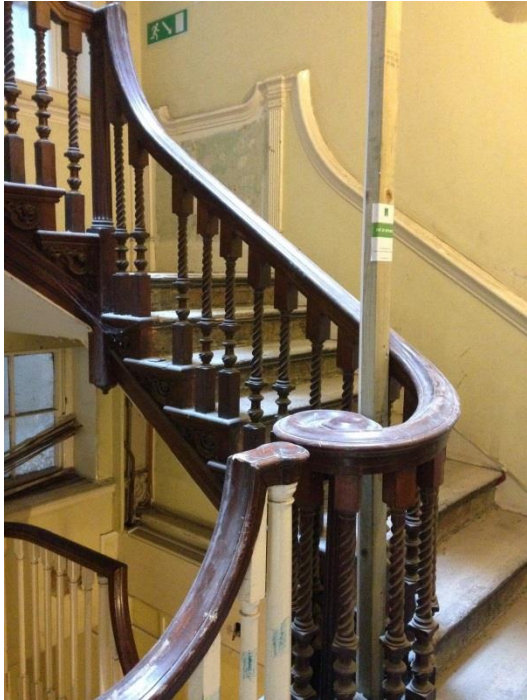
The flight consists of a curtail step with 1no central newel post with rams horn handrail ramping up into straight handrail. Balusters are positioned on the curtail step following the line of the handrail. The flight has 6no treads leading onto the landing.

There are 6no carved brackets to the inner cut string including the tread nosing returns. The second bracket up has carved sections missing and would require attention (Figure 1)

Nosing return to the curtail step is missing and would require a replacement.

18no existing balusters in position with 1no baluster missing on the 5<sup>th</sup> Tread and would require a replacement (Figure 2)

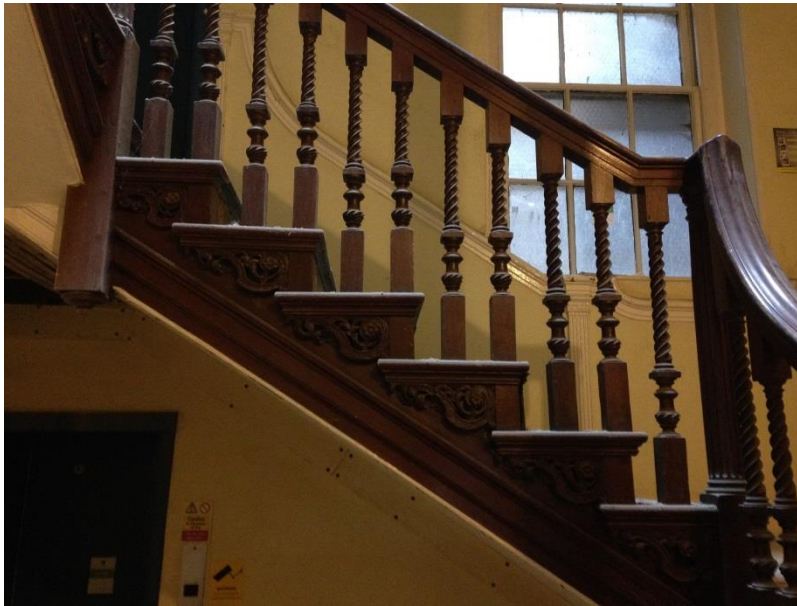
The flight consists of 6no treads leading onto the second ¼ landing.

There are 6no carved brackets to the inner cut string. The first bracket has sections missing and requires attention (Figure 3)

There are 11no balusters to this flight – all present.

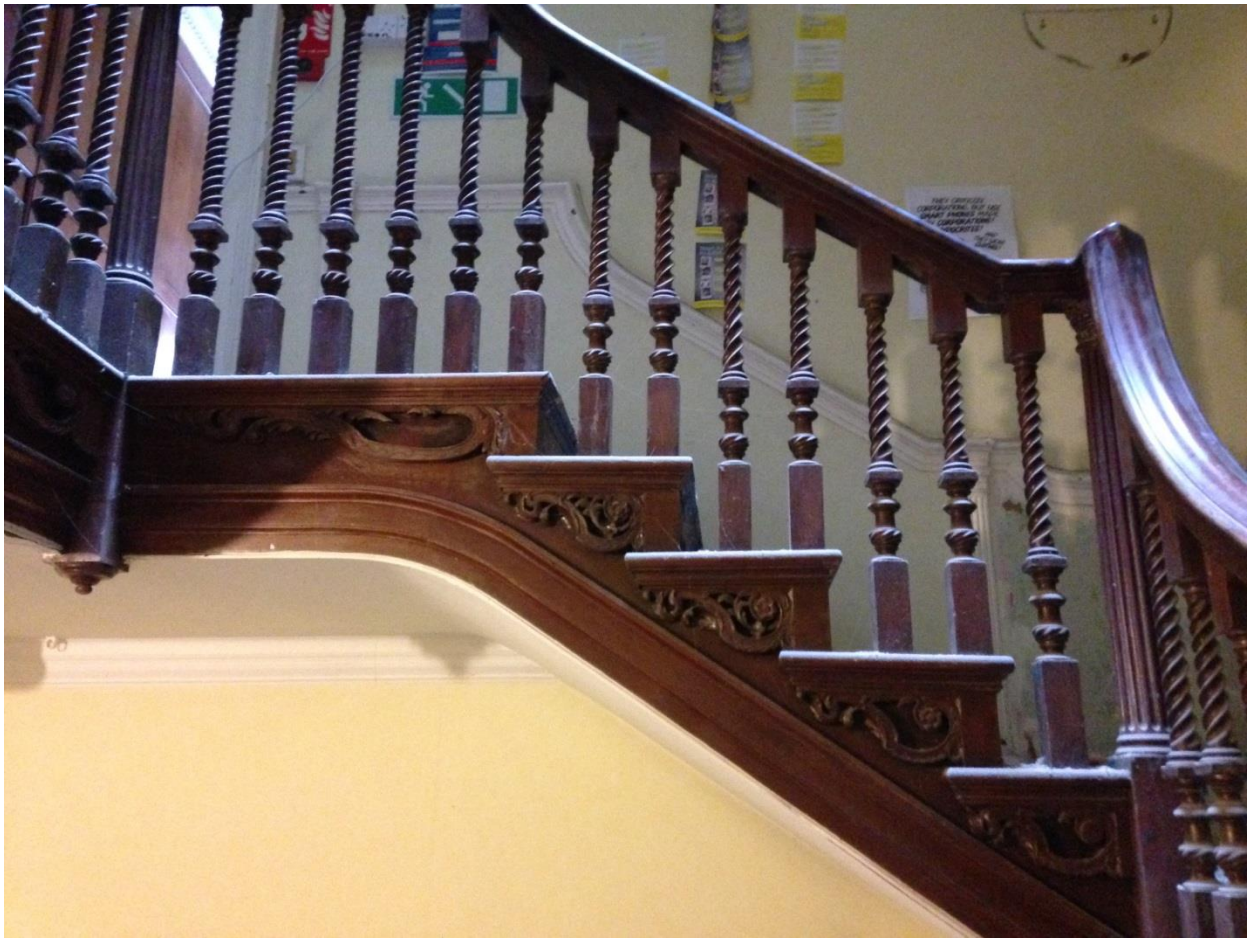
The flight consists of 4no treads leading onto the first split level first floor landing. 13no baluster all present.

There are 4no carved brackets to the inner cut string. The first and second brackets have sections missing and require attention (Figures 4) The carved bracket to the landing also requires attention (Figure 5)

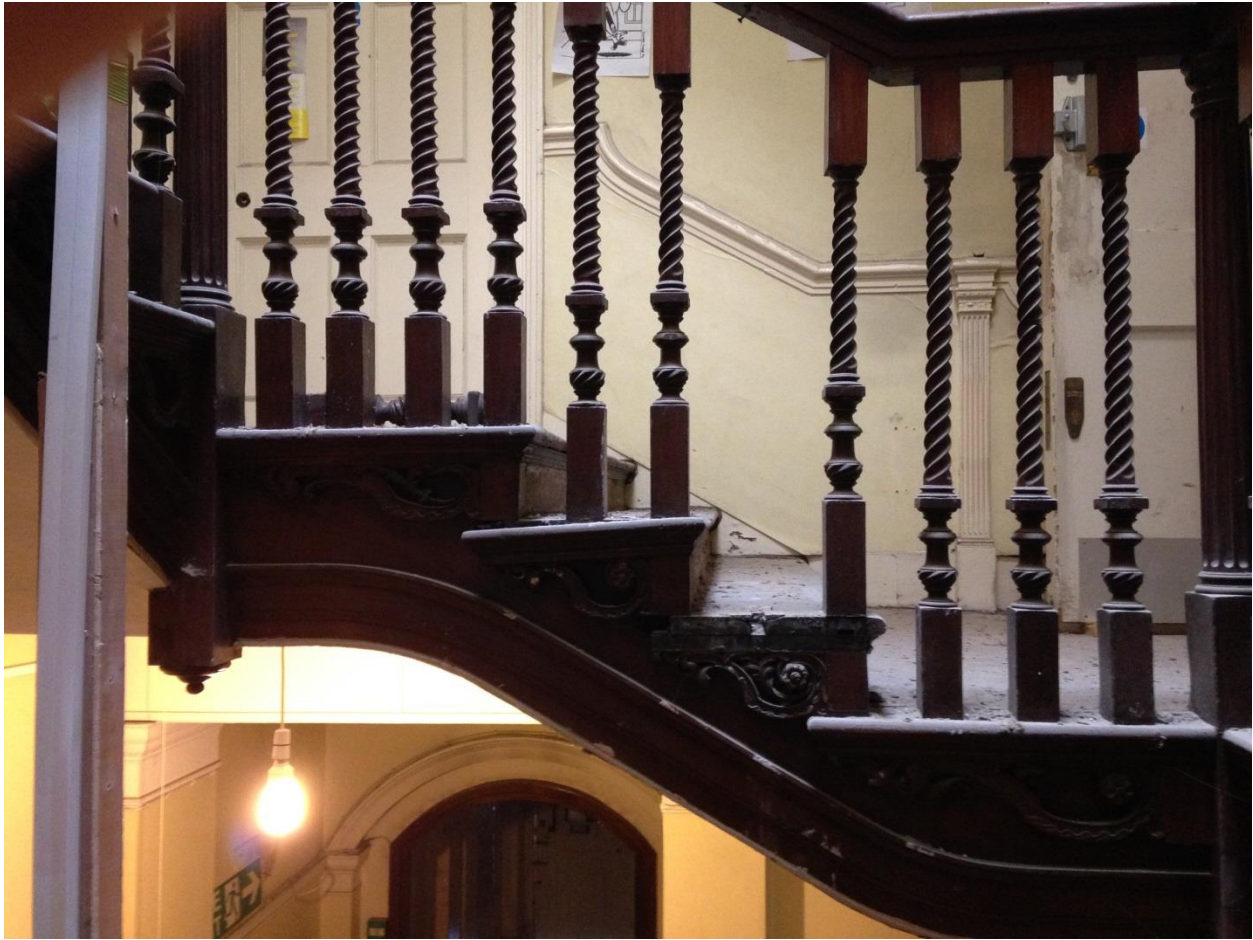
The flight consists of 2no treads leading onto the second split level first floor landing. 10no existing baluster with 1no baluster missing from 1<sup>st</sup> tread.

There are 2no carved brackets to the inner cut string and 2no landing brackets. The second bracket and both landing brackets require attention. Tread return nosing is missing on first tread and is loose on the second tread (Figure 6 & 7)

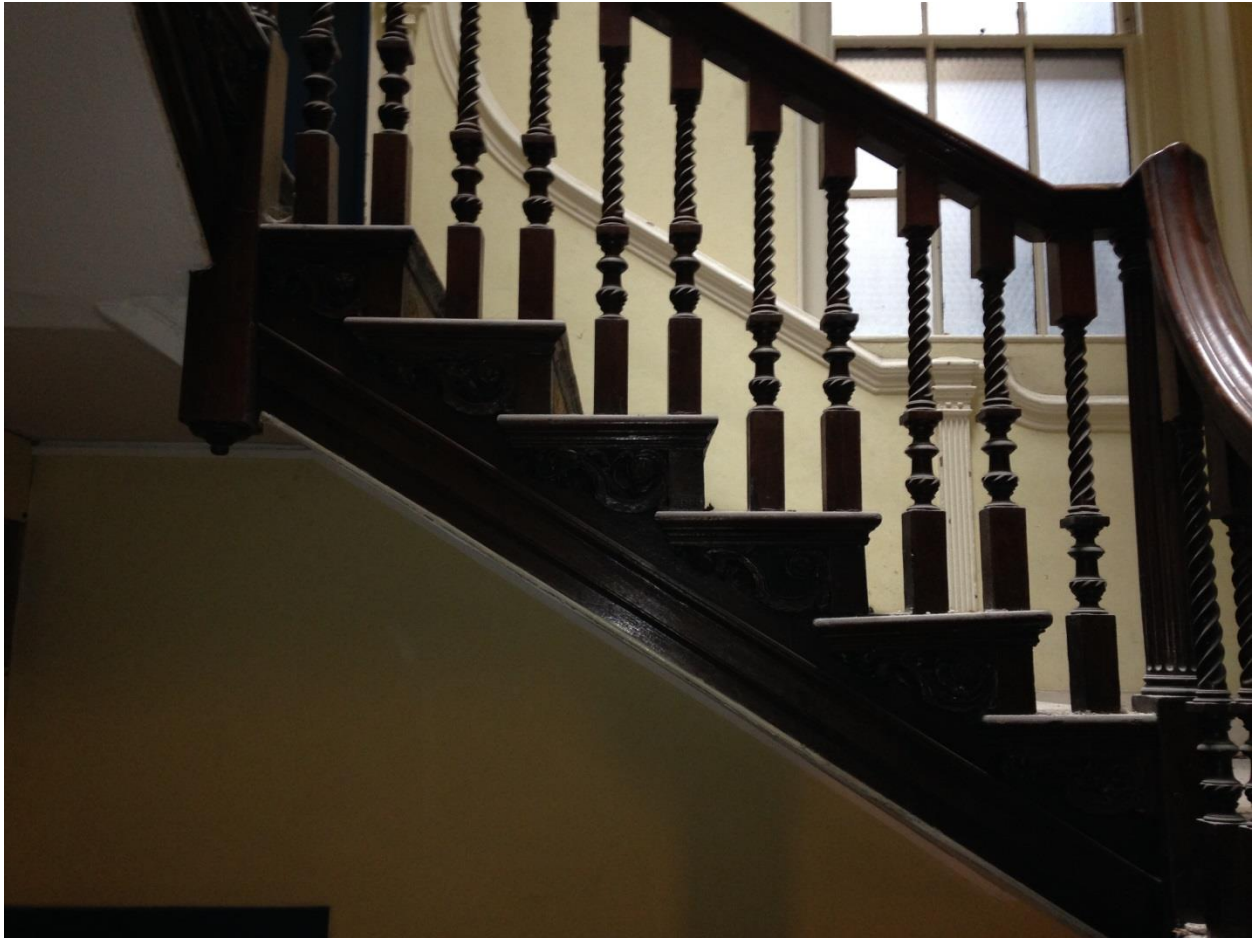
The flight consists of 6no treads leading onto ¼ landing. 11no balusters are all present.

There are 6no carved brackets to the inner cut string with the second and third brackets all having sections missing and all requiring attention. Loose nosing return on tread no2 (figures 9& 10)

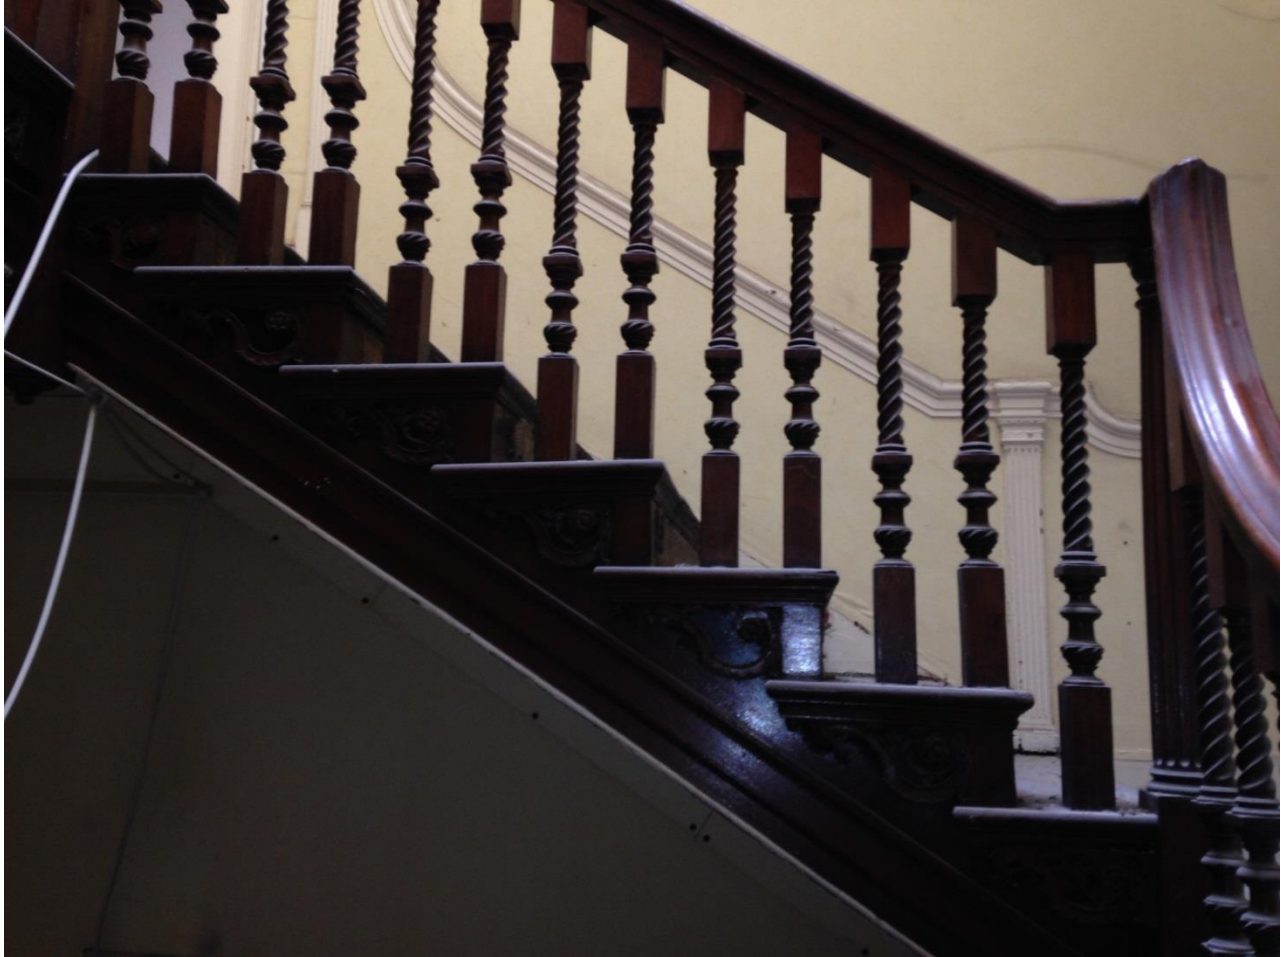
The flight consists of 7no treads leading onto first split level second floor landing. 13no balusters are all present.

There are 7no carved brackets to the inner cut string with the third, sixth and seventh brackets all having sections missing and all requiring attention (figures 11 & 12)

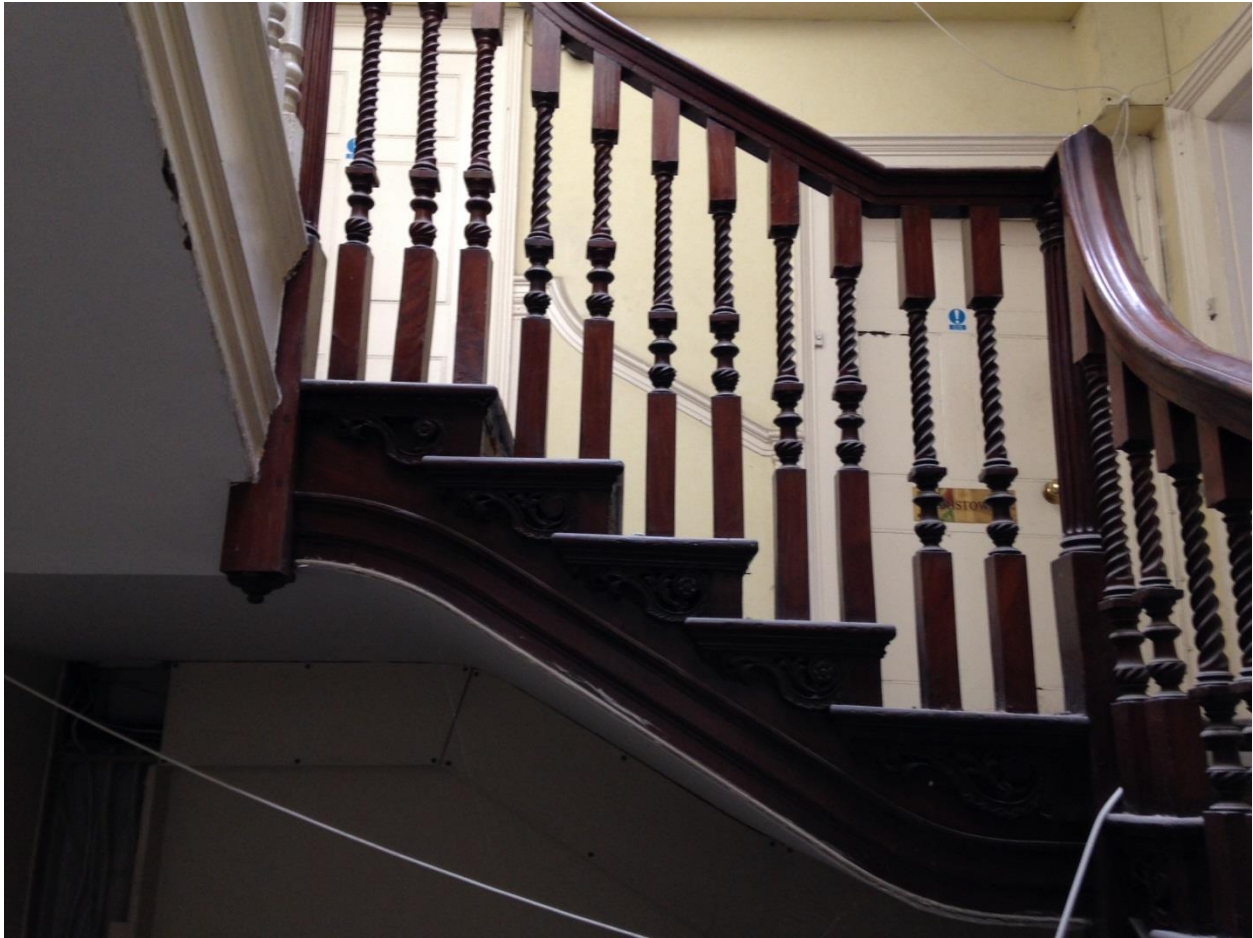
The flight consists of 3no treads leading onto second split level second floor landing. 11no balusters are all present.

There are 3no carved brackets to the inner cut string and 2no landing brackets. The third bracket and both landing brackets having sections missing and all requiring attention (figures 13 & 14)

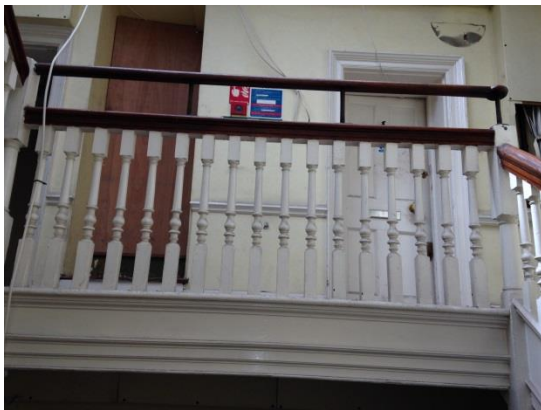
The full landing at the top of the second flight
