Heritage Surveys Limited

Conservation Plan & Statement of Heritage Significance Report

1-28 Levita House
Ossulston Estate
Chalton Street
London
NW1 1JJ

Report date: 9 May 2014

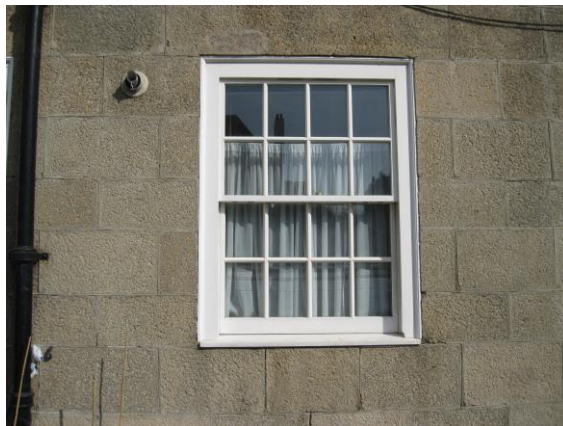
Proposed replacement timber window type as fitted in adjacent part of Levita House

A similar replacement window scheme has been carried out on the immediately adjacent part of Levita House. The proposal is to use windows similar to those previously approved, i.e.; new timber double glazed windows, factory painted in white with sight lines, glazing beads etc. to replicate the existing as far as reasonably practical. The vertical sliding sashes will tilt to facilitate cleaning from inside. This will preserve the visual appearance of the building but at the same time offer residents much improved thermal and acoustic insulation. The double glazing will be provided with glazing bars very similar to the existing with white integral space bars to give the appearance of a through,
