59 Birkenhead Street Camden London WC1 Heritage Statement

14 April 2014

1.0 Introduction

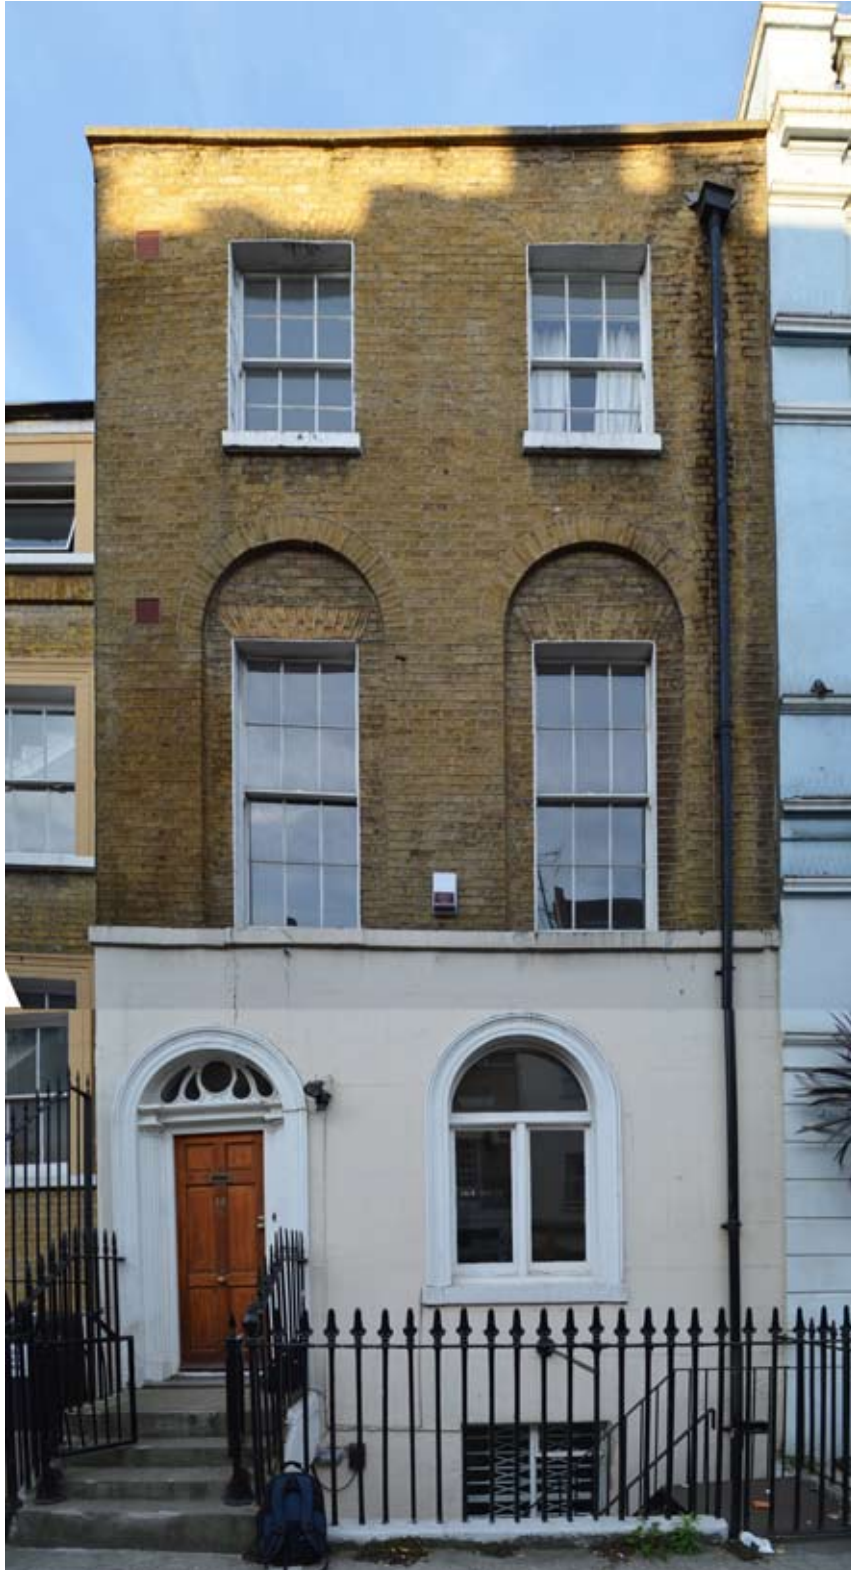
No. 59 Birkenhead Street today; the ground-floor render and architraves are probably Victorian additions, while the windows are all 20th century.

The front façade from ground floor to second floor is Highly Significant as it retains much of its late Georgian character. The replacement of the windows and rendering of the ground floor has reduced its aesthetic value but the original design can still be appreciated.

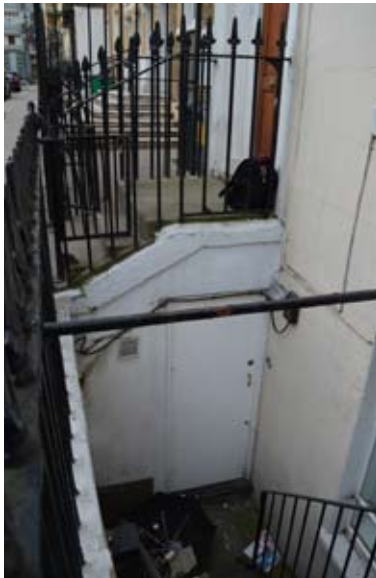
No. 59's basement area with modern door.

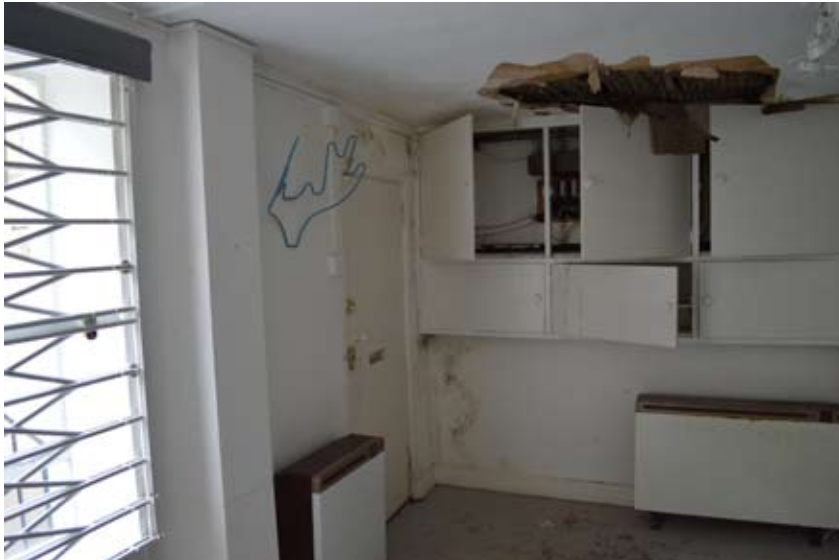
The front basement room showing the modern utilities cupboards on the south wall.

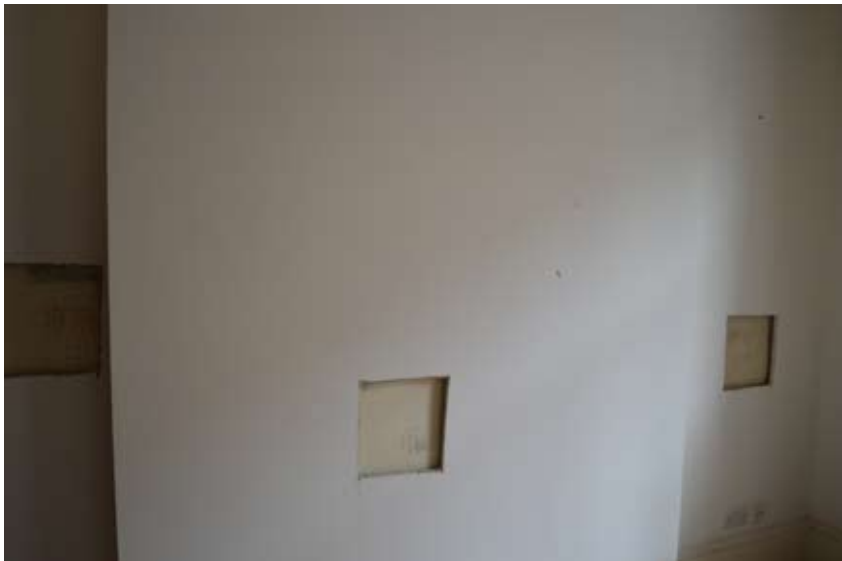
The recent flooding has caused damage to the lath and plaster ceilings in the entrance hall and front room: some of the ceilings have fallen or had to be cut away, while nearby areas of the ceilings and also the walls appear in need of repair and/or replacement. The water has

The north wall of the front room, with dry lining cut away to show the original wall behind.

In some cases, where large sections of ceiling plaster have already collapsed, it is proposed to remove and replace what remains, essentially because, although still in place, the ceilings have become de-bonded and there is the strong likelihood of further collapse. In such cases, the removal of extant plaster would allow for full inspection (and repair as necessary) of the ceiling joists. Ceilings would be replaced with lath and plaster, using a lime-based plaster reinforced with horsehair. It is also proposed to replace some badly-damaged cornices considered to be at risk of further collapse. Moulds of the existing cornices would be taken to ensure that the replacement cornices exactly match. The new cornices would be constructed of lath and plaster, using a lime mix reinforced with horsehair.

Similarly, in some cases, wall plaster would be removed where plaster has become saturated or has blown to allow underlying masonry to dry out (and be repaired as necessary), or to allow for the full inspection (and replacement where necessary) of timber studwork. Lath and plaster, using a lime-based plaster reinforced with horsehair to match the existing, would be reinstated. The basement staircase, the lower part of which has rotted, would be removed to allow repairs to be undertaken to the adjacent wall; it would be reinstated using as much of its fabric as practicable.

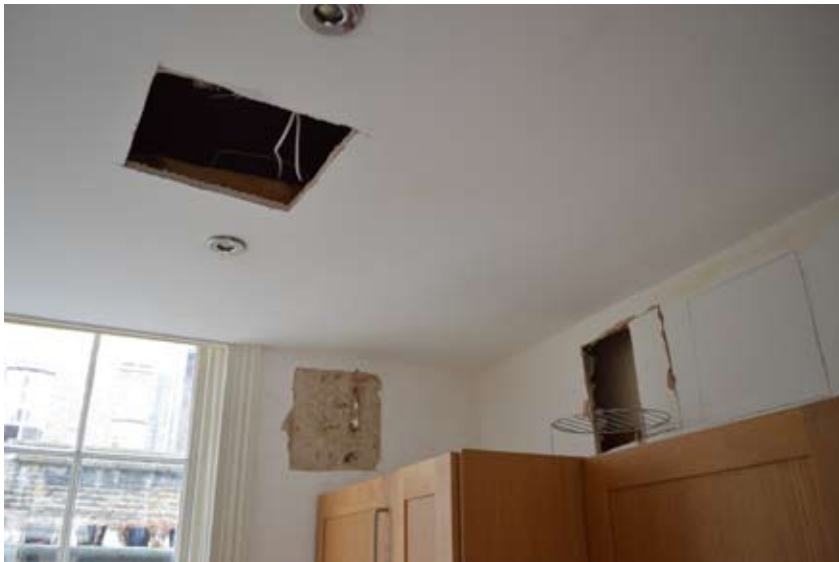
The suspended ceiling and dry lined north wall in the rear room. Both have since been removed.

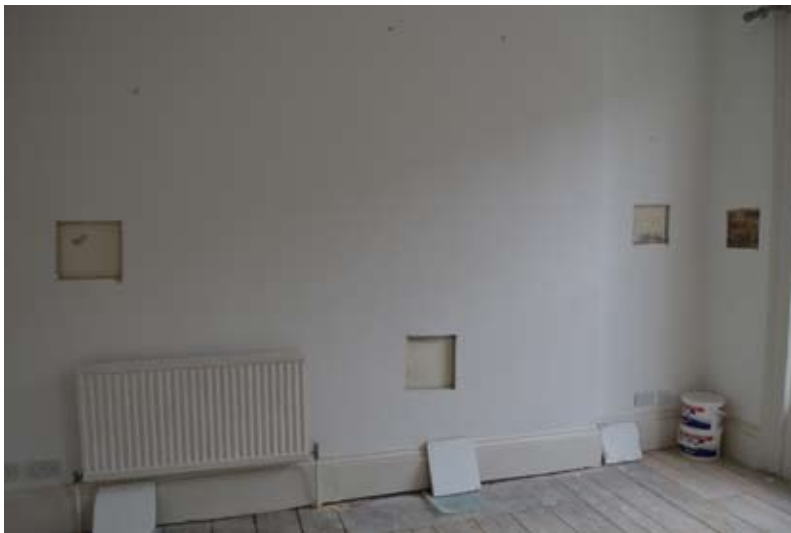
The dry-lining in the north wall cut away to show the original wall behind. (The dry-lining has since been removed.)

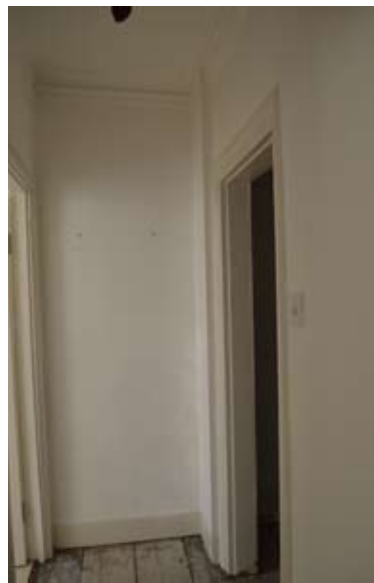
The lobby between the bedroom and bathroom, showing the disruption caused to the original room volume and to the cornice by the partitions and trunking.

The second floor front bathroom Detracts, as it disrupts the original room volume and has caused the localised removal of the historic cornice.

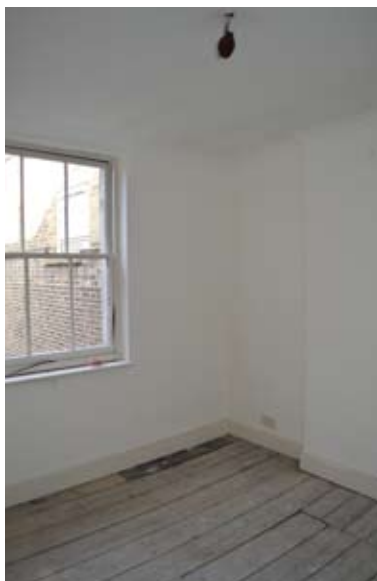
The rear room, with modern sash window and coving.

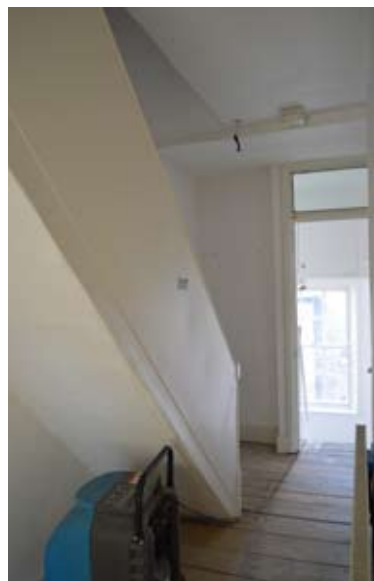
The corridor and staircase, with the modern partition blocking light from the staircase beyond.

beneath, while the party wall to the west was, at the time of the site visits, dry-lined. The dry-lining has since been removed. The modern installation of stud partition and door at the stair head has ruined the sense of space that originally existed, as well as taking away the daylighting of this landing from the staircase window. The original balustrade remains behind the partition and could be reopened to view. A hidden water tank has been installed over the main staircase, which has unfortunately reduced the volume of the space, although the large west window has been left intact.

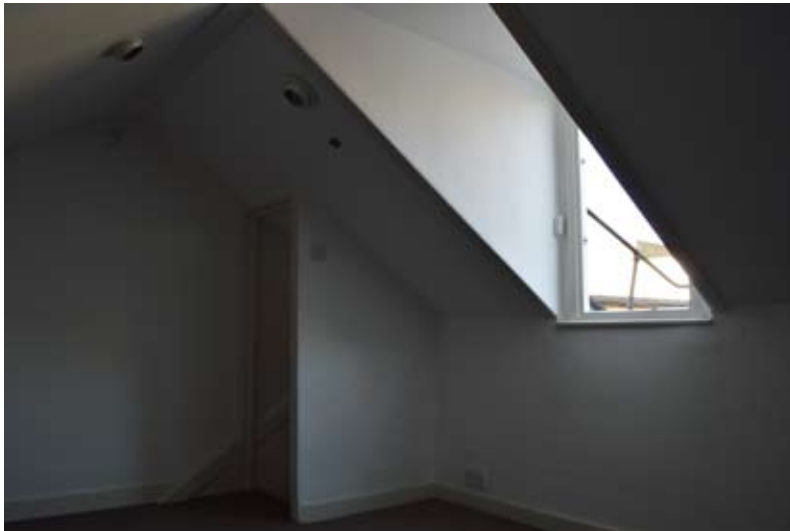
The doorway is very plain but may be historic. The room has been dry-lined with plasterboard, obscuring the roof structure. The dormer window facing west is a modern insertion but may stand in place of an original opening. The underside of the roof is visible through openings in the walls: the rafters do not form a truss with the joists but run to the side of them, and the roof may thus be 20th century in date. Above the rafters is modern felt sheeting topped by boards and modern slates, so that any historic battens have long since been removed.

The third floor, with the modern dormer to the right and the doorway beyond.
