**DAMAGE ASSESSMENT REPORT  
OF  
NEIGHBOURING STRUCTURES  
DUE TO EXCAVATION AT**

**99A FROGNAL, HAMPSTEAD,  
LONDON, NW3 6XR**

**REF: 214073 - MARCH 2014**

RIBA Stage C - Damage Assessment Report

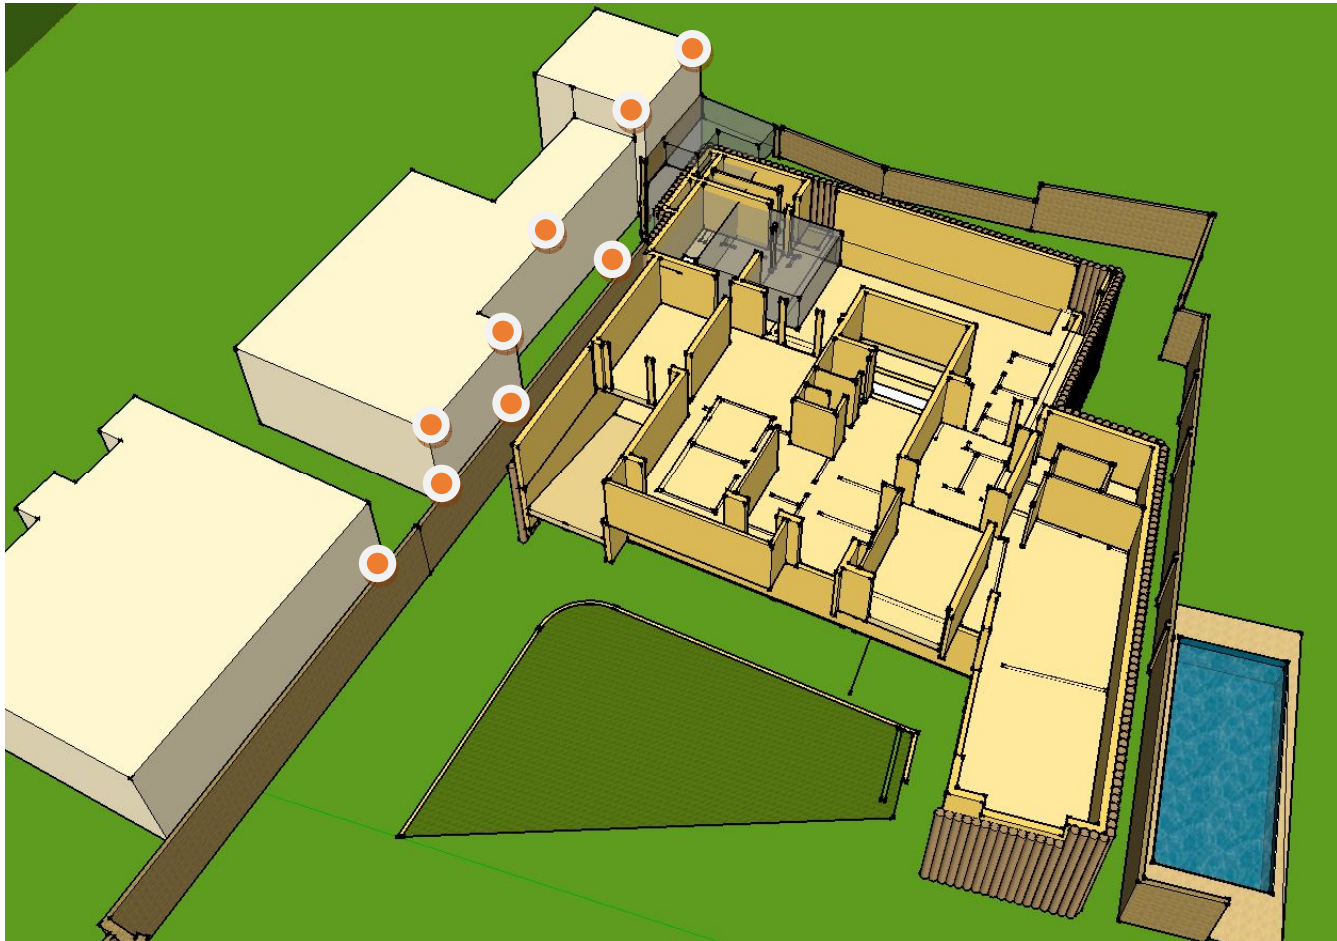
Figure 8 - target monitors to no.4 Oak Hill Park.

- 5.11 In order to understand the relative levels and proximity to neighbouring structures a model of the proposed development has been prepared. The dots indicate the location of level monitoring targets to be installed on the neighbouring structures and boundary walls.

- 5.7 A wall separated no.4 from the development site. See photographs 5 and 6. The wall was approximately 2.5m tall with a wider low plinth and frequent buttress piers. The wall had an outward lean of approximately 70mm at the head. This was longstanding with no evidence of progression. Level monitoring will be required at the head of the wall and we recommend flying shores are adopted to prevent any progression.
