Conservation Plan & Statement of Heritage Significance Report

**1-28 Levita House
Ossulston Estate
Chalton Street
London
NW1 1JJ**

Ref: SEB/181

Report date: 9 May 2014

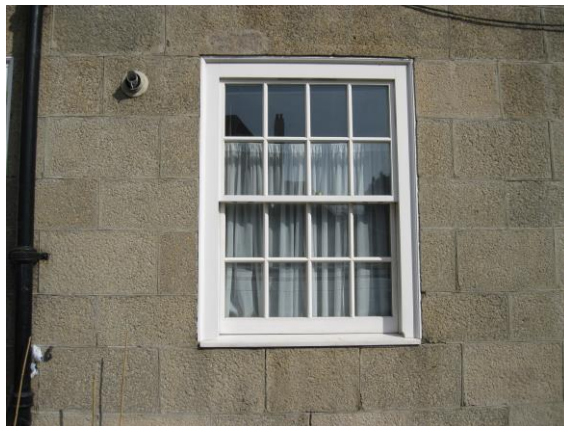
Proposed replacement timber window type as fitted in adjacent part of Levita House

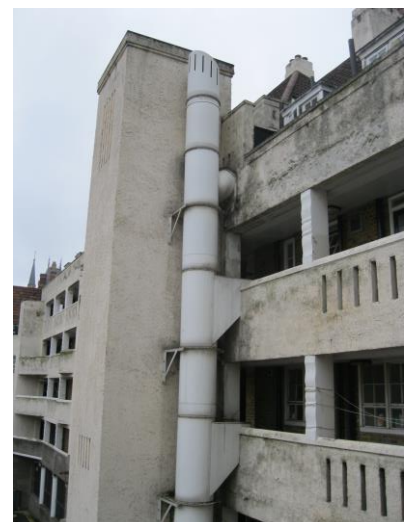
It is acknowledged that Levita House was one of the original social housing designs to include refuse chutes. In our view the original would have been in what is now the lift shaft, and the steel tube is not in the original position, nor in accordance with the original design intent.

The proposal is to remove this and reinstate communal access balcony walls to match the adjacent original design.

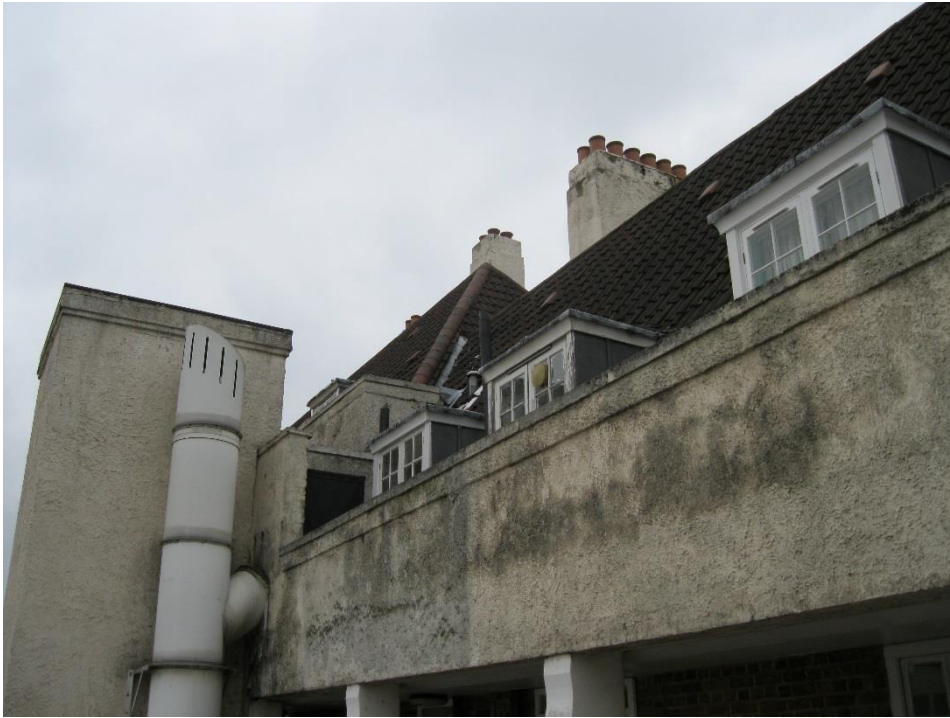
Photograph 1 **Front Elevation (Part) Courtyard**

The external walls are of load bearing brickwork with a stone effect façade to the ground storey, and thereafter finished with a painted roughcast render (Photos 1, 2, 3, 4 and 24). The access balcony elevations are finished in yellow stock brickwork with red bricks to the stairs.

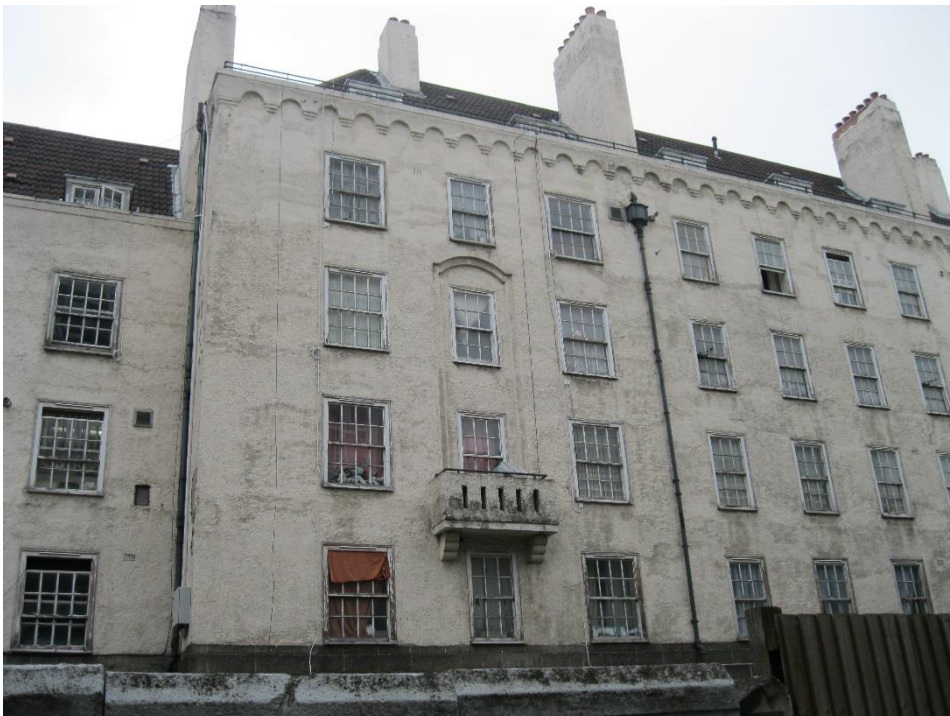
Photograph 2 **South East/Rear elevation – part Weirs Passage**

Construction is of load bearing brickwork, rendered with coloured rough cast finish with ground floor elevations to appear as stonework (photos 2 and 3). Reinforced concrete communal access balconies are provided.

The existing windows comprise mostly flush framed vertically sliding sash windows with exposed boxing to the shear elevations. Dormers are side hung casement windows and on the communal access balconies they are predominantly bottom hung open inwards "hopper" windows. (Photos 2, 3, 16 and 17).

All windows are single glazed timber and are in a poor state of repair. They have reached the end of their serviceable life with evidence of timber decay, extremely poor decorations, glazing defects, draughts and poor levels of thermal insulation.

To comply with modern standards, it is proposed to replace all of the windows. The principle of installing double glazing has been established elsewhere in the listed estate (plasesee1.8 earlier).
