Arboricultural Assessment Report

Summary Report on Trees

For:	Client:	Oriel Services Limited
	Insurer:	Aviva
Site:	Policyholder:	14 Greville Road Management
	Risk Address:	Flat 4, 14 Greville Road, London, NW6 5JA
Refs:	OCA Ref:	55206
	Client Ref:	7489761
	Insurer Ref:	9590302120

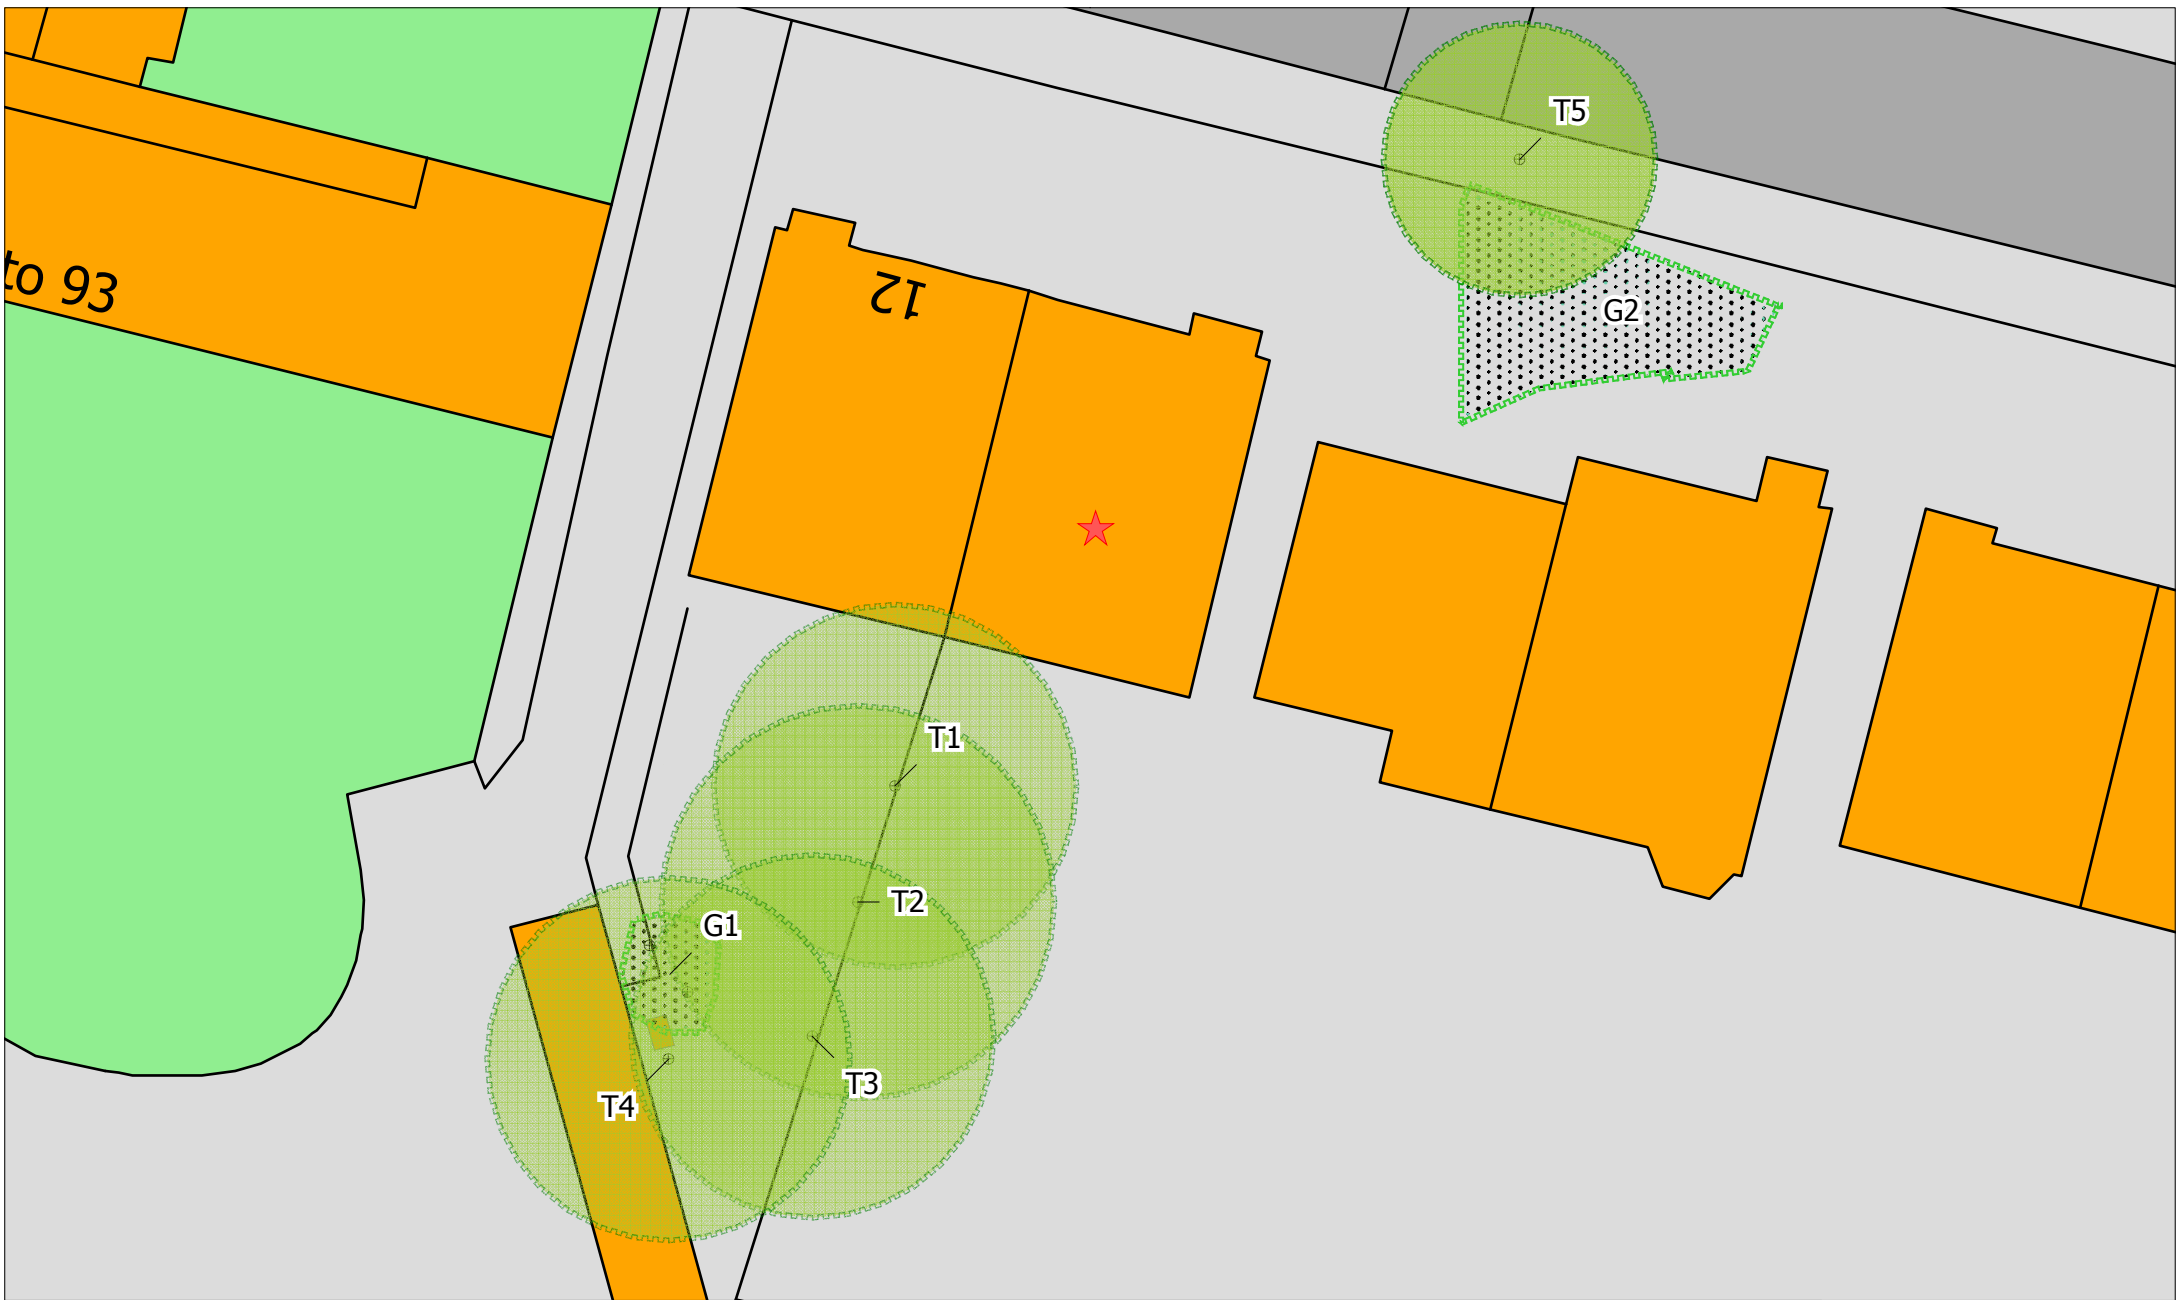
Location: 14 Greville Road, London, NW6 5JA
Job Ref.: 55206
Survey Date: 28/11/2013
Scale: 1:250 @ A4

Tree No	Common Name	Age Class	Condition	Height (m)	Crown Spread (m)	Stem diam. (mm)	Dist to bldg (m)	Pruning history	Recommendation	Tree work constraints	Notes	Owner address	Owner
T3	Sycamore	MA	F	18	12	800	17.3	Crown lifted.	Fell and treat - for health and safety	Overhangs adjacent substation	Significant cavity and decay in main trunk.	12 Greville Road, London, NW6 5JA	3P
