In response to site meeting 07.03.14

Robin Cripps Restoration (stone restoration specialists) were commissioned to compile a specialist report on the existing front entrance stone detailing the repair to replacement of the stone to the entrance, the entrance steps and carry out a survey and report on the condition and repair of the existing internal entrance corridor. This report was prepared by Lee Harris (Director) and is outlined on the following and attached documents & drawings.

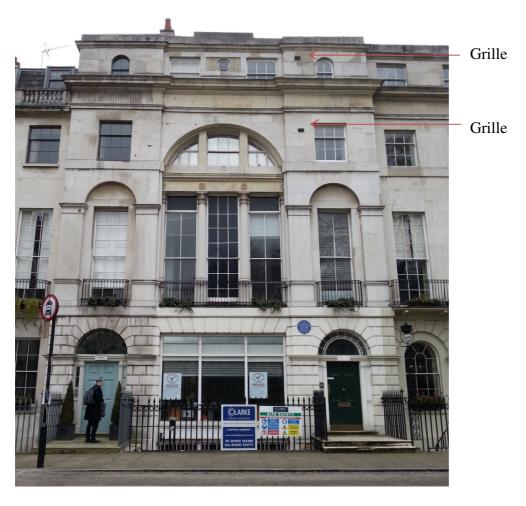
As discussed, it was not part of the façade cleaning proposal to remove these cast iron grilles as our approach considered these as a noteworthy evidential part of the buildings historic development, through various uses and phases over time. As the building was used as commercial, banking as for a significant time as a hospital, these were considered as remaining traits of its historic storyline as an important part of the buildings evolution and would been retained.

If this is not agreeable a careful patch repair would be carried out if removal is requested.
