**41 / 42 CHESTER TERRACE
STUCCO CONDITION REPORT.
Rev A.**

Author R Greer

Dated 15th July 2014

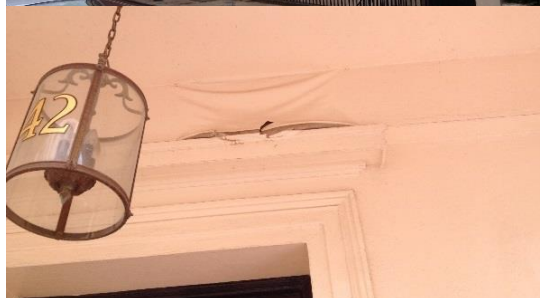
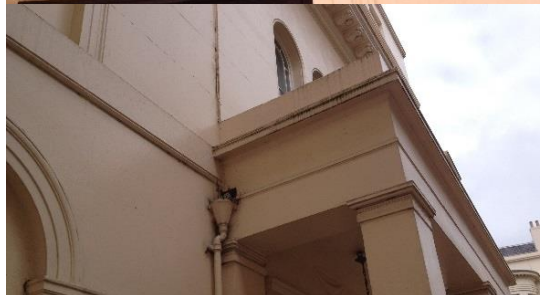
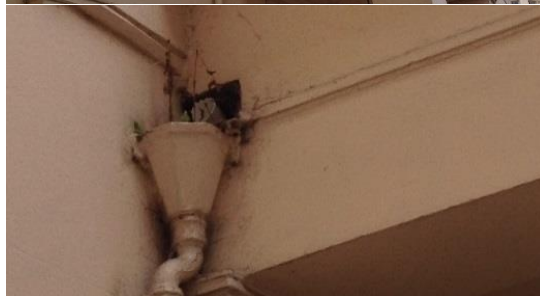
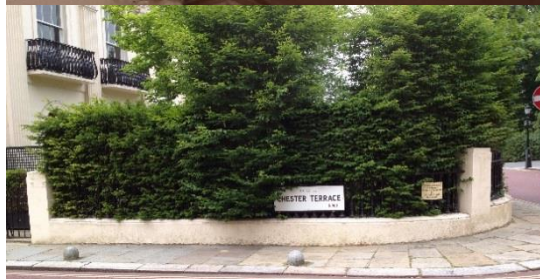
- 13 The boundary wall to the Cumberland Place elevation is constructed of three bays.

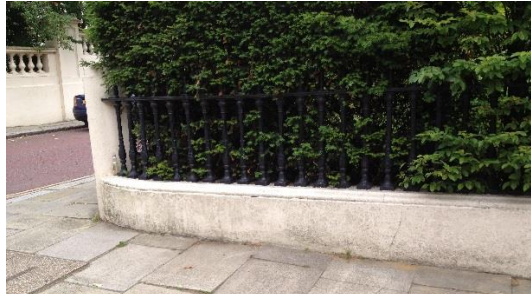
- 19 The outer circle boundary wall comprises of 5 bays of cast iron balustrading set between cementitious rendered brick piers. The decorations are in a poor condition due to traffic pollutants and the texture of the stucco.

- 20 The vegetation covers a considerable amount of the railings and it is difficult to determine the condition of the iron railings.
- 21 The pier between bays 1 & 2 is showing signs of fracture in two levels.

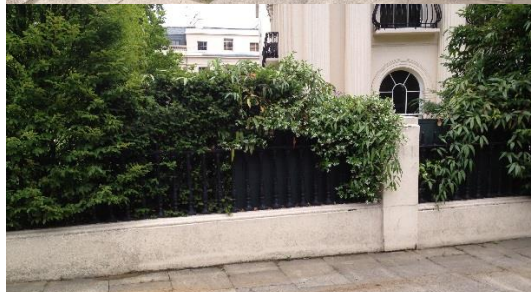
- 22 The connection between the pier and the boundary wall has fractured which is most probably due to the dissimilar thermal movement patterns of the masonry and the cast iron.

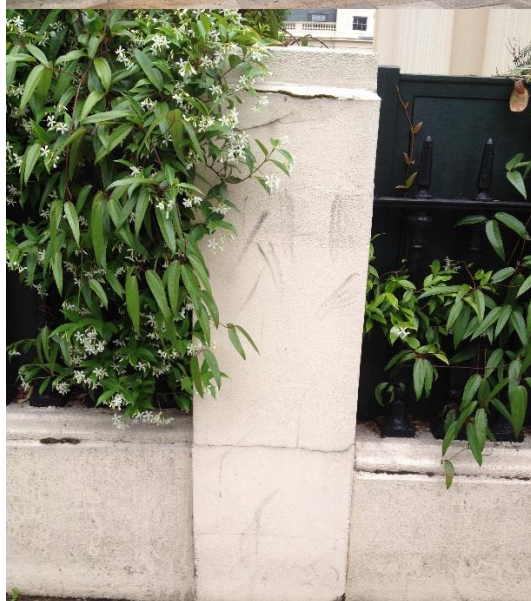
- 23 The stucco render just below the capping stone has blown which is most probably attributable to the saturation of the pier cap and water ingress through incorrectly applied stucco renders.

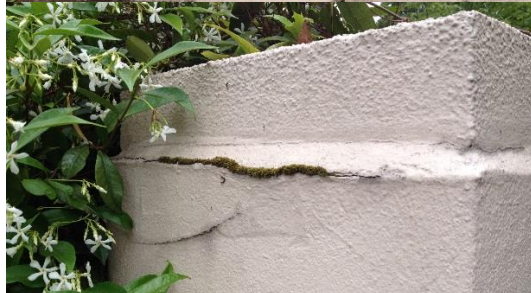
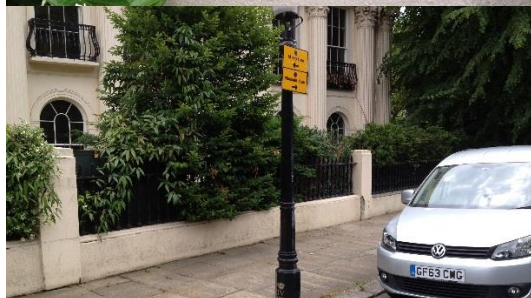
- 24 The stucco to bay 2 walling is in a reasonable condition and requires cleaning and redecorating.
