SOAS into Senate House

Information in support of LBC Condition 8

Document Number: 28731-SOAS-A-REP-XXX-XX-006

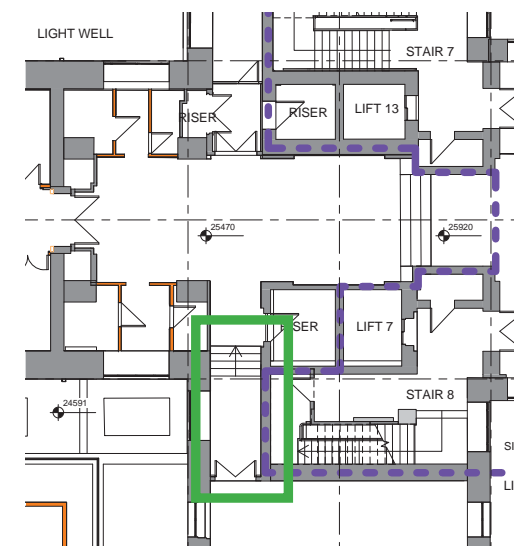
Ground Lobby G05 existing

- 1 existing travertine, unaffected
- 2 existing terrazzo replaced as noted on following page

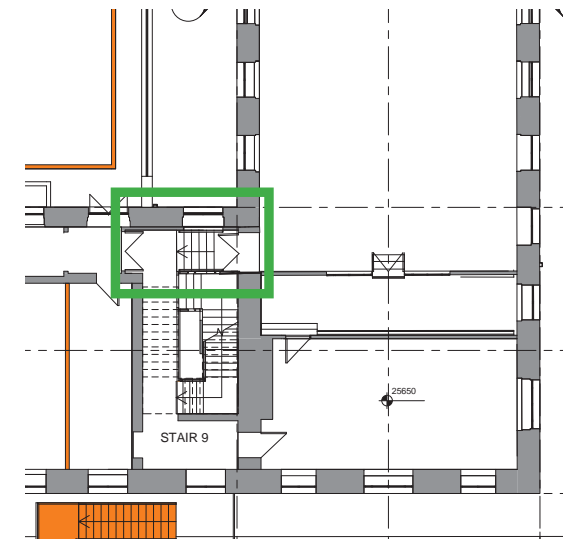
Ground Lobby G21 existing

- 1 existing terrazzo unaffected
- 2 existing terrazzo replaced as noted on following page

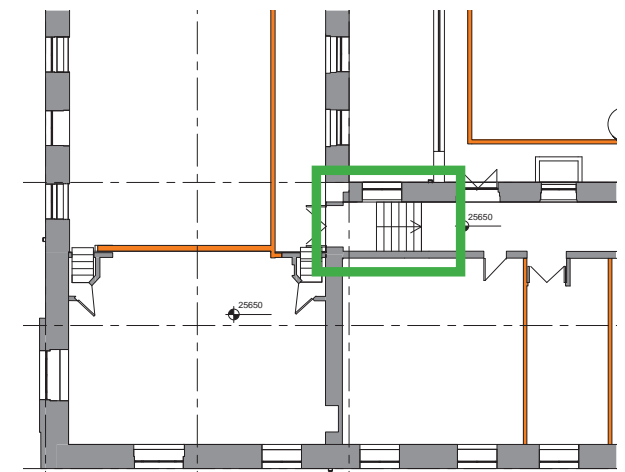
Ground Corridor G12 existing

- 1 existing terrazzo unaffected
- 2 existing terrazzo replaced as noted on following page

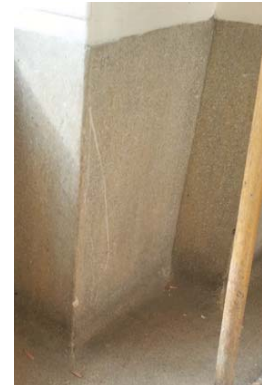
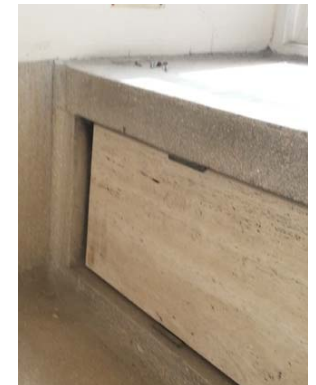
480mm skirting

general condition, tiled infill only visible on 3rd floor, tiled infill generally painted over elsewhere, or not present. Instances vary

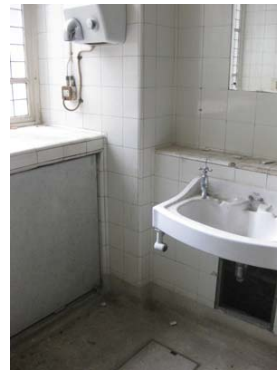
LG. 41-45, LG.08

existing terrazzo with vinyl sheet and sheet adhesive. All to be replaced
