**section 3** conservation  
principles

# section 4 elements

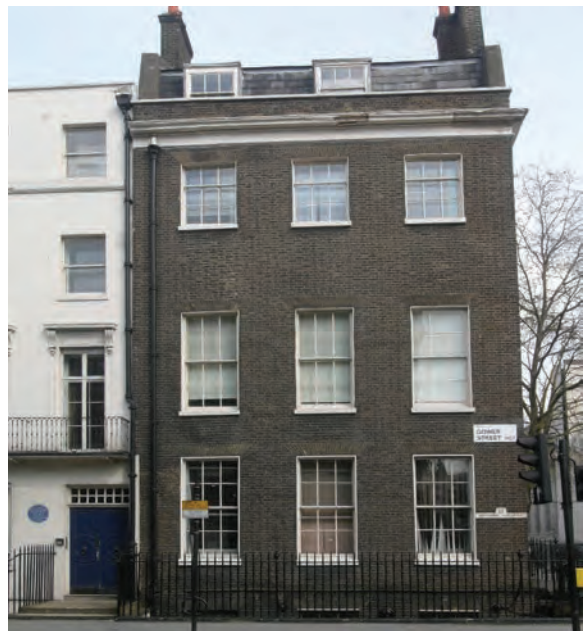
- The second floor stucco cornice shows signs of weathering.
- A modern television aerial is fixed to the northern chimney and detracts from the significance.

- The rainwater pipe is cast iron.
- There is a metal address sign on this elevation as well as a modern road sign.

- Investigations should be made into the source for the deterioration of the cornice and remedial work planned (5.1).
- Consideration should be given to relocating the television aerial (6.6).
- Changes should be documented (3.1, 3.3 and 3.5).
- Work to the windows should be part of a planned maintenance programme (5.1).

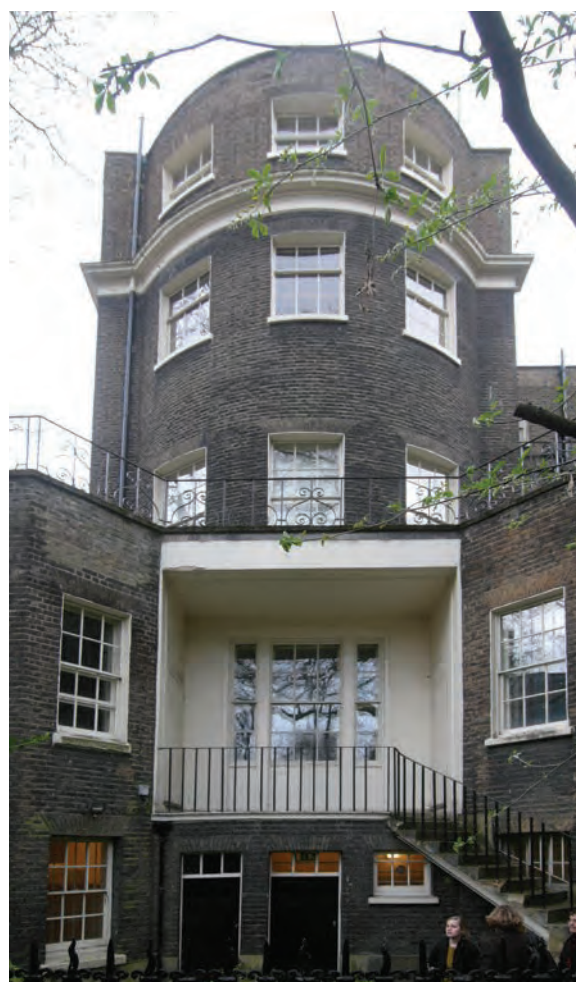
- The brick window reveals were originally unpainted. Now they are painted white.
- The ground floor balcony is finished with substantial stone flags. The stairs appear to be of cantilever construction but are now supported by a steel joist. The railings to the balcony and external stairs have missing rails and show signs of wear and tear.

- An external cementitious tanking system has been applied to the first five or six courses of brickwork.
- The northern rainwater system from the flat roof is in cast iron, the southern is in modern plastic. The soil vent pipe is cast iron.

- The lower ground floor doors are an escape route from the building.

- Consideration should be given to the removal of the felt (5.2, 5.4).
- The stair railings should be part of a planned maintenance programme (5.1).

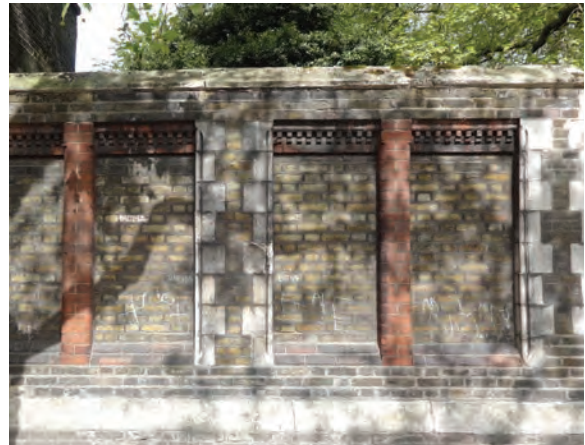
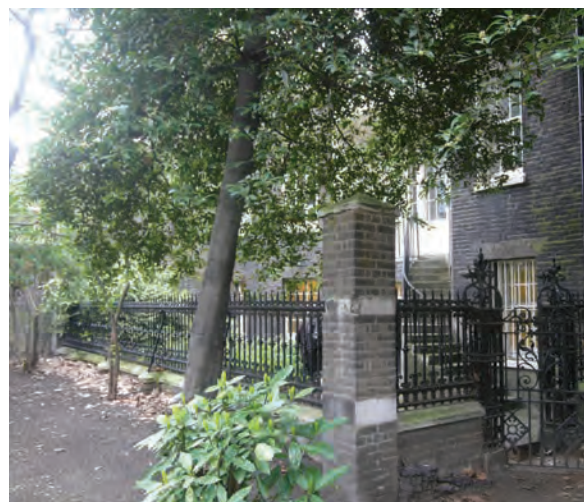
## Garden

Assessment: **Generally: Some Significance**

- The rear garden was reduced in length in the late 1890s and is described on a 1896 plan as a 'basement yard'. The original garden extended to Malet Street where there was a stable and coach house. The garden is at basement level and is part paved with stone flags and part cement flags.
- The eastern part of the original garden is now part of a shared private garden for the use of 11 Bedford Square and 2-20 Gower Street.
- The private garden of 11 Bedford Square is enclosed by railings on a low brick and stone plinth wall with a gate and gate posts, probably designed by Doll. They are a fine example of late Victorian iron work and are in good condition. Similar railings enclose the private gardens of the neighbouring Gower Street houses.
- There is a modern raised planter against the 1890s wall and railings.
- Recent tree planting overshadows the east façade.

- Changes should be documented (3.1, 3.3 and 3.5).

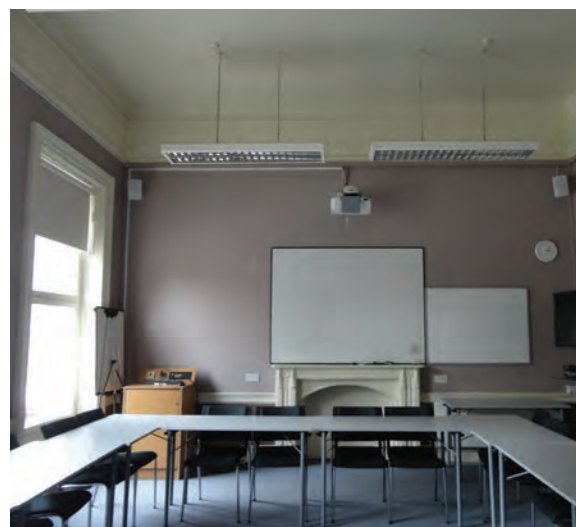
### First Floor West

Assessment: High Significance

- Original features include the fireplace, ceiling frieze, dado rail, skirting, sash windows, panelled doors, architraves and panelled reveals.
- There is timber secondary glazing over the windows.
- There is a small modern door to the space behind the lift.
- There is evidence that the room was previously divided by partitions.
- The room suffers from traffic noise and solar heat gain.
- The surface wiring and modern lights detract from significance.

- Ad hoc services should be removed (6.6).
- Changes should be documented (3.1, 3.3 and 3.5).

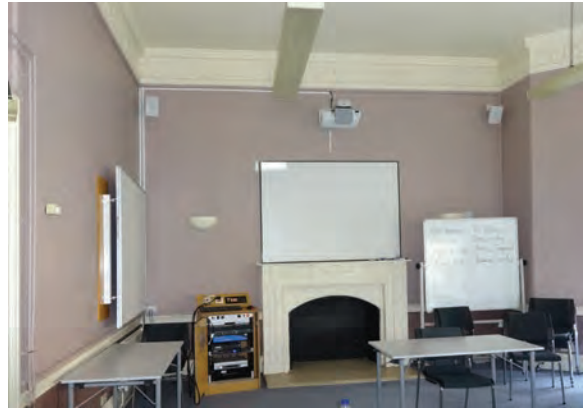
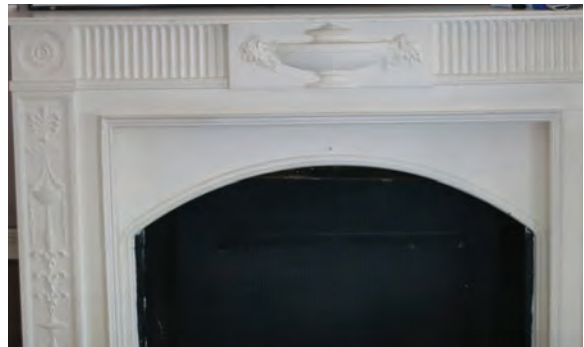
## Second Floor West

Assessment: Significant

- Ad hoc services should be removed (6.6).
- Changes should be documented (3.1, 3.3 and 3.5).

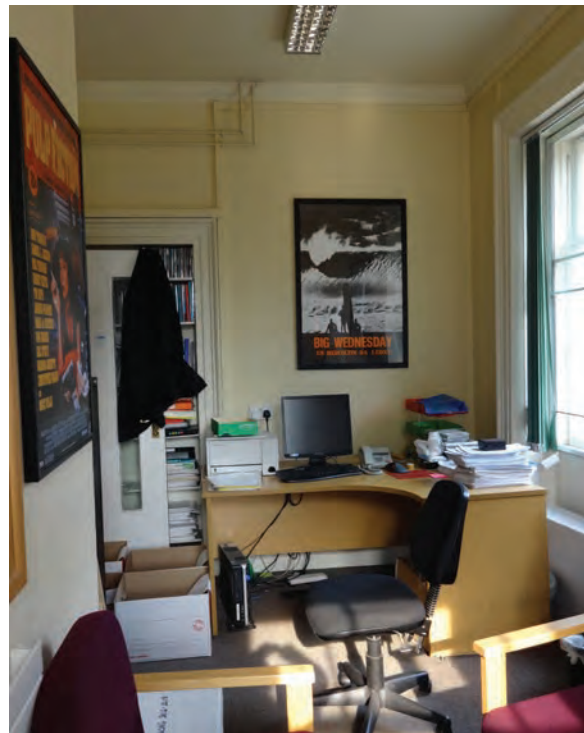
## Second Floor Side Rooms

**Assessment:** Generally: Some Significance  
Lift: No significance

- Ad hoc services should be removed (6.6).
- Changes should be documented (3.1, 3.3 and 3.5).

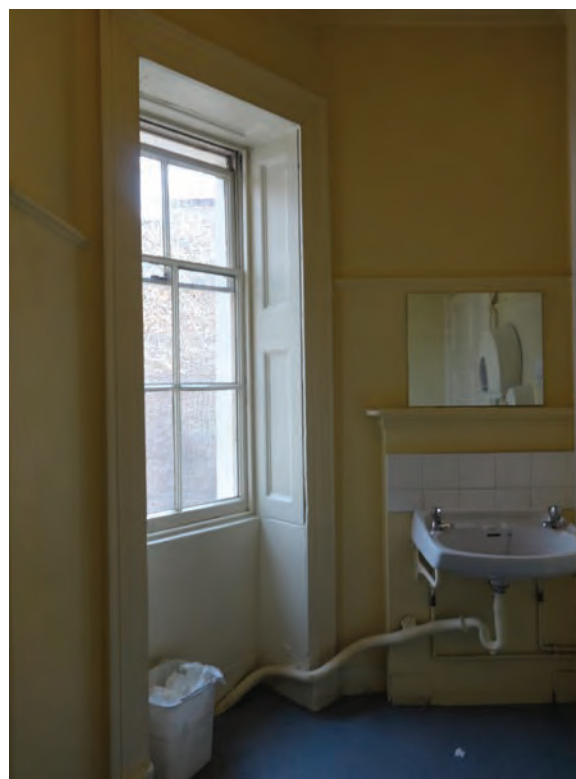
## Second Floor East

**Assessment:** Significant

- Ad hoc services should be removed (6.6).
- Investigations should be made to check if there are ceiling voids for the lower sash windows to slot into (5.4).

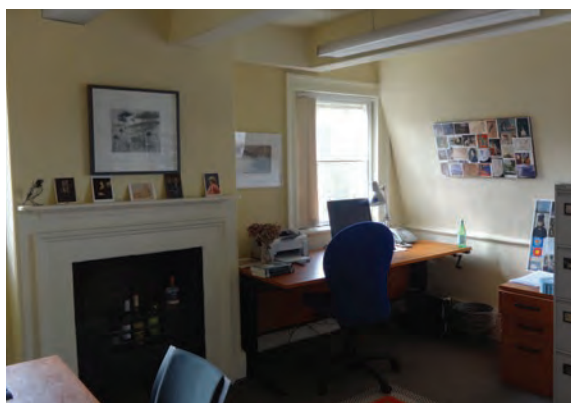
### Third Floor Side Rooms

- The original configuration and use of this space is uncertain. There is no bay at this level.
- The lift shaft was cut through in the 1930s. There is now a staircase leading to the attic plant room that probably dates from the nineteenth or early twentieth century. A redundant doorway to the east has panelled reveals. It is now used as a shelved alcove.
- The doors on the landing to west and east rooms have panelled reveals. There are signs of water damage reveals of the door that leads into the east room. There is a modern partition between the landing and the staircase.
- The surface wiring and modern lights detract from significance.

- Ad hoc services should be removed (6.6).
- Investigations should be made into the cause for the water-damaged ceiling (5.5).
- Changes should be documented (3.1, 3.3 and 3.5).

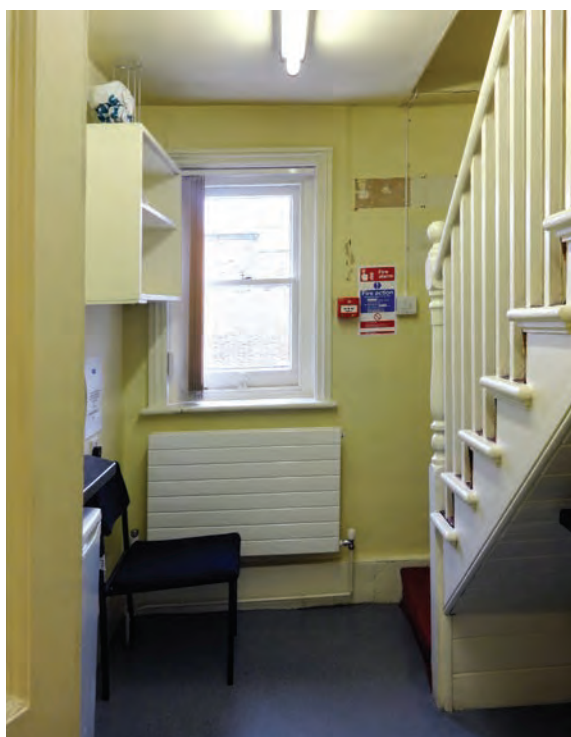
### Third Floor East

Assessment: Significant

- Changes should be documented (3.1, 3.3 and 3.5).
- Investigations should be made into reusing the window shutters (5.4).

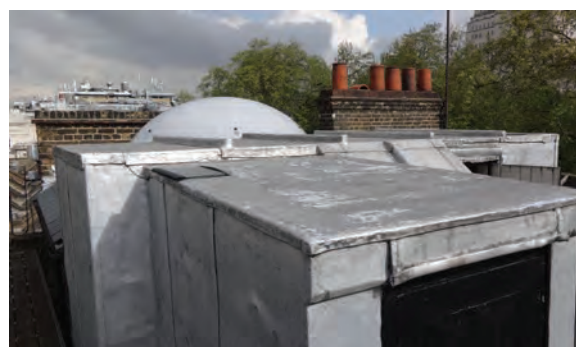
- The attic plant room was built in the valley between the original pitched roofs. It is visible from Bedford Square.
- The covering is of lead sheet covered decorated with silver paint and shows signs of wear and tear.
- It is part of a fire escape route.
- The insulation has been disturbed during maintenance.

- Changes should be documented (3.1, 3.3 and 3.5).
