# Design & Access Statement including Heritage Statement

60 Carey Street, London WC2A 2JB

8 December 2014

Report No	Date
XL03593/R1	29 <sup>th</sup> July 2014
Project	<b>No. 60 CAREY: STREET VISUAL INSPECTION ON ROOF PARAPET OF FRONT ELEVATION</b>
Client	<b>The Law Society</b>

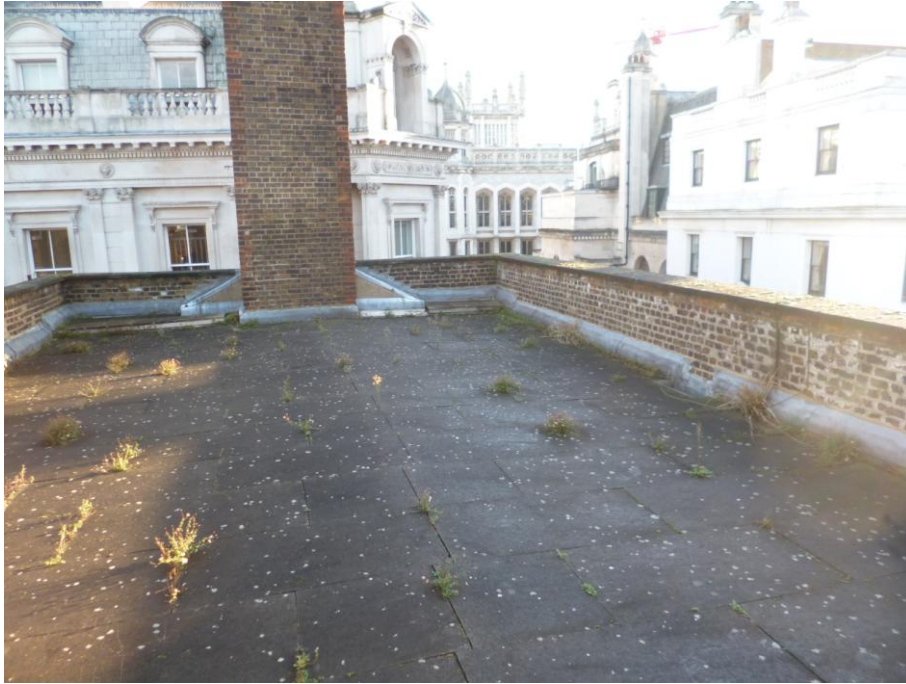
**PHOTOGRAPH 1:** General view of front upper roof.

The installation of a new waterproof roof covering will have no visual impact. The existing concrete paviers will be reinstated upon completion of the works. The existing roofs are believed to have last been recovered in the 1960s, and are not considered to be of aesthetic or historical importance ([photographs 1 & 2](#)).

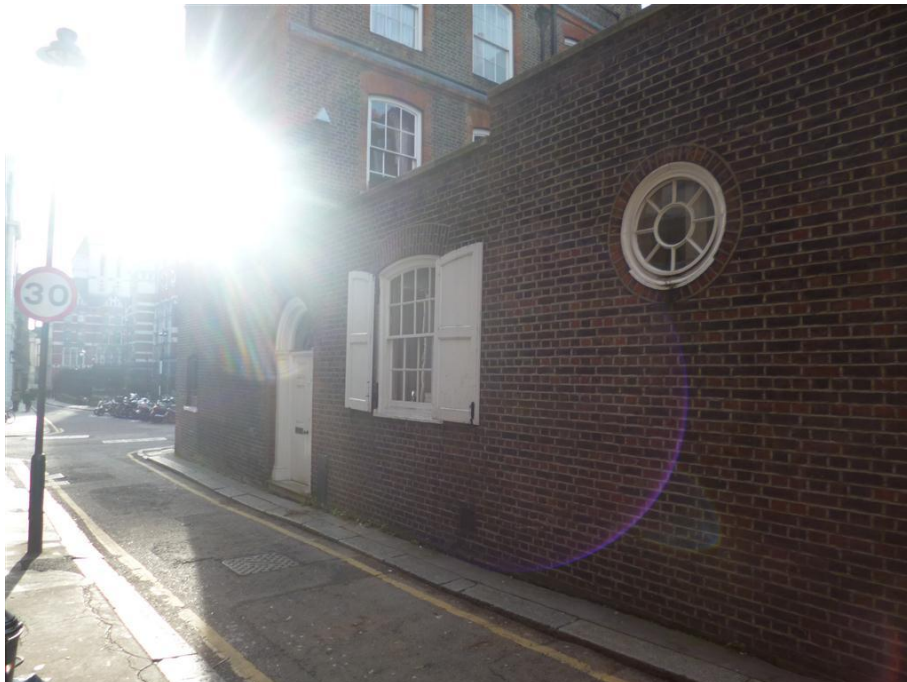
**PHOTOGRAPH 6:** Rear extension (courthouse) viewed from Star Yard.

The railings proposed to the lower roof will impact upon the visual appearance of the property from Star Yard, but not significantly given the narrow width of the road and limited view of 60 Carey Street from this location ([photograph 6](#)). There will be minimal visual impact from Carey Street. The railings will be fabricated in black painted mild steel in a design considered suitable to the building (refer to drawing P03). The rear extension was constructed in 1930 and we believe that provision of railings will not impact upon its heritage value, which as discussed above is primarily historical, rather than age or architectural significance.

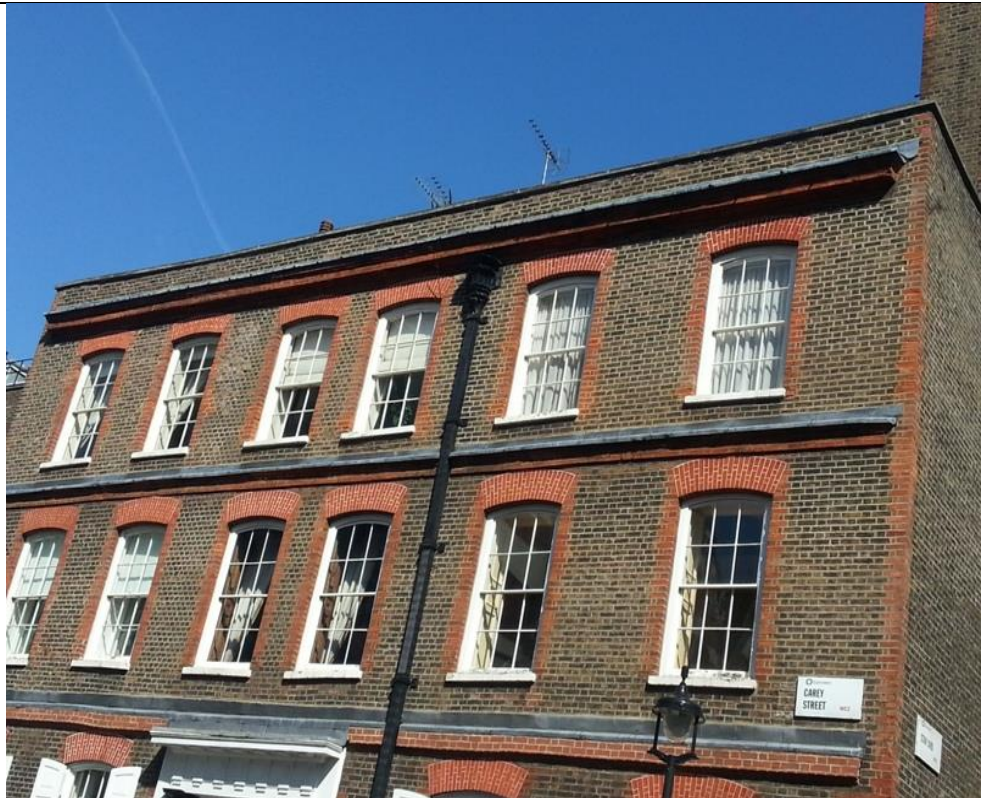
**PLATE 1**

Front Elevation showing the perimeter masonry roof parapet.

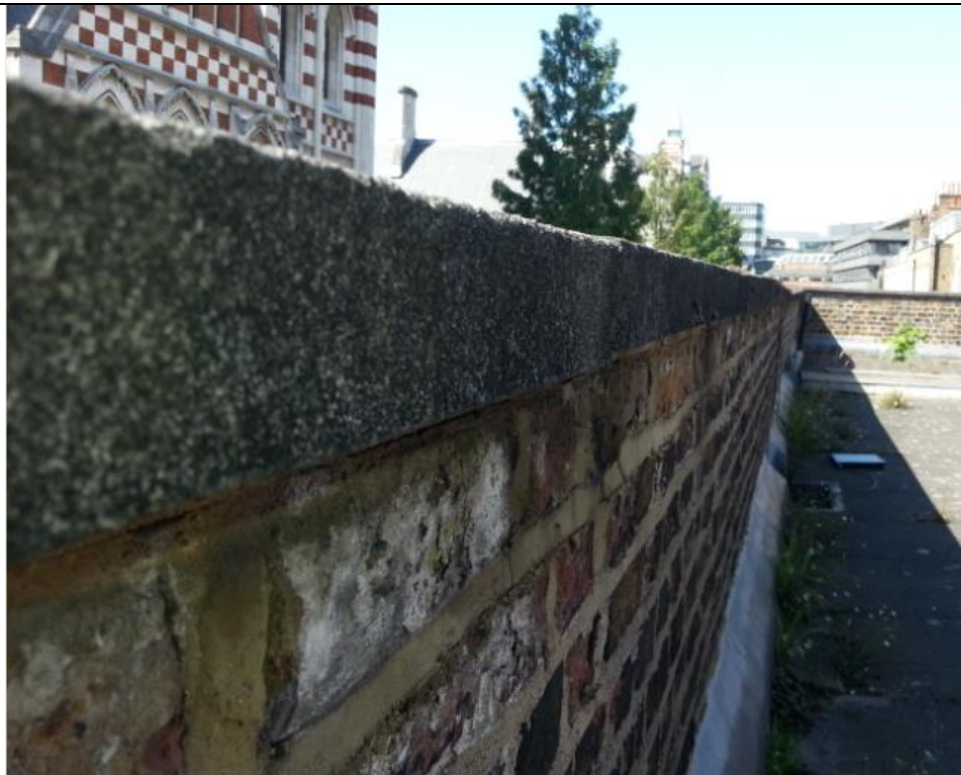
**PLATE 2**

Internal elevation of the masonry parapet wall on the front elevation.
