TECHNICAL REPORT ON A SUBSIDENCE CLAIM

Crawford Reference: SU1403227

[REDACTED]
14a Downshire Hill
London
NW3 1NR

SUBSIDENCE CLAIM

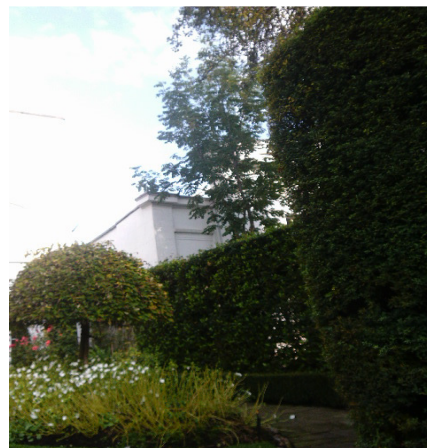
Vegetation photographed from no 14

The cause of the movement needs to be dealt with first. We have completed a soil risk analysis (VISCAT Assessment) and we are satisfied that your neighbour's ash and bay can be removed. Our Mitigation Unit will liaise with your neighbour in this respect.

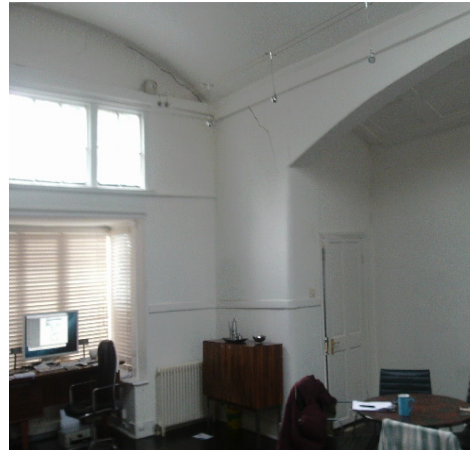
12mm diagonal crack to the main left wall (and to the right of the entrance) extends up the ceiling, and half way around the curved wall/ceiling junction of the front wall.

In structural terms the damage falls into Category 3 of Table 1, Building Research Establishment⁹ Digest 251, which describes it as “moderate”.

The pattern and nature of the cracks is indicative of an episode of subsidence. The cause of movement appears to be clay shrinkage.

Interior of main room looking towards the front entrance

Following completion of the tree management works, we will undertake a suitable period of monitoring to confirm stability has been achieved before undertaking repairs to the property.
