41-42 CHESTER TERRACE
LONDON, NW1 4ND

PROPOSED ALTERATIONS TO EXISTING WINDOWS DESIGN & ACCESS STATEMENT and HERITAGE STATEMENT

PREPARED FOR
SHALIMAR INVESTORS LTD
February 2015

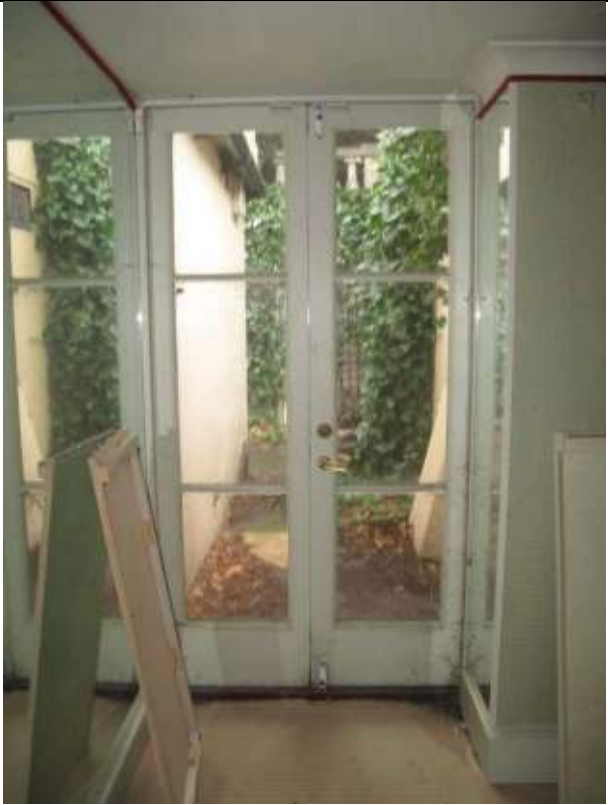
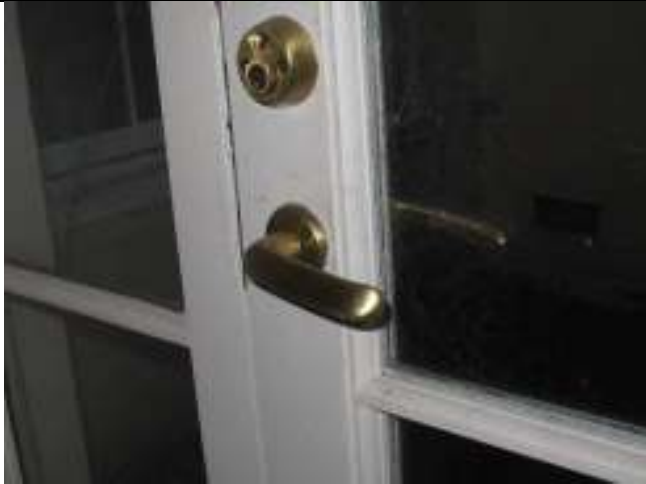
WB42-04	<p style="text-align: center;">NO ACCES</p>

B-03	W-B42-04	South	3 over 3 panes sash window	Original opening	None. Modern frame and glazing bars. Modern staff bead, cords and fittings of no significance.	1260	1530	Openable	Timber/ Paint	Fair/ Good.	Replace window to match early design and profile (to be agreed with SLHA and LA/EH/CE) - refer to proposed detail design by MMM Architects.	Modern single plate glass.	New single plate Crown glass. Apply protective film to panes under 800mm.
GROUND FLOOR

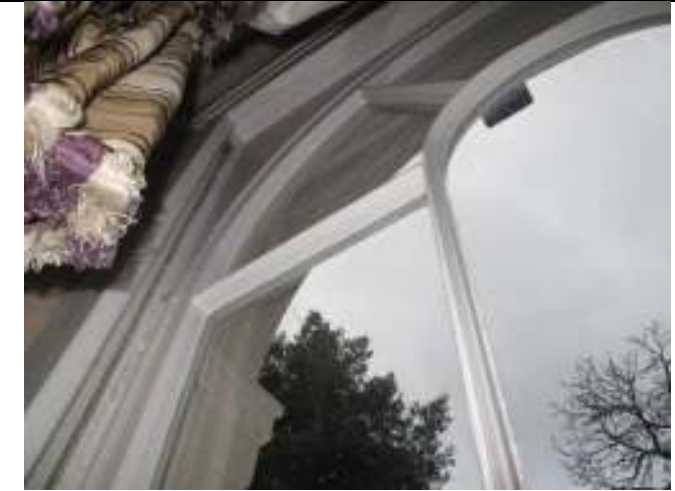
WG42-02

G-02	W-G42-01	South	Round-arched 6 over 6 sash window.	Original opening	Low. Later date frame and glazing bars. Modern staff bead, cords and fittings of no significance.	1250	2520	Openable	Timber/ Paint	Fair/ Good.	Replace top and bottom sashes to match early profile (to be agreed with SLHA AND LA/EH/CE - as a guidance W-F41.02). Refer to Ventrolla schedules.	Modern single plate glass.	New single plate Crown glass to new sashes (12 panes). Apply adhesive film to panes under 800mm.
G-02	W-G42-02	South	Round-arched 6 over 6 sash window with "dwarf" doors under the window.	Original opening	High. Early frame, glazing bars and "dwarf doors". Modern staff bead, cords and fittings of no significance.	1250	2520	Openable	Timber/ Paint	Fair/ Poor ("dwarf doors")	Retain existing window. Repair and overhaul. Replace "dwarf doors" to match existing historic profile and design. Refer to Ventrolla schedules.	Modern single plate glass.	Replace modern damaged/scratched panes of glass with single plate Crown glass. Apply adhesive film to panes under 800mm.

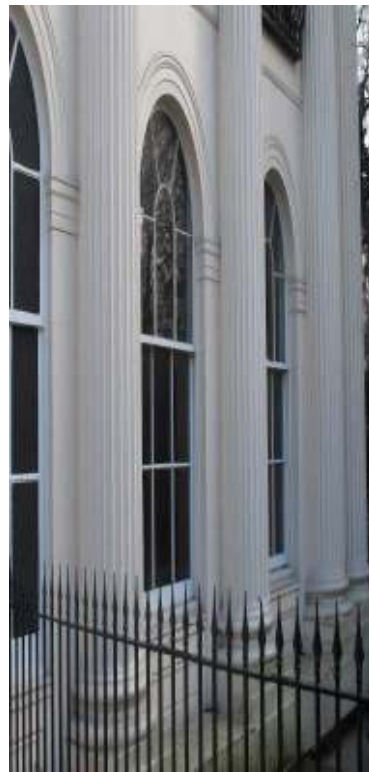
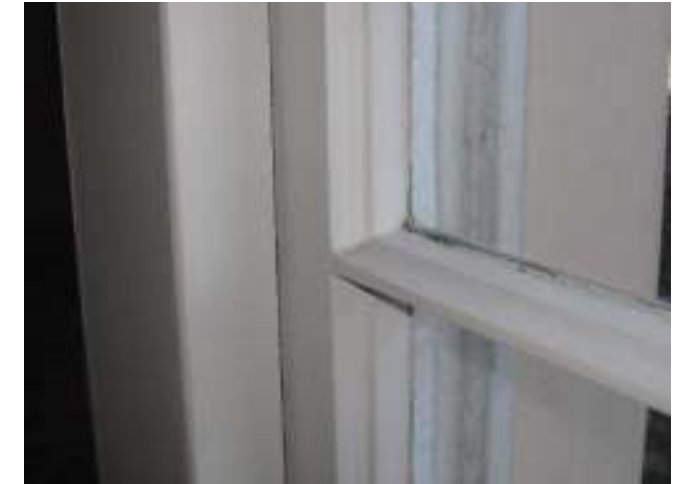
WG42-03

WINDOW			WINDOW TYPE								GLAZING		
G-03	W-G42-03	West	Round-arched 6 over 6 sash window.	Original opening	High. Early frame and glazing bars (top moulding completely eroded). One later date glazing bars on lower sash of no significance. Modern staff bead, cords and fittings of no significance.	1250	2520	Openable	Timber/ Paint	Fair/ Good.	Retain existing window. Repair and overhaul. Replace later date glazing bar to match historic profile. Refer to Ventrolla schedules.	Modern single plate glass.	Glaze new 2 panes of glass in bottom sash. Replace modern damaged/scratched panes of glass with single plate Crown glass. Apply adhesive film to panes under 800mm.
G-03	W-G42-04	West	Round-arched 6 over 6 sash window.	Original opening	Top - High. Early frame and glazing bars. Bottom - Low. Later replacement. General: Modern staff bead, cords and fittings of no significance.	1250	2520	Openable	Timber/ Paint	Fair/ Good.	Retain window and overhaul. Refer to Ventrolla schedules.	Top - Modern single plate glass (x2) and probably early glazing (x4). Bottom - Modern single plate glass.	Replace modern damaged/scratched panes of glass with single plate Crown glass. Historic glazing to be retained (4 panes - to be confirmed on sited by SLHA). Apply adhesive film to panes under 800mm.
