BS5837 Arboricultural Impact Assessment

7 Boscastle Road, London, NW5 1EE

Job Reference: 02260R

February 2015

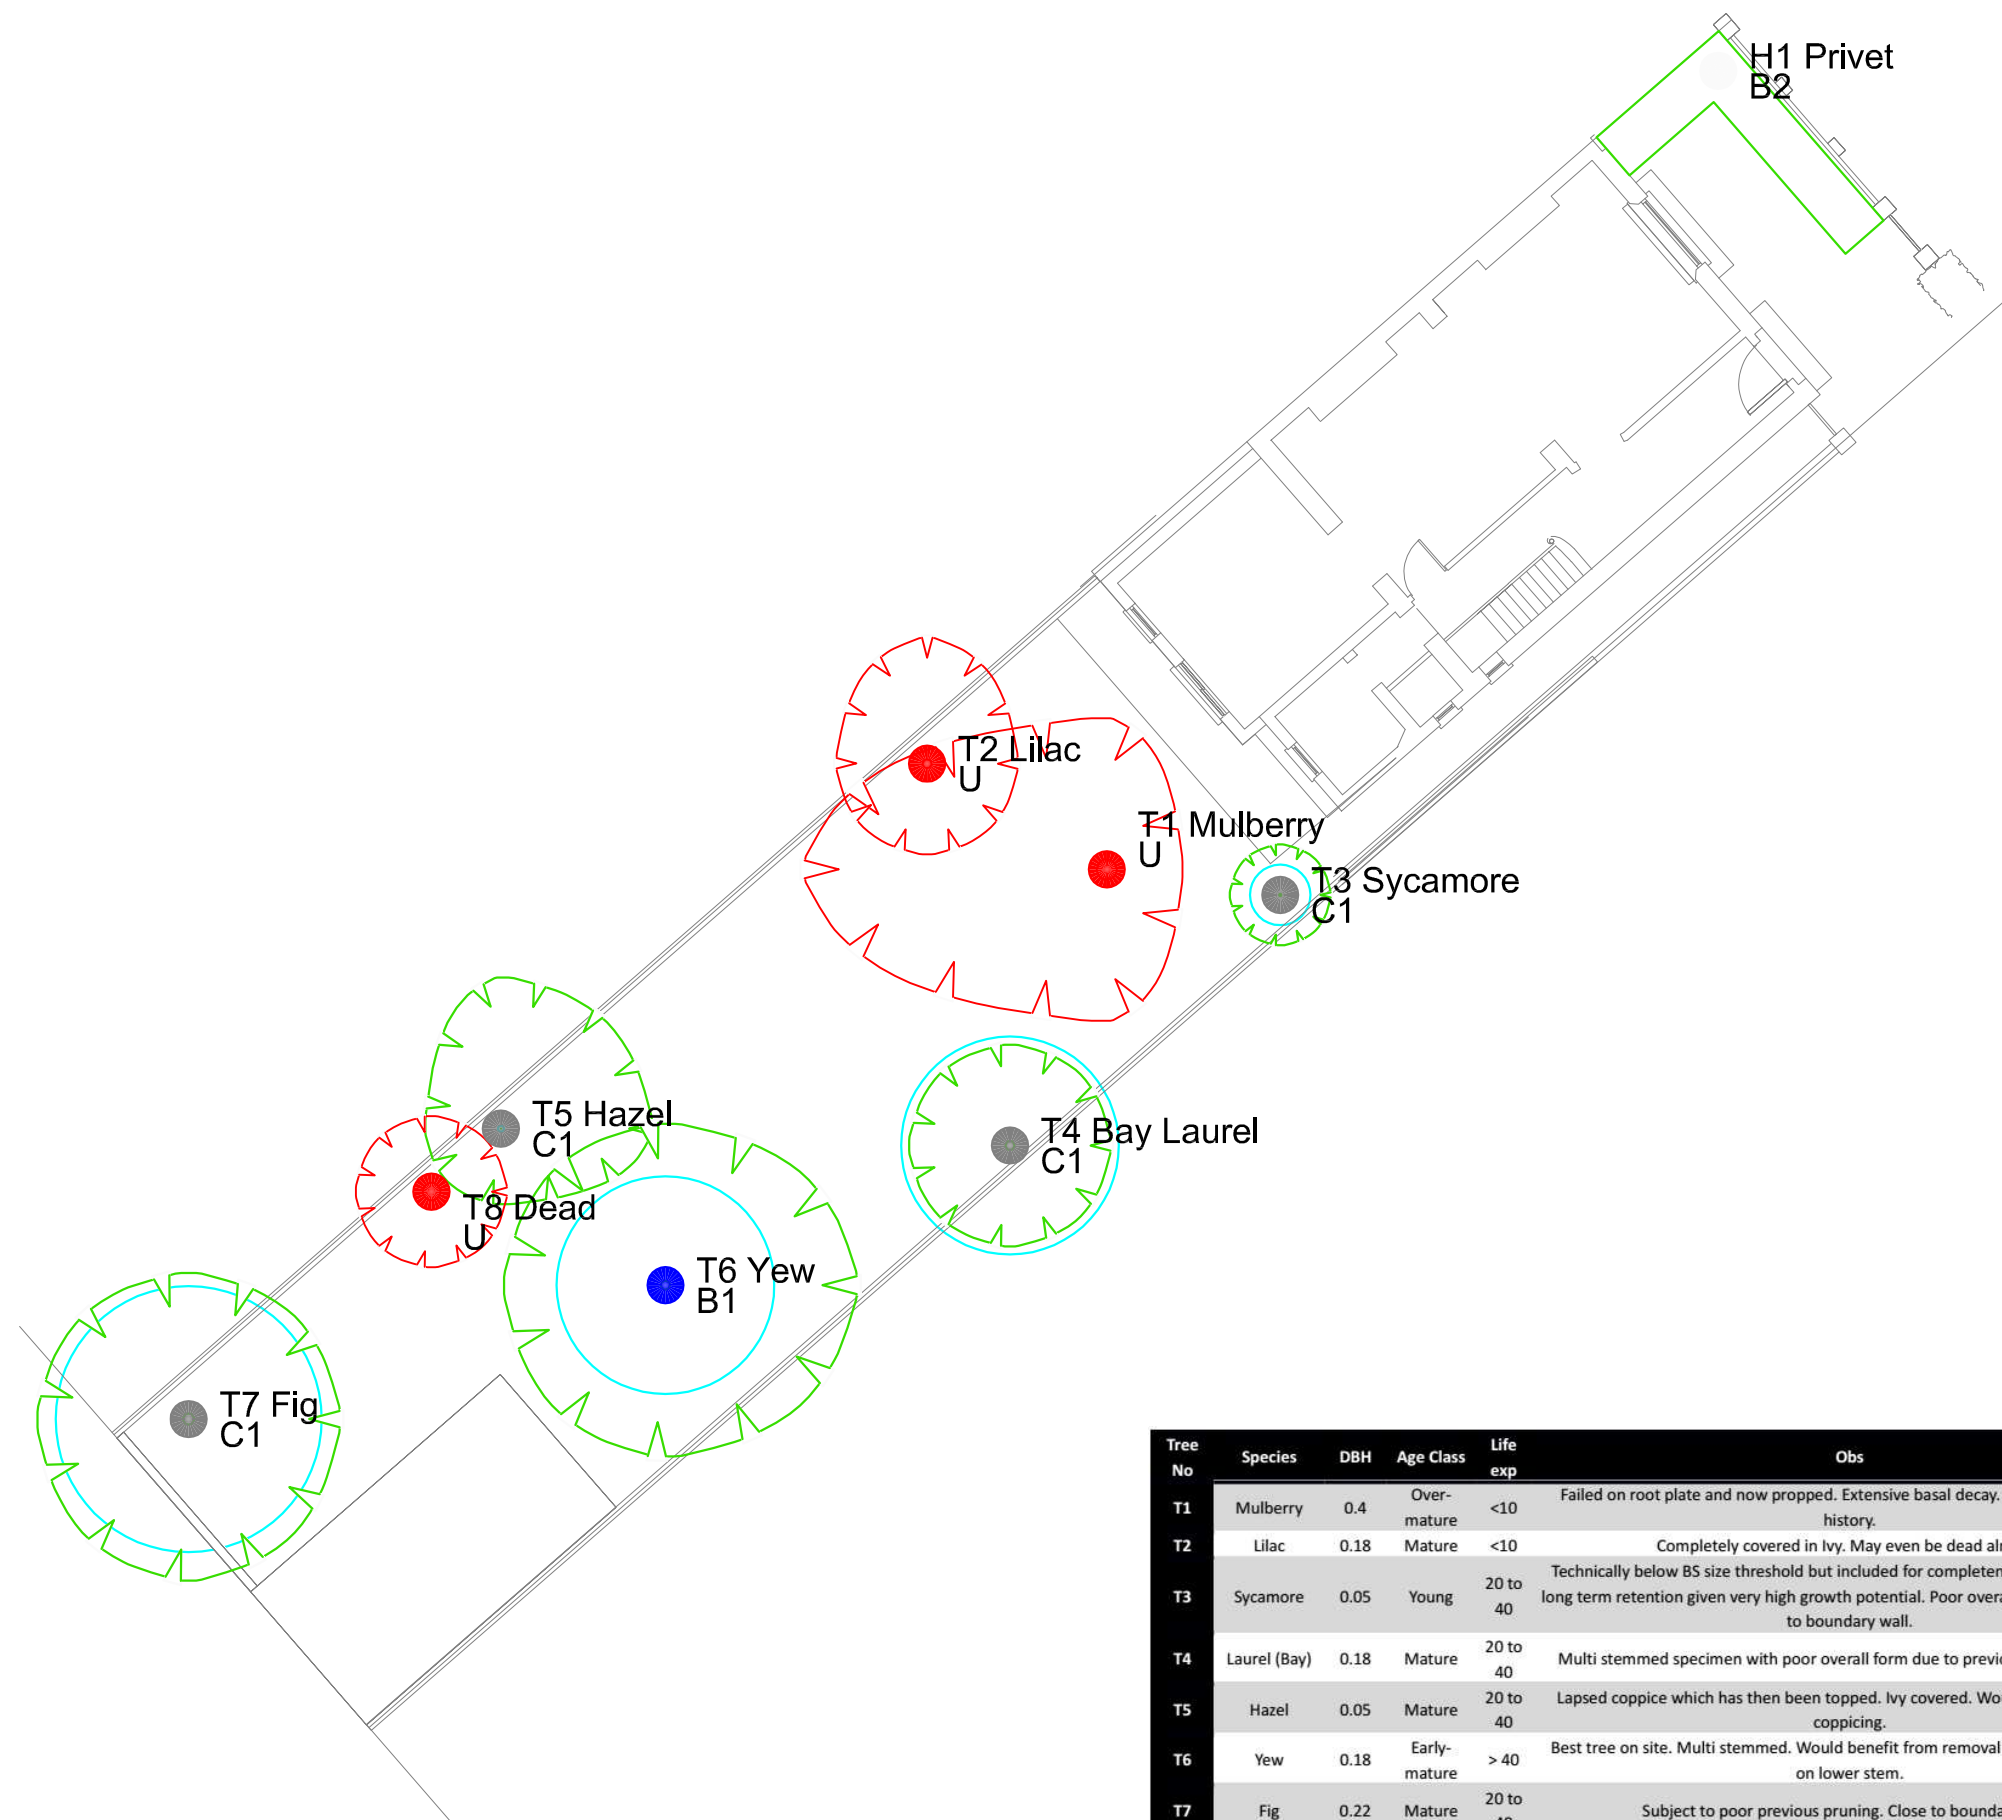
Appendix 4 - Tree Constraints Plan

Tree No	Species	DBH	Age Class	Life exp	Obs	BS Cat	RPA
T1	Mulberry	0.4	Over-mature	<10	Failed on root plate and now propped. Extensive basal decay. Significant pruning history.	U	4.8
T2	Lilac	0.18	Mature	<10	Completely covered in Ivy. May even be dead already.	U	2.2
T3	Sycamore	0.05	Young	20 to 40	Technically below BS size threshold but included for completeness. Not suitable for long term retention given very high growth potential. Poor overall form and proximity to boundary wall.	C1	0.6
T4	Laurel (Bay)	0.18	Mature	20 to 40	Multi stemmed specimen with poor overall form due to previous pruning history.	C1	2.2
T5	Hazel	0.05	Mature	20 to 40	Lapsed coppice which has then been topped. Ivy covered. Would benefit from re-coppicing.	C1	0.6
T6	Yew	0.18	Early-mature	> 40	Best tree on site. Multi stemmed. Would benefit from removal of old pruning stubs on lower stem.	B1	2.2
T7	Fig	0.22	Mature	20 to 40	Subject to poor previous pruning. Close to boundary wall.	C1	2.6

T8	Unknown	0.35	Mature	<10	Completely covered in Ivy. Appears dead.	U	4.2
H1	Privet	0.05	Mature	20 to 40	Established hedge which would benefit from regular pruning to shape.	B2	0.6

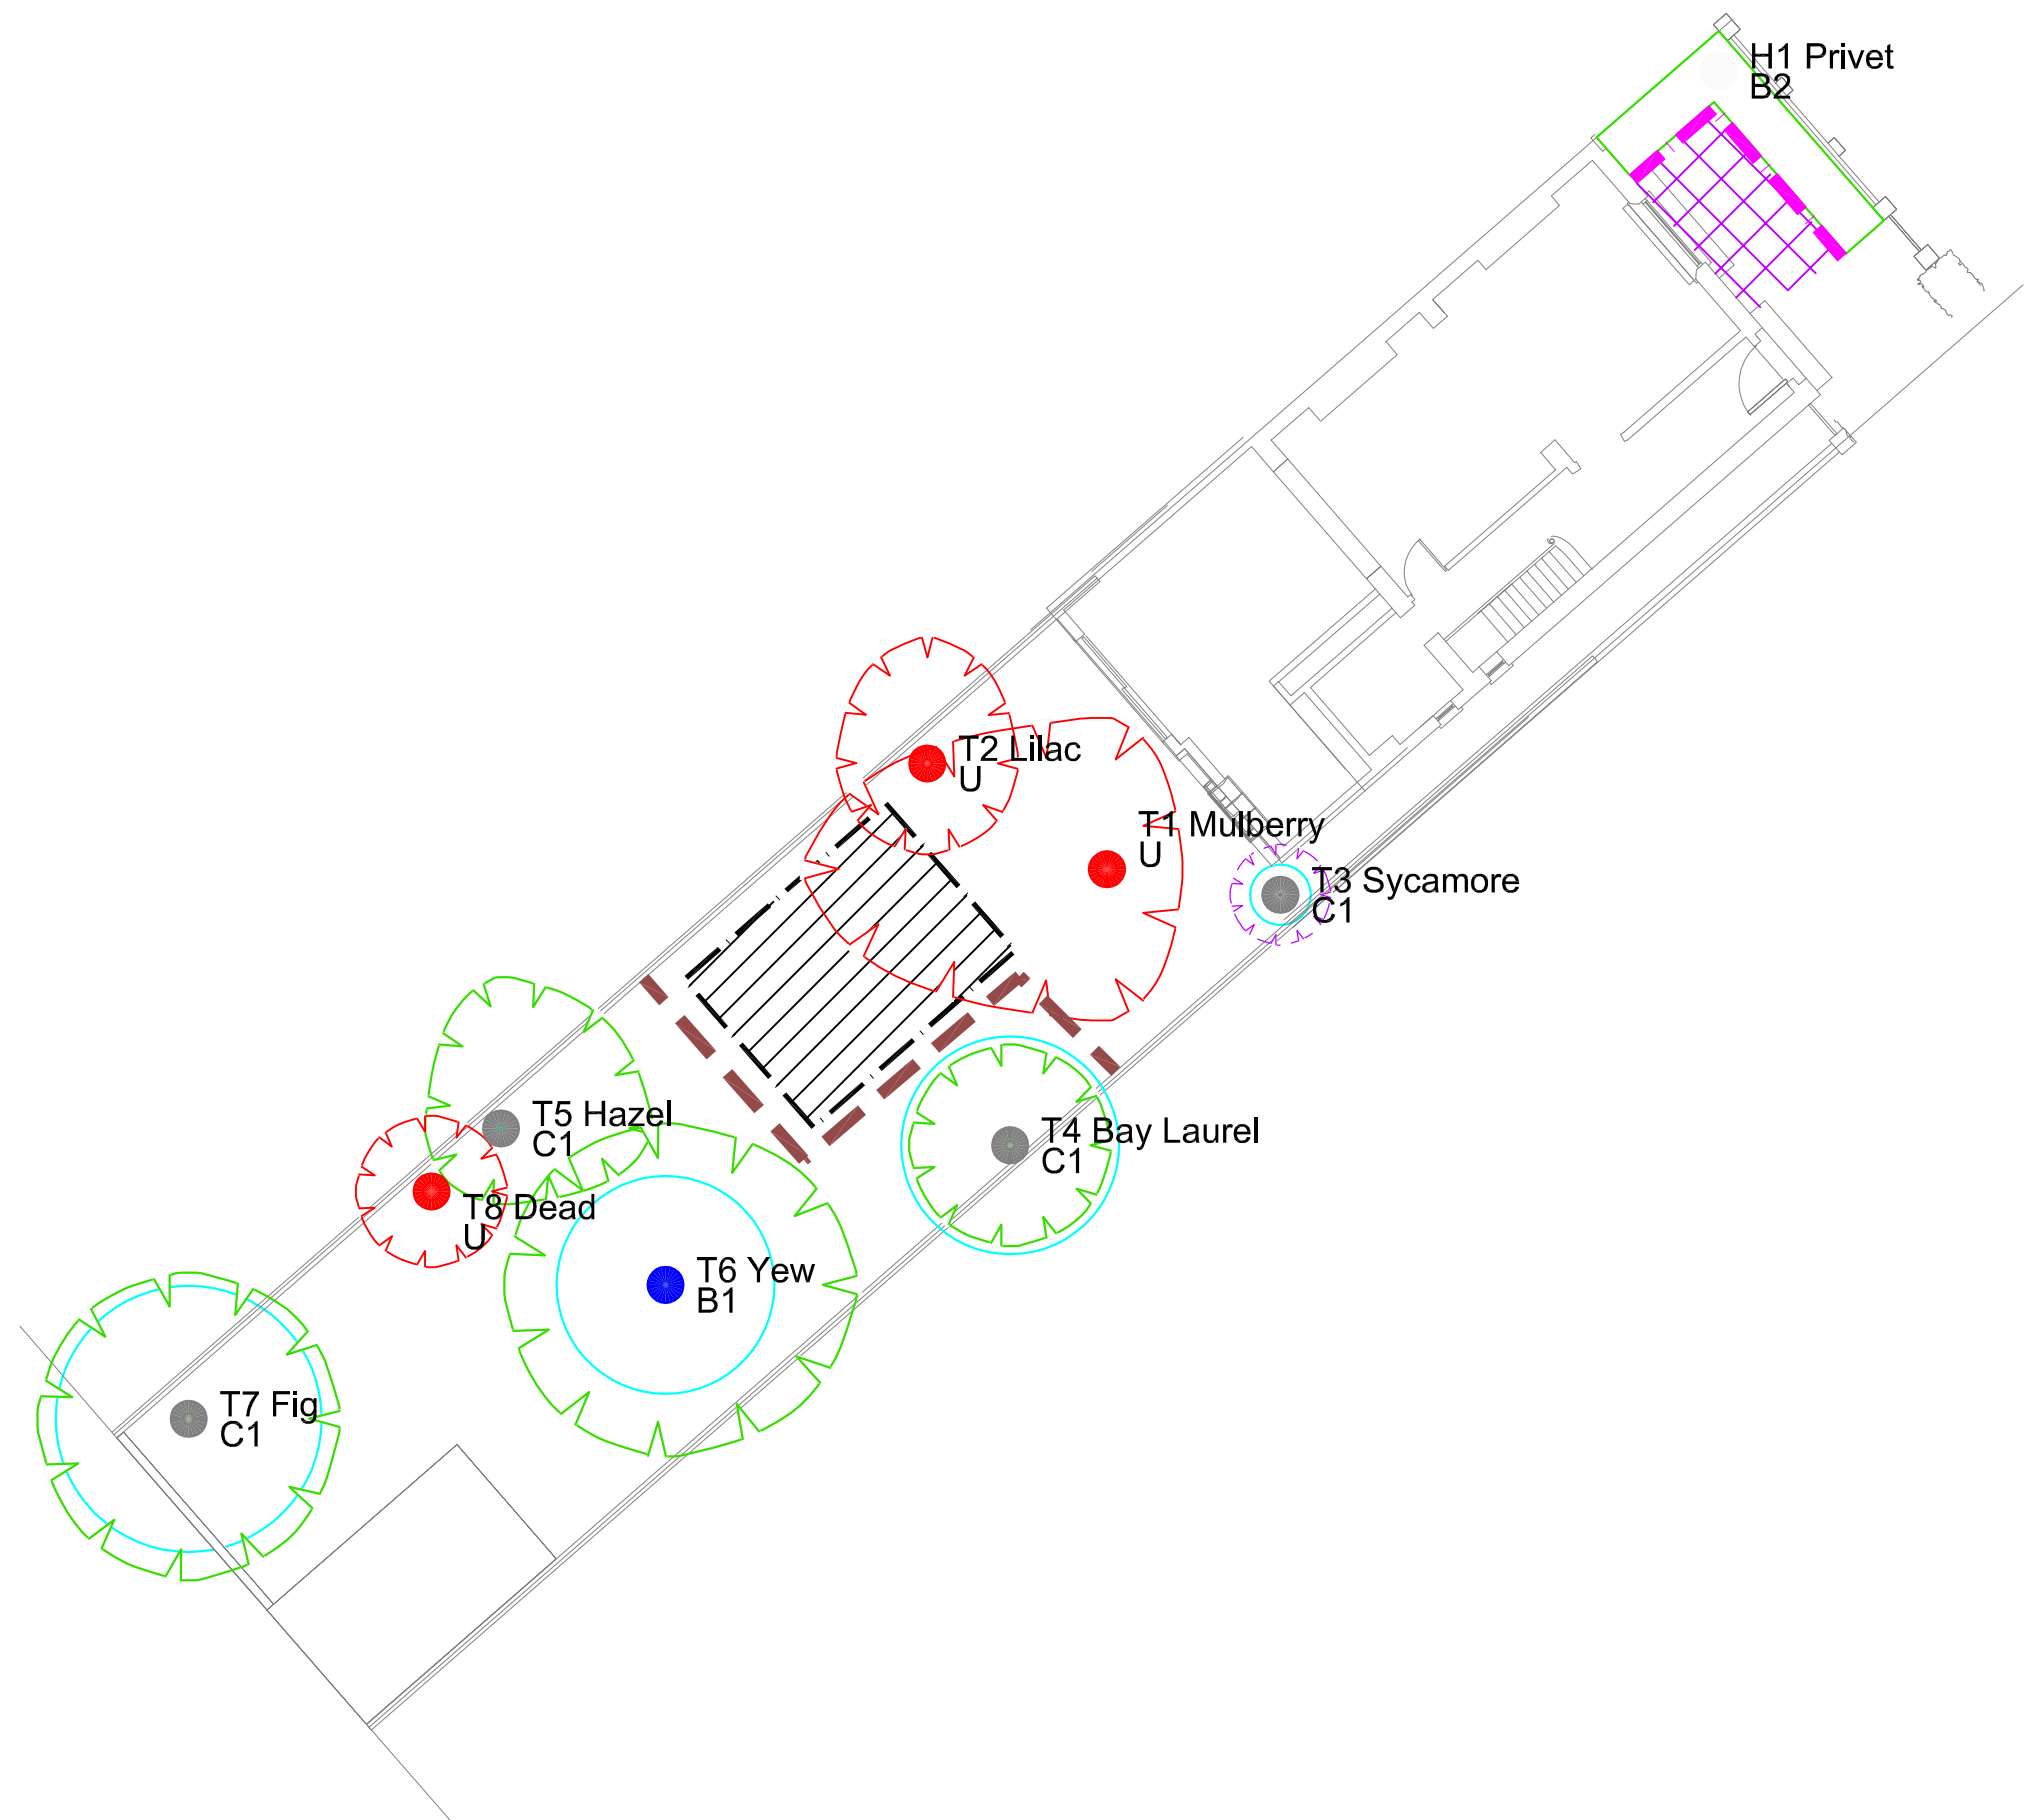
- RPA - root protection area as defined by Table 2 BS 5837:2012
- Proposed removal
- Proposed removal - to facilitate Development
- Location of protective fencing
- H1 - Protection with 1.6m ply hoarding
- Temporary ground protection
- Area for site storage

- Fencing to be installed prior to any on site works.
- Fencing to be maintained during construction phase.
- To be effective it should be signed with the provided sign to advise site workers of the fencing function.
- Herras fencing for rear garden
- Temporary ground protection and ply hoarding for internal face of H1
