Arboricultural Consultancy for Aviva

Insured	Mrs H Megarry	Address	43 Woodsome Road, London, NW5 1SA		
Client	Infront Innovation	Contact	Dayna Riley	Claim No.	IFS-AVI-ROF-13-0046234
MT Ref	NL/1212131146/TP-REV1	Consultant	Thomas Peppiatt	Contact No.	08702 416 180
Report Date	10/01/2014 revised 17/11/2014

Scope of Report: To survey the property and determine significant vegetation contributing to subsidence damage, make recommendation for remedial action and assess initial mitigation and recovery prospects. The survey does not make an assessment for decay or hazard evaluation.

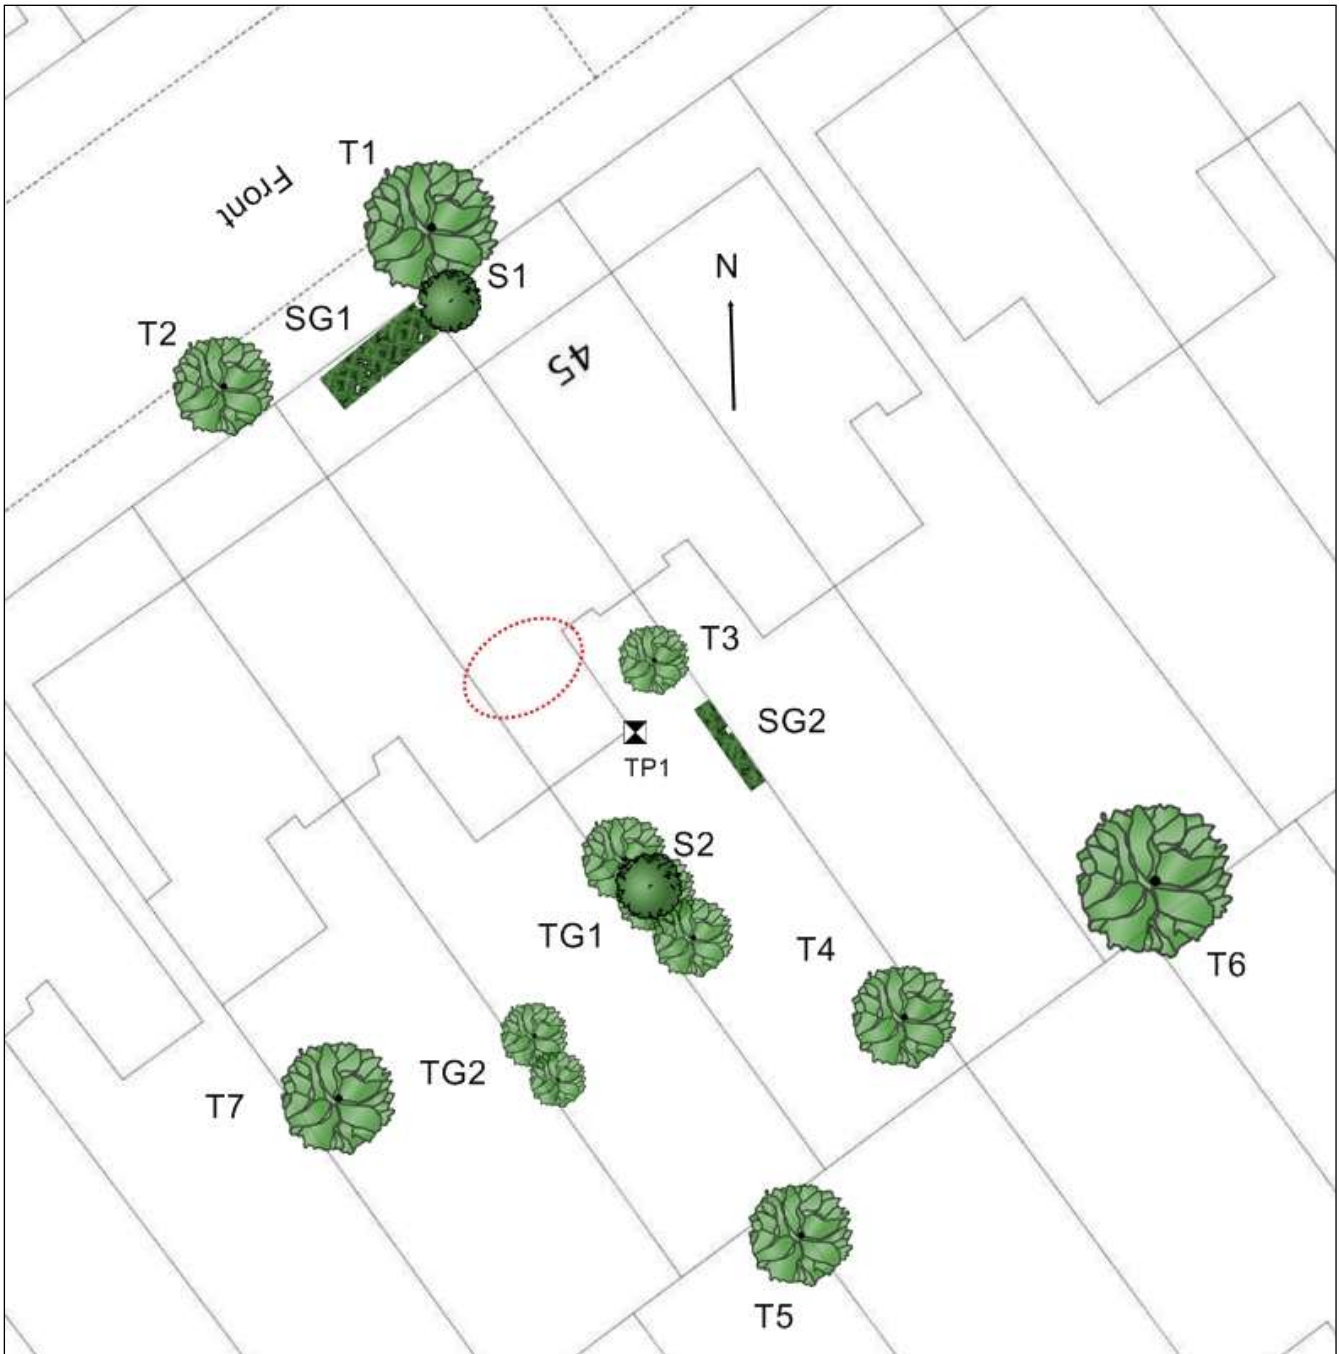
7. Site Plan

In assessing the potential drying influence of the vegetation on site TG1 (Mixed species group) is considered the dominant feature and accordingly we have identified them as the principal cause of subsidence.
