GEOTECHNICAL

43 Woodsome Road, London, NW5 1SA

Client: Infront Innovation
 Client Contact: Paula Sheldon
 Client Ref: IFS-AVI-SUB-13-0046234
 Policy Holder: Mrs H Megarry
 Report Date: 8 November 2013
 Our Ref: C9399G4125

DRAINAGE

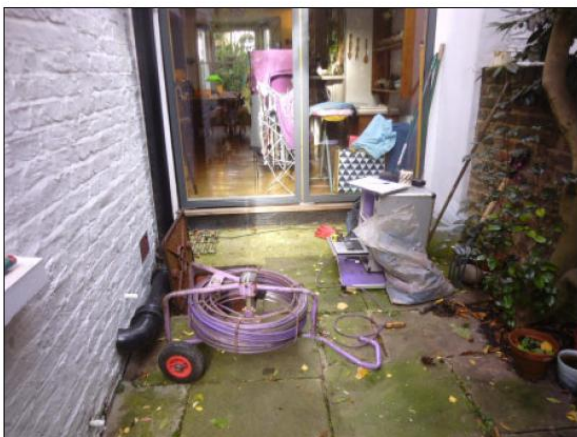
RWP & FWG

Water Pressure Test Result: Run failed

CCTV Survey Result: Fractured and cracked sections of pipework

1. To excavate and replace FWG and pipework downstream to FMH1, reinstating all surfaces upon completion.
