King's Cross Station: Clock Tower Repairs

Listed Building Consent Application
Rev A 19/03/2015

JOHN MCASLAN + PARTNERS

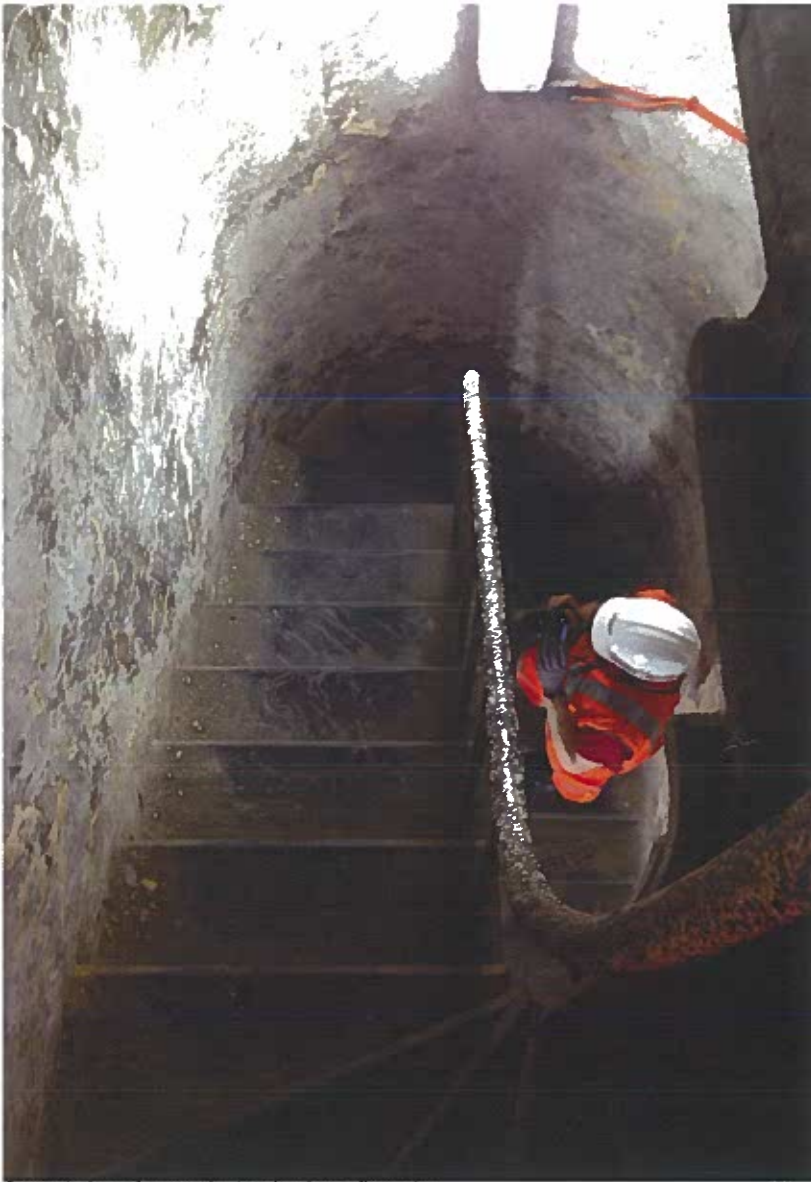
General view of the stair showing its configuration

The Clock Tower stair is very narrow and was originally intended for occasional maintenance access onto the roof. During the major refurbishment works over the last few years it has been heavily used by contractors for access to this part of the station and has become damaged.

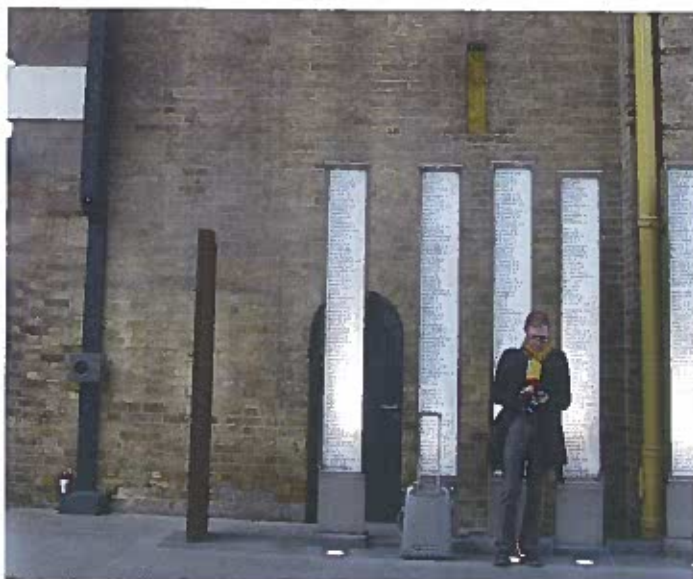
Photo showing the door to the Clock Tower behind the war memorial

The existing door to the clock tower stairs is a modern door, put in as part of the recent project. As a part of the cleaning works this door will be temporarily removed and replaced with a temporary door which will allow the extract of the dust through a duct whilst keeping the area secure. The door will be reinstated on completion of the cleaning works.
