SECOND ADDENDUM REPORT

Crawford Reference: SU1300377

9 Rosslyn Hill
London
NW3 5UL

SUBSIDENCE CLAIM

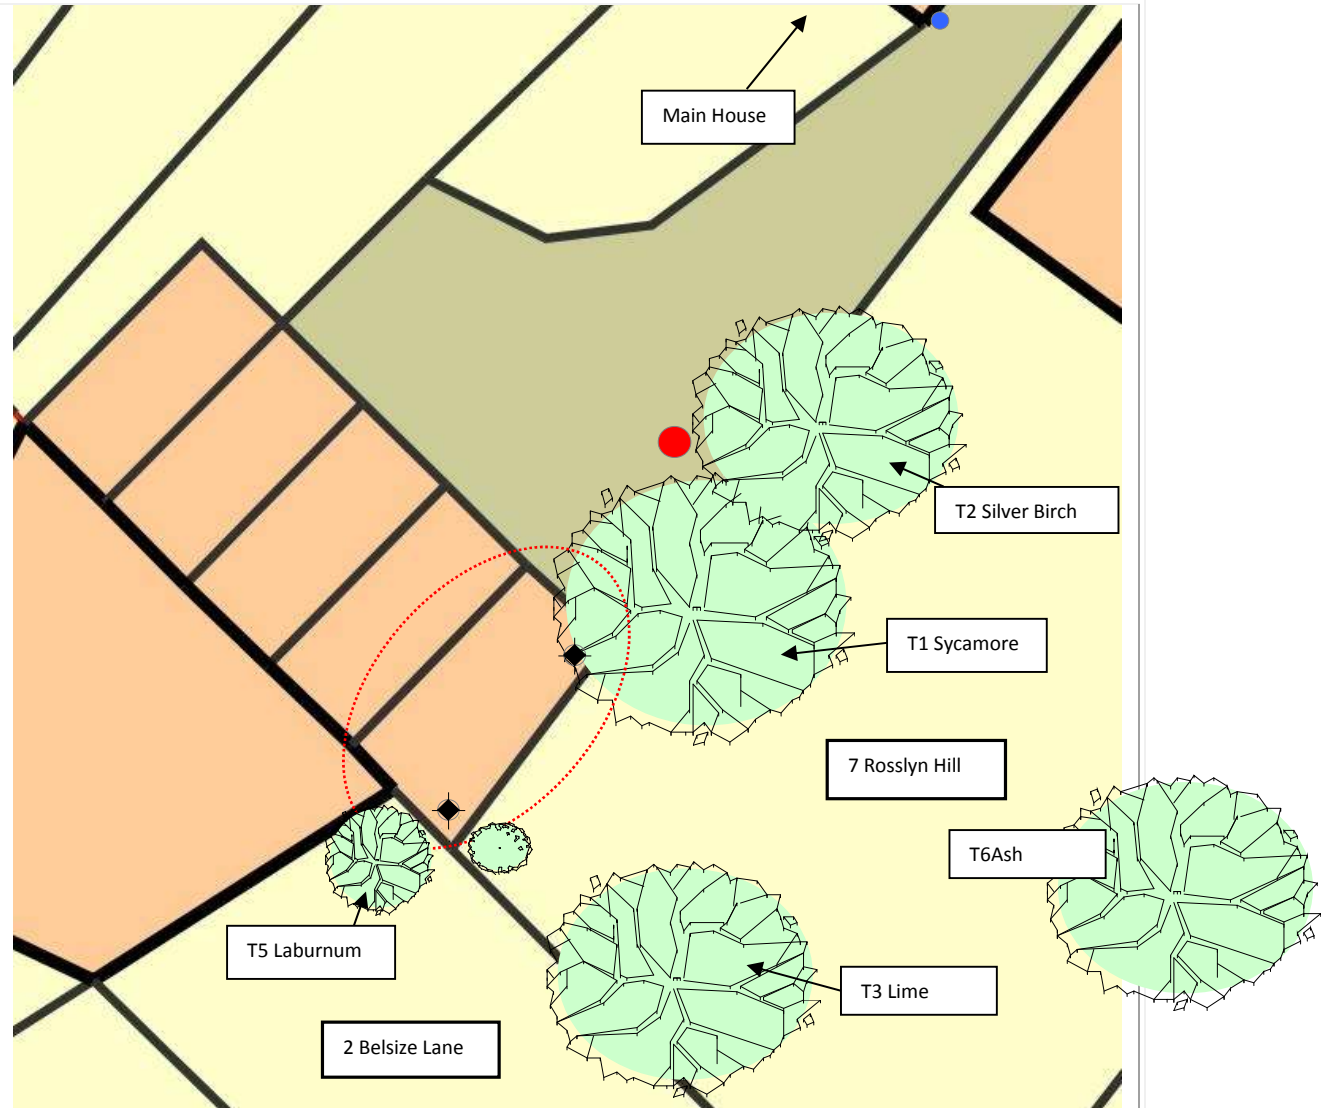
Site Plan

Two further trial holes were excavated to expose the foundations - see site plan for location and the diagram below for details:-
