Landmark Trees

**ARBORICULTURAL IMPACT ASSESSMENT REPORT:**

73-75 Avenue Road  
London  
NW8 6JD

**Ref:** BWR/75AVR/AIA/01a

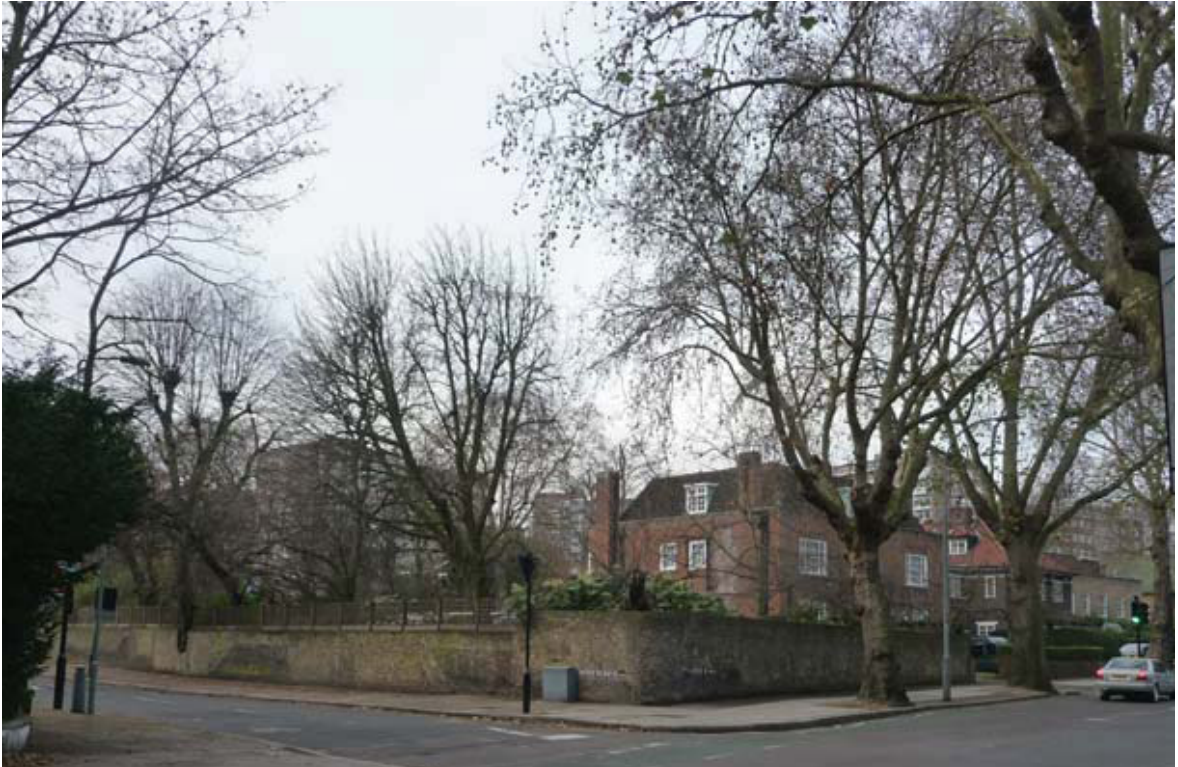
Photograph 1: View of existing dwelling from Avenue Road and Queen's Grove Junction

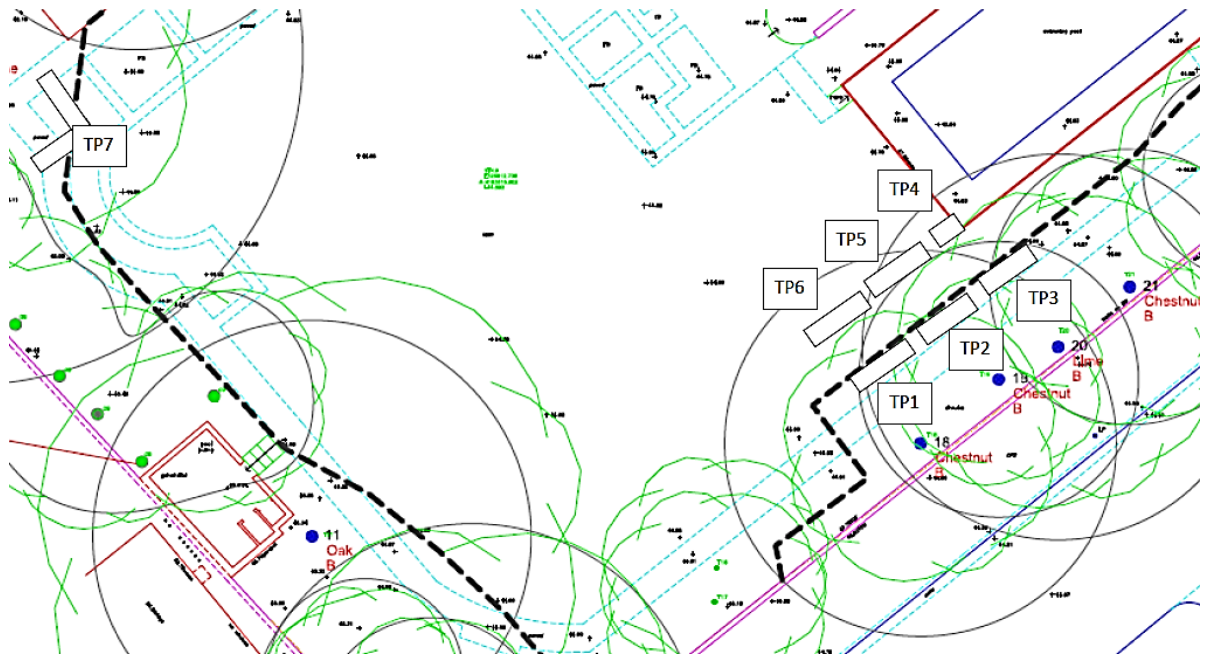
Plan Extract Showing Location of Trial Pits

Table 2: Trial Pit Results – Located as per plan extract below

Trial Pit 1	1.5m Long, 40cm Wide, 12cm Deep. 1x60mm root Number of fibrous roots
Trial Pit 2	1.5m Long, 40cm wide 18cm Deep. 1x 50mm Root
Trial Pit 3	1.5m long, 35cm wide, 13cm Deep 1x45mm root 1x50mm root
Trial Pit 4	90cm long, 40cm wide, 12cm deep 2x30mm roots 1x25mm root
Trial Pit 5	1.5m long plot containing 2x 40mm roots, Chased this back into the lawn to determine point that roots reduce <25mm. 2.5m out from initial plot (11m from boundary wall) roots are still 30mm in diameter.
Trial Pit 6	1.5m long, 40cm wide, 20cm deep 1x45mm root 1x30mm root
Trial Pit 7	1.5m longx1.5m long "L", 40cm wide, 70cm deep No Roots
