41-42 CHESTER TERRACE
LONDON, NW1 4ND

REPAIR OF THE STUCCO FACADE: Schedules of Work and Specification

PREPARED FOR
SHALIMAR INVESTORS LTD
September 2014

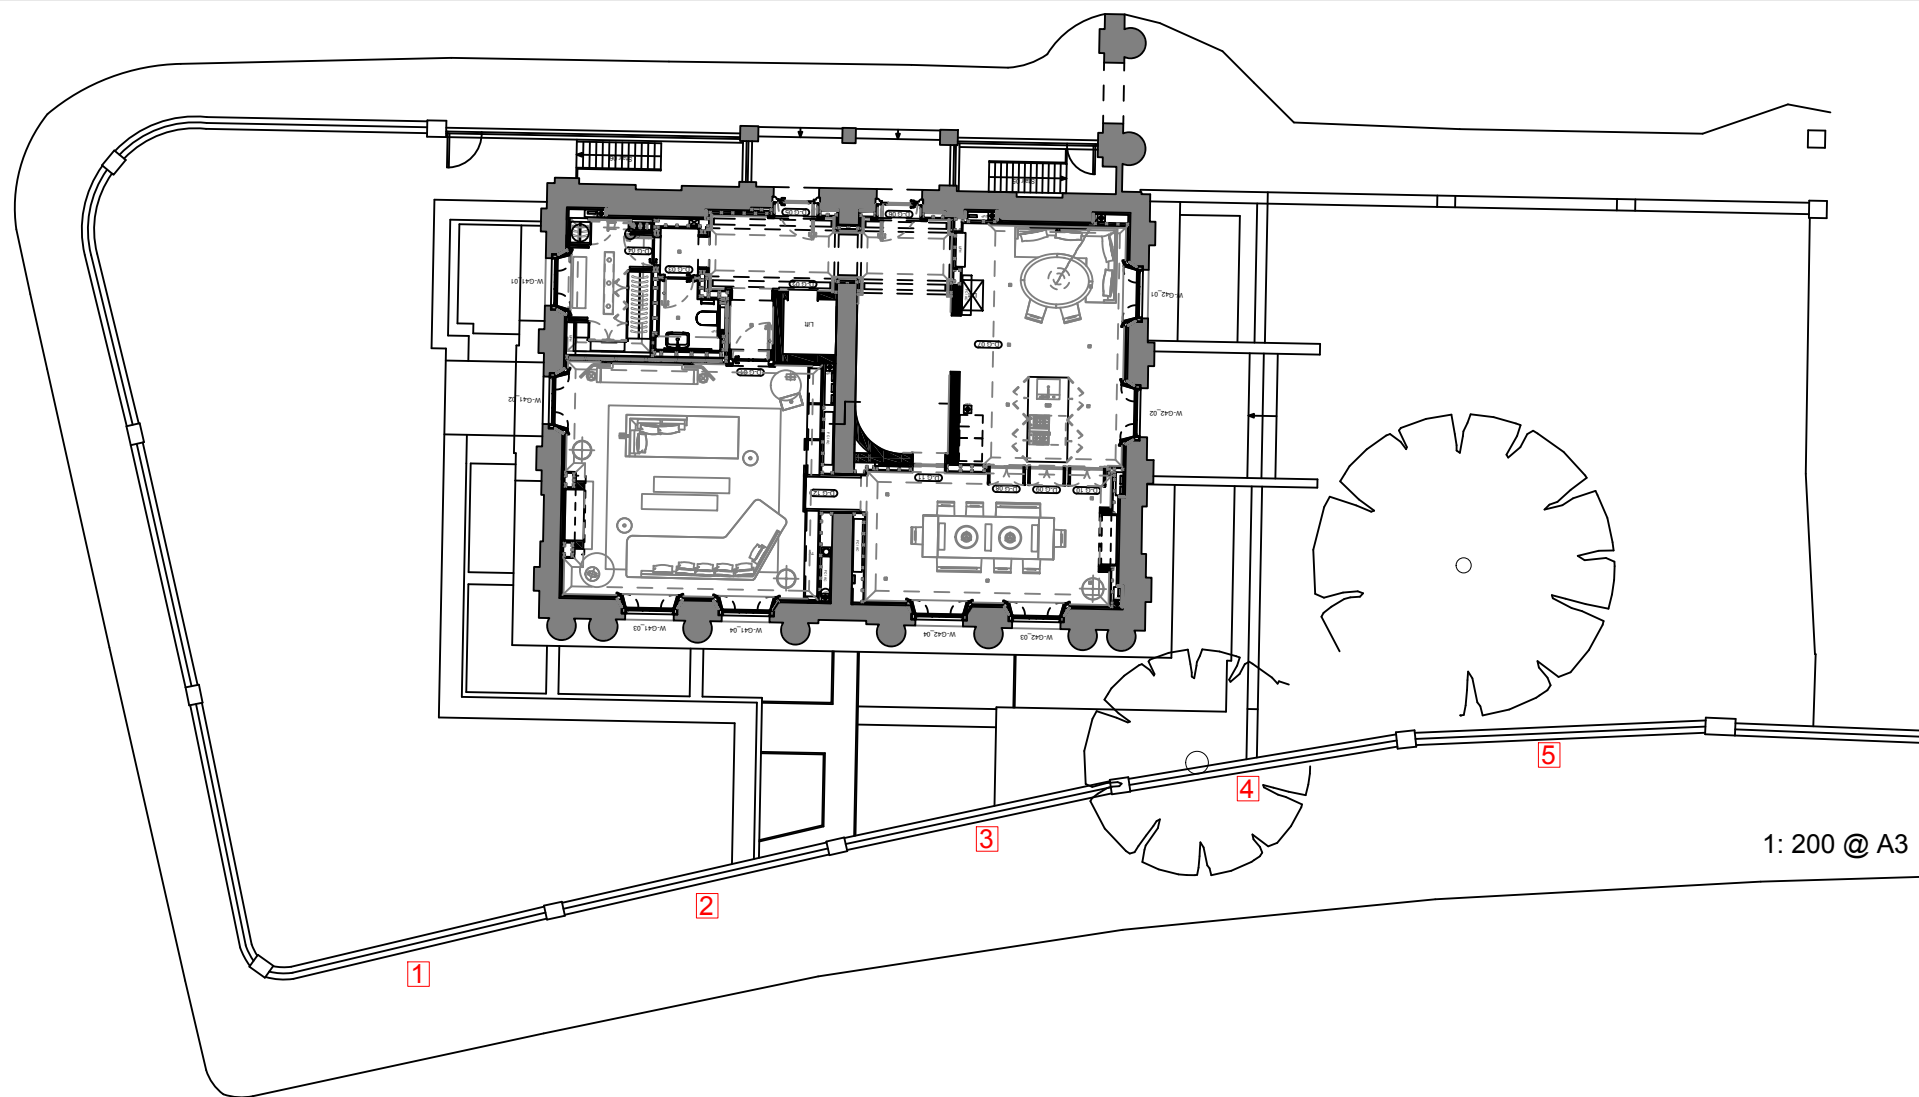
Fractures through the stucco

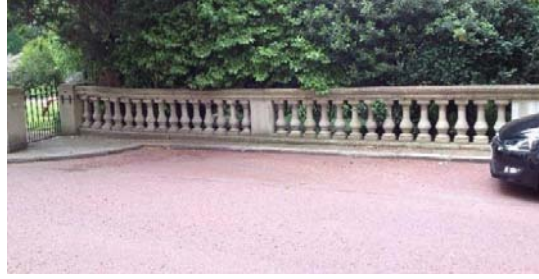
- 1 The Chester Terrace balustrade walling adjacent to the communal garden gate is undecorated reconstituted stone with some minor discolouration and carbonation.

- 2 The pointing to the plinth wall and balustrade connecting to the house is open and should be repointed.

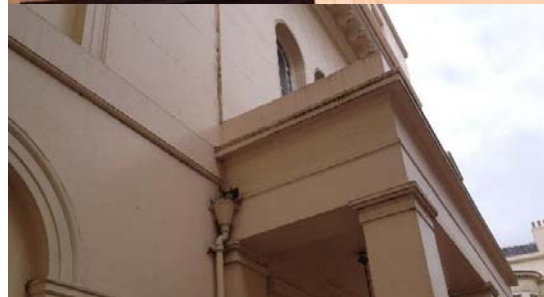
10 The current rainwater discharge from the porch is via a small cast iron hopper and 50mm diameter downpipe with no lead shoe to the outlet.

11 The hopper contains tree growth and also plastic cups impeding the flow from the porch roof.

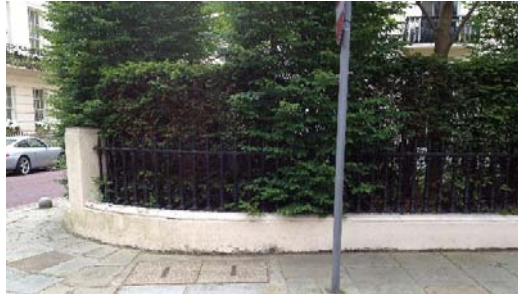
14 The conifer tree screening has been planted close to the boundary wall but at present root disturbance is not evident.
