51 Werrington Street, NW1 1QN

Report on Vault Structures

Ref: 150234/TA

Date: 12 May 2015

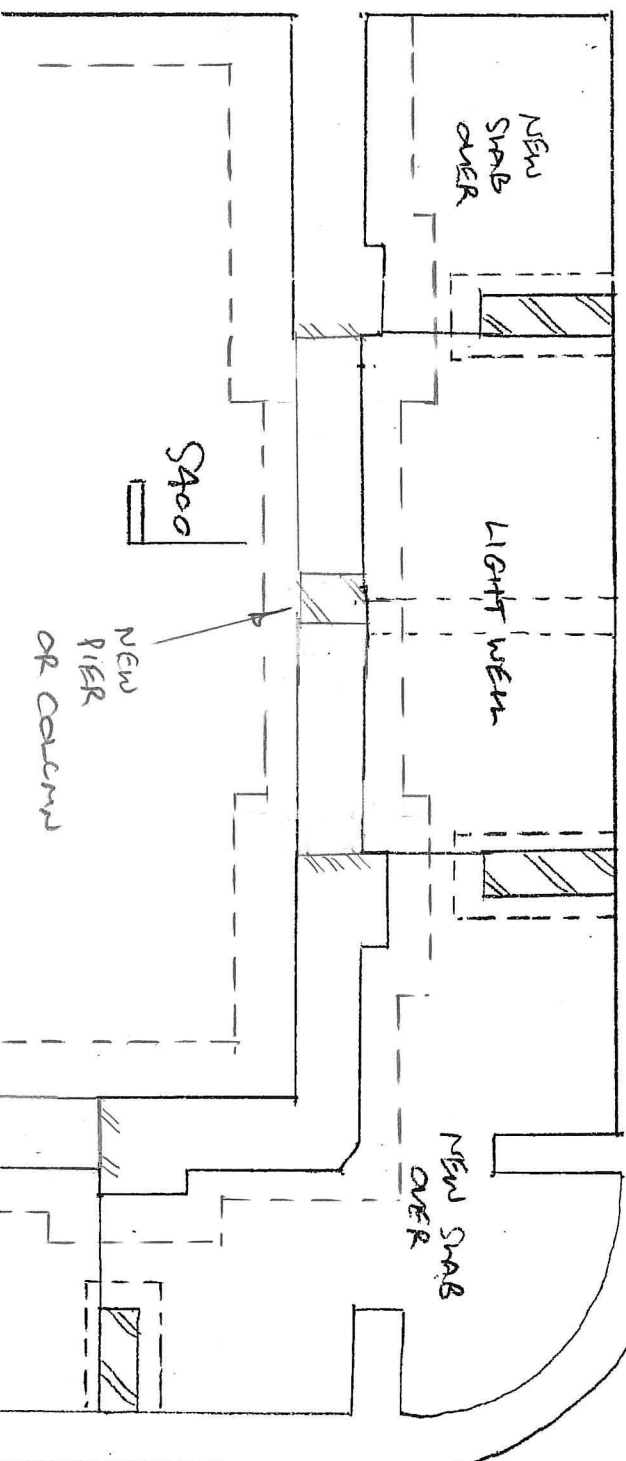
5101

NEW 330 PIER
IN CROSS & BRICKWORK
PIER TIED TO EXISTING
WALL. BUILT @ 600W
x 450DP CASTING
FOUNDATION

- 3.1 To create the light wells will require sections of slab to be removed. The remaining slabs will also be replaced to provide a new permanent structure. The restraining effect of the slabs will be replaced by adding a reinforced concrete ring beam to the top of the brick retaining wall. Where buttressing walls need to be removed to create the light wells their effect will be reproduced by constructing new buttressing walls in alternative locations. Drawing S101 shows the proposed layout with typical sections shown on S400 and S401.

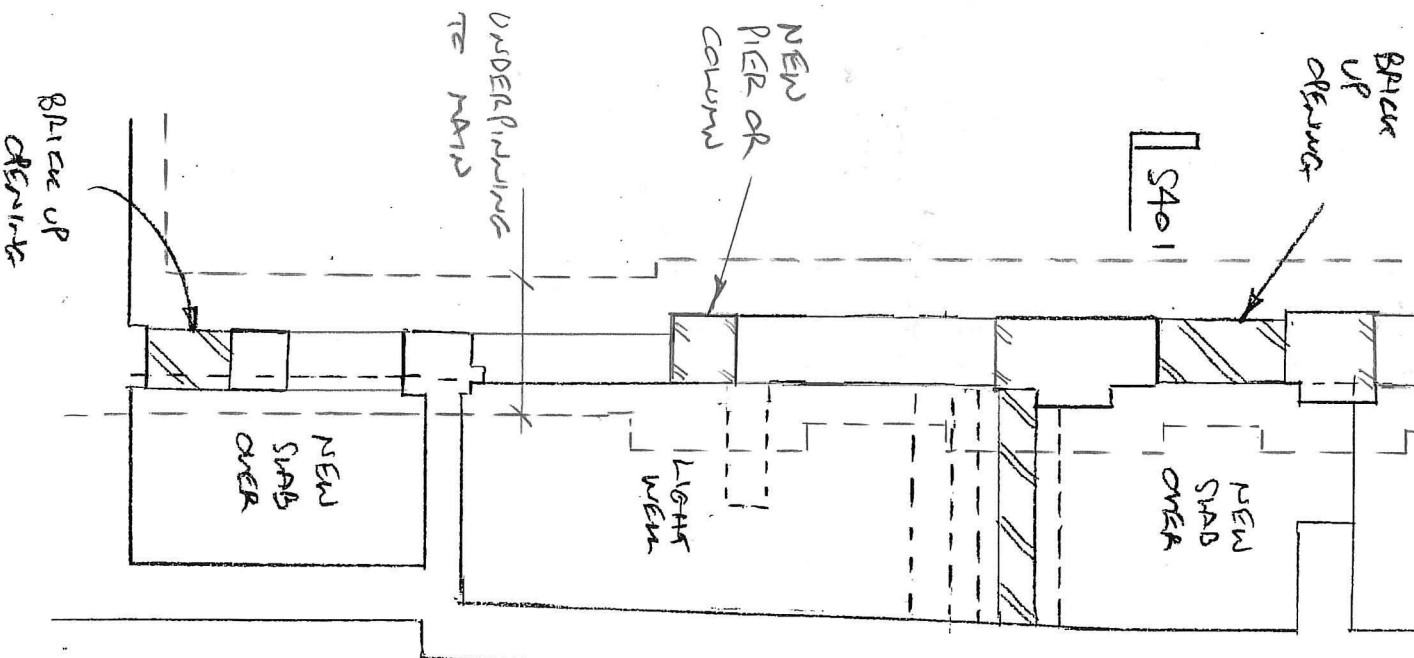
S400

UNDERPINNING STOUND
IS INDICATIVE ONLY
FINAL WIDTHS WILL
BE DETERMINED AT
DETAIL DESIGN STAGE
