# Arboricultural Impact Assessment

***5A Fitzroy Road, London NW1 8TU***

Project Number: P2353.1.3

Date: 6 October 2015

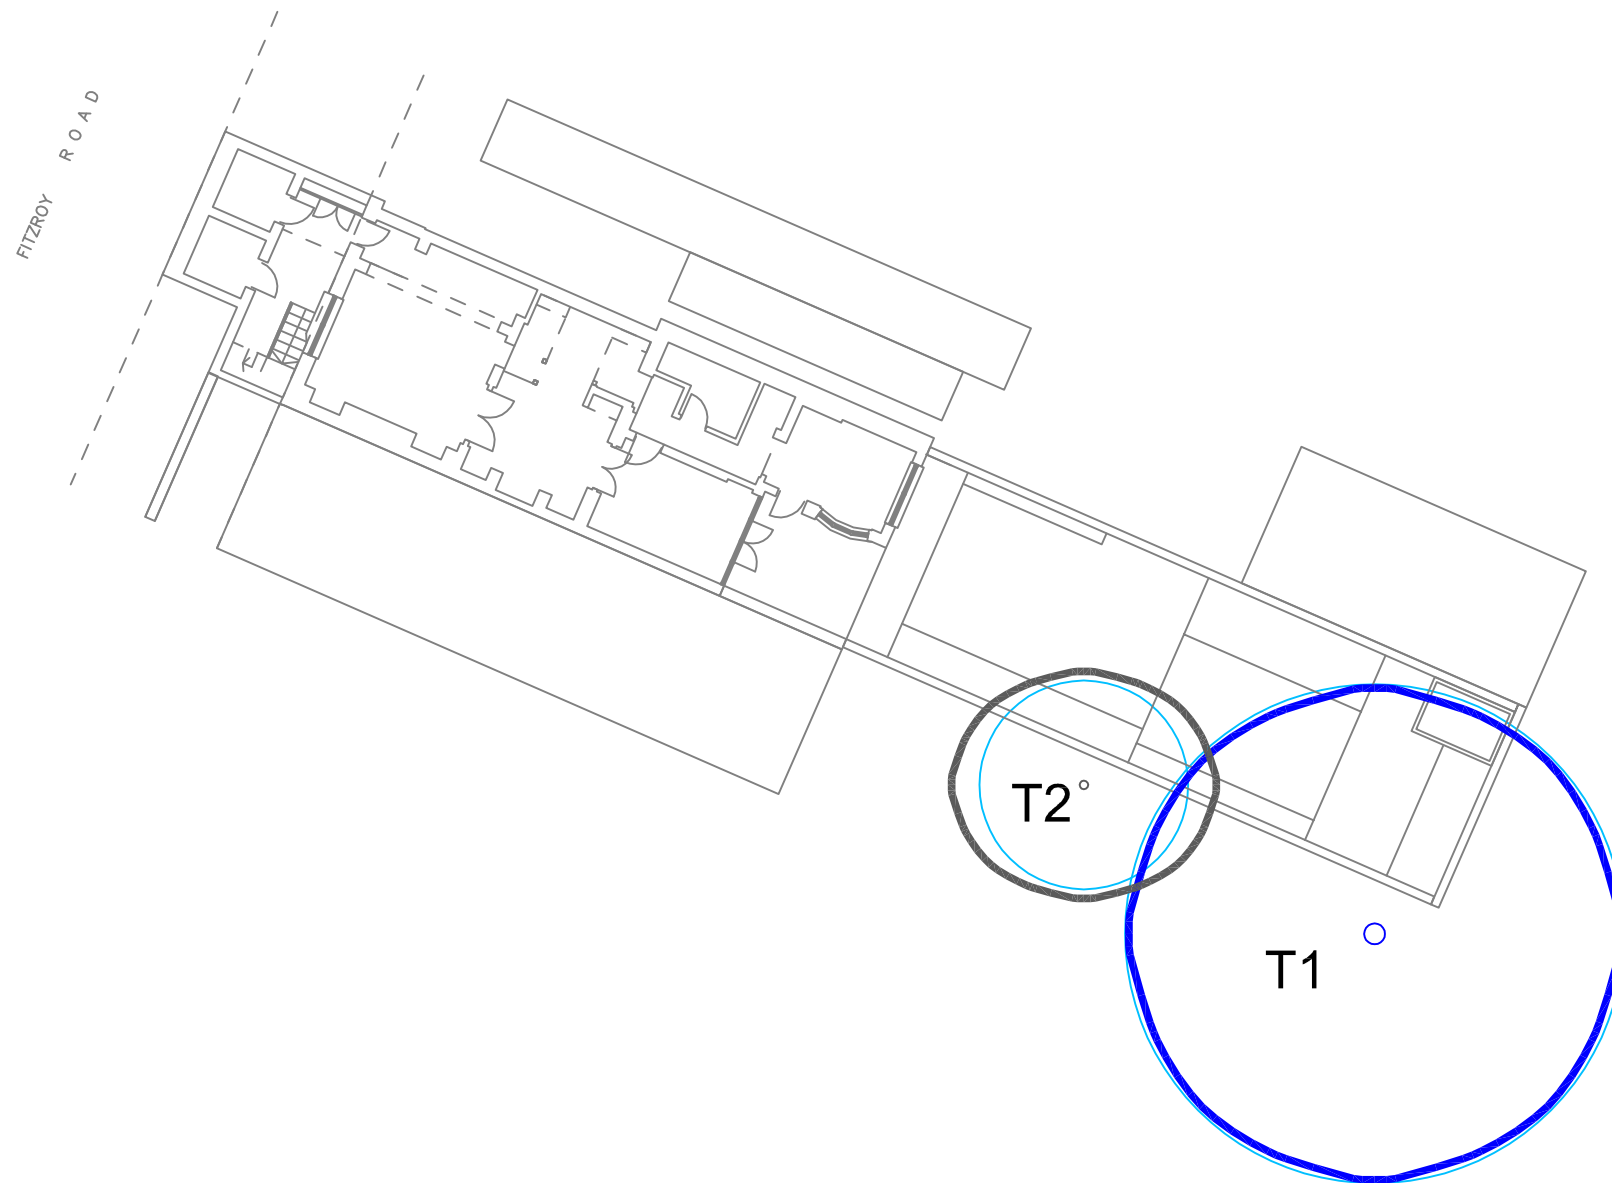
# Appendix 4 Tree Constraints Plan

No tree removal or reduction is required, either for reason of condition or to facilitate the development. Sufficient clearance is already present beneath the crowns of both offsite trees to accommodate the cabana.

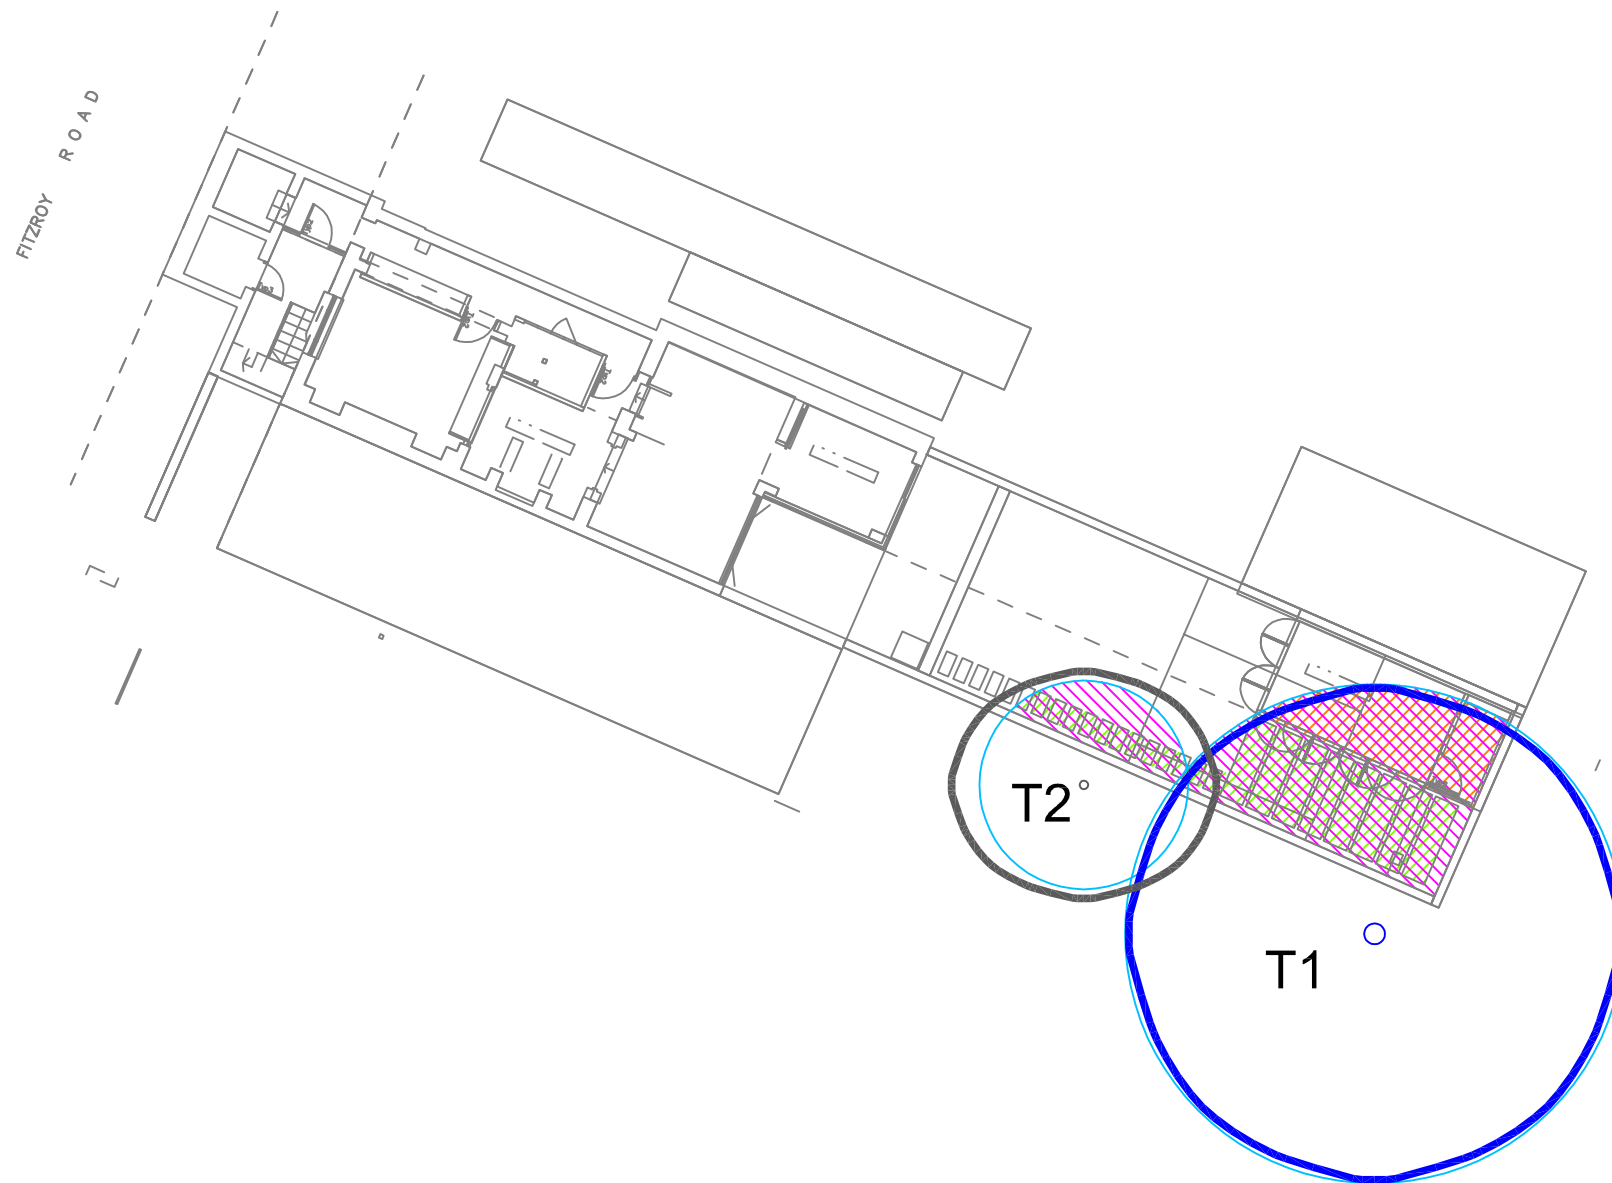
# Appendix 5 Tree Protection Plan

The cabana has potential to affect T1 both during its construction and following completion. During construction installation of the bearing pads could damage roots through excavation, construction access and materials storage could compact and contaminate soil, and the installation of underground services within the RPA could lead to root severance.
