Report No: SD5239  
Date: JANUARY 2014  
Edition 1

## MANAGEMENT SURVEY REPORT

24 – 28 HATTON WALL  
BLACK BULL YARD  
LONDON  
EC1N 8JH

BOULTBEE LAND PLC  
36 BROAD STREET  
HEREFORD  
HR4 9AR

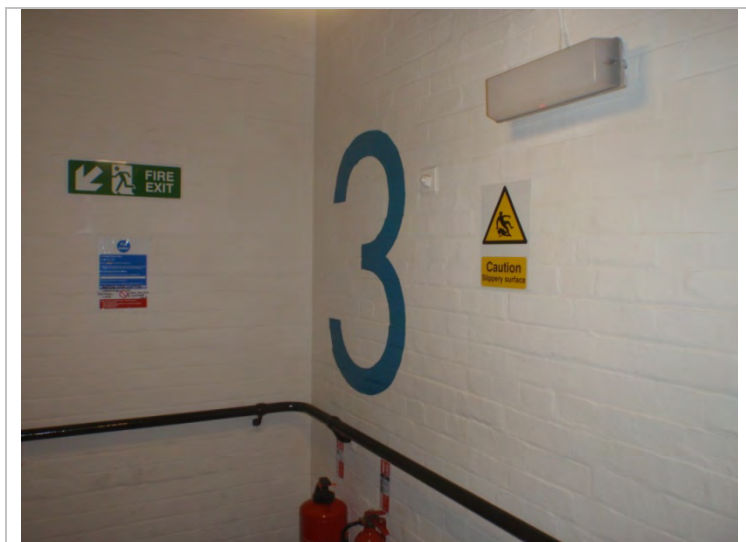
Sample Ref:	n/a	Survey Type:	Management
Area:	n/a	Product Type:	n/a
Floor:	3 <sup>rd</sup> floor	Damage:	n/a
Location:	Stairwell 1	Surface Treatment:	n/a
Product:	n/a	Asbestos Type:	n/a
Asbestos:	n/a	Accessibility:	n/a
14 Day: Notification	n/a	Identification:	n/a
Next Inspection:	n/a	Material Assessment:	n/a
Quantity:	n/a	Priority Assessment:	n/a
		Risk Assessment:	n/a
Action:	General photograph

Comments: View at 3<sup>rd</sup> floor level

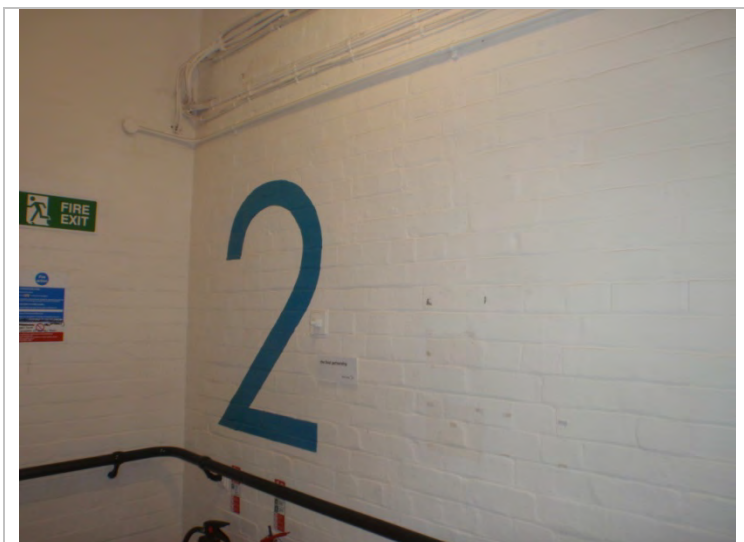
Sample Ref:	n/a	Survey Type:	Management
Area:	n/a	Product Type:	n/a
Floor:	2 <sup>nd</sup> floor	Damage:	n/a
Location:	Stairwell 1	Surface Treatment:	n/a
Product:	n/a	Asbestos Type:	n/a
Asbestos:	n/a	Accessibility:	n/a
14 Day: Notification	n/a	Identification:	n/a
Next Inspection:	n/a	Material Assessment:	n/a
Quantity:	n/a	Priority Assessment:	n/a
		Risk Assessment:	n/a
Action:	General photograph

Comments: View at 2<sup>nd</sup> floor level

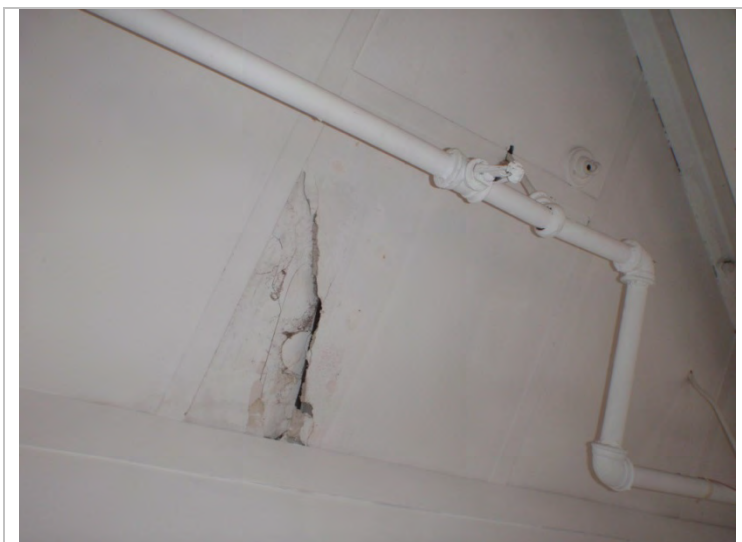
Asbestos insulation board panel to underside of roof in a damaged & friable condition

Encapsulate, label & manage

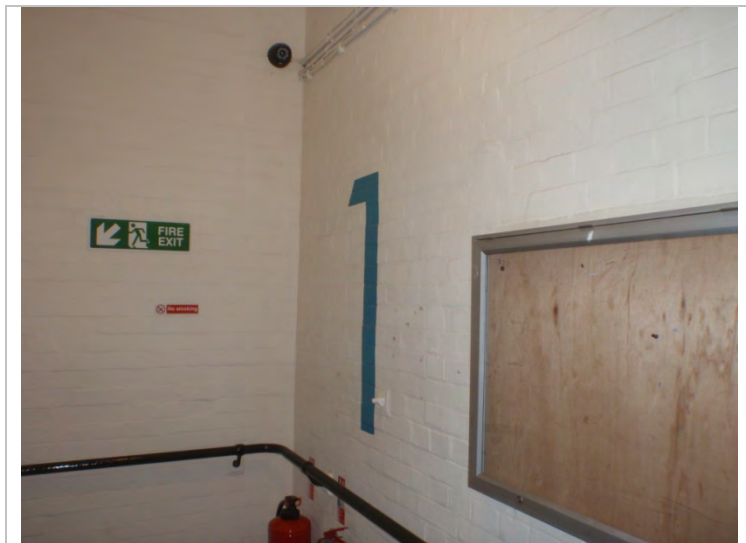
View at 1<sup>st</sup> floor level

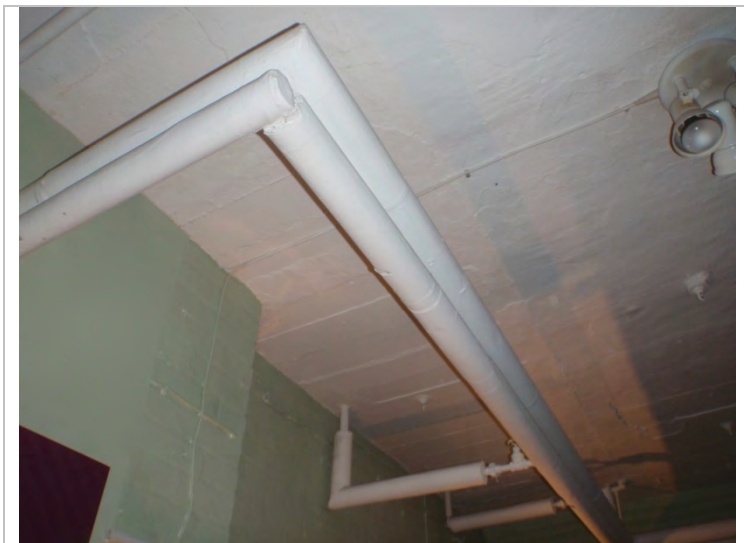
Sample Ref:	B014/542117	Survey Type:	Management
Area:	n/a	Product Type:	Asbestos paper 2
Floor:	1 <sup>st</sup> floor	Damage:	Good condition 0
Location:	Unit 104A	Surface Treatment:	Painted 1
Product:	Paper insulation	Asbestos Type:	Chrysotile 1
Asbestos:	Yes	Accessibility:	Medium
14 Day Notification:	Yes	Identification:	Identified
Next Inspection:	January 2015	Material Assessment:	Very low risk 4
Quantity:	2 x 7 linear meters	Priority Assessment:	Very low risk 4
		Risk Assessment:	Low risk 8

Action: Label & manage

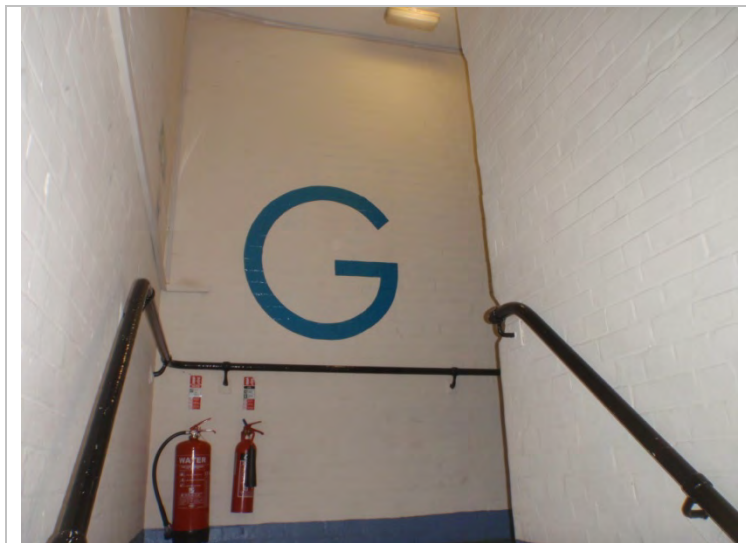
View at Ground floor level

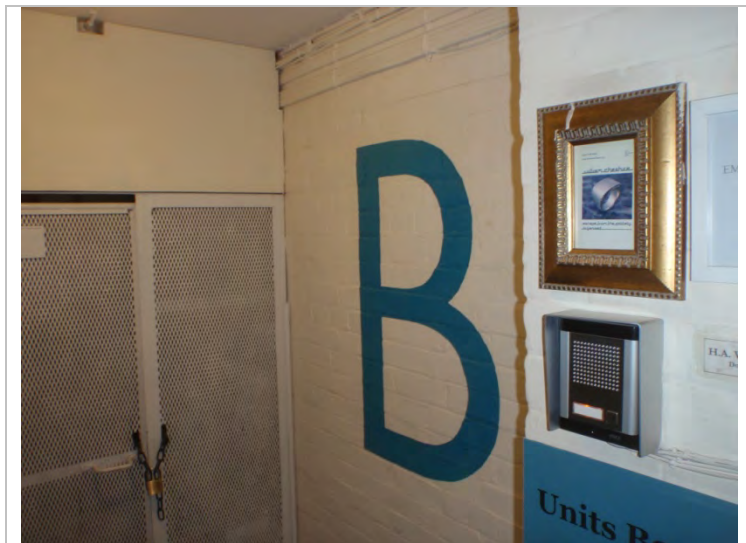
Sample Ref:	n/a	Survey Type:	Management
Area:	n/a	Product Type:	n/a
Floor:	Basement	Damage:	n/a
Location:	Stairwell 1	Surface Treatment:	n/a
Product:	n/a	Asbestos Type:	n/a
Asbestos:	n/a	Accessibility:	n/a
14 Day Notification	n/a	Identification:	n/a
Next Inspection:	n/a	Material Assessment:	n/a
Quantity:	n/a	Priority Assessment:	n/a
		Risk Assessment:	n/a
Action:	General photograph

Comments: View at Basement level

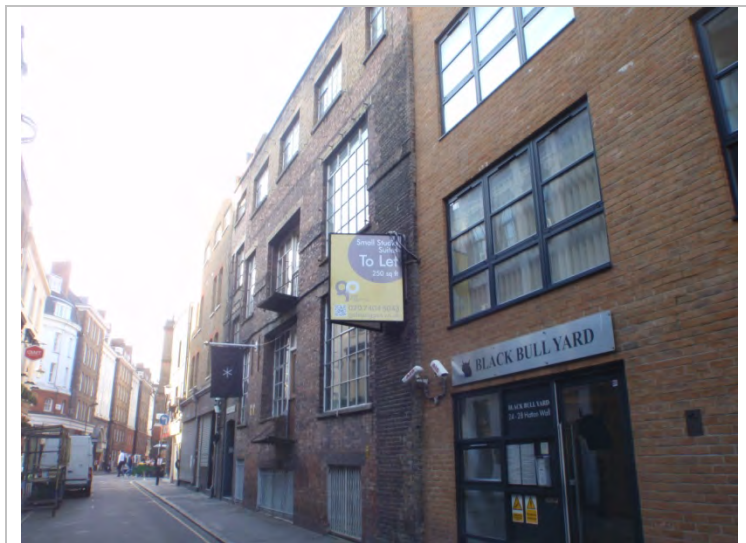
Sample Ref:	n/a	Survey Type:	Management
Area:	n/a	Product Type:	n/a
Floor:	External	Damage:	n/a
Location:	Front elevation	Surface Treatment:	n/a
Product:	n/a	Asbestos Type:	n/a
Asbestos:	n/a	Accessibility:	n/a
14 Day: Notification	n/a	Identification:	n/a
Next Inspection:	n/a	Material Assessment:	n/a
Quantity:	n/a	Priority Assessment:	n/a
		Risk Assessment:	n/a
Action:	General photograph

View of front elevation & entrance to 24 – 28 Hatton Wall, Black Bull Yard
