P3075 BULL & LAST PUBLIC HOUSE, NW5 1QS

REVIEW OF INFORMATION IN RESPECT OF FORMER CELLAR HATCH

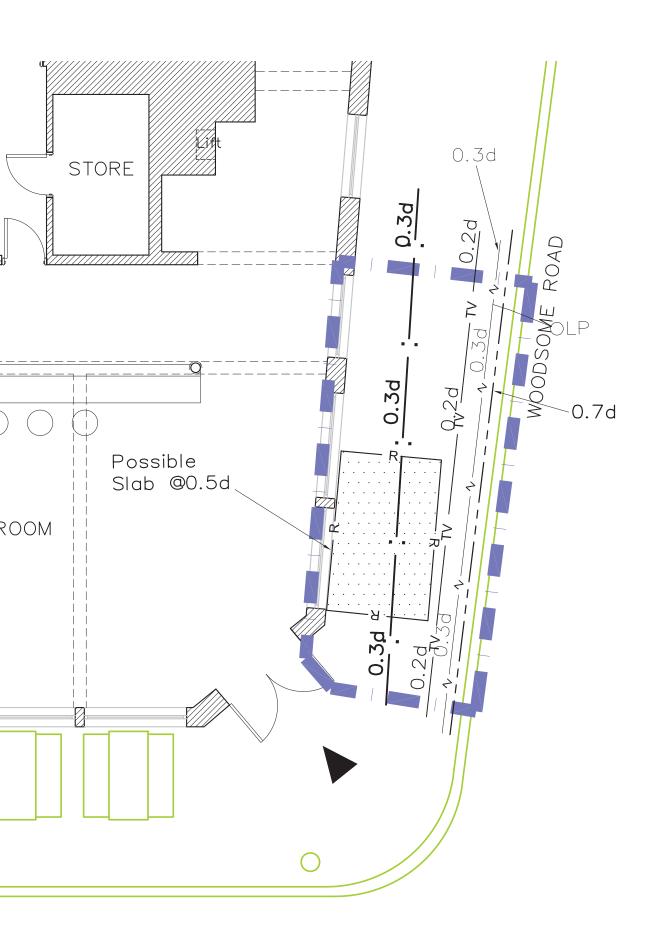
5.	Survey Results
5.	1. Gas
	NA.
5.2.	Electricity
	Located Low Voltage Cable with Radiodetection 0.3 deep.
5.3.	Water
	Located using radiodetection
	O.7deep.
5.4.	Surface Water
	$\sim \mid A$.
5.5.	Foul Water
5.6.	Telecom Located by clamping Cable within BT manhote + tracing electromagnetically
5.7.	depth at 0.3 deep above slab. Pipework
	NA.
5.8.	GPR Results void located at 0.5 deep we
6.	clieve this to be the old hatchmay to conclusions and Recommendations Sellar beneath, here is a Solid obstruction at a Solid abstruction
+	here is a Solid obstruction at 0.5dep
1.	adingus to believe there is a void
E	Beneath.
File:	Page 6 Of 6 Date:
