### Arboricultural Survey (BS5837:2012) & Impact Assessment Report

26 Dartmouth Park Avenue  
London  
NW5 1JN

16th November 2015

Marcus Foster  
*BA (Hons) NDArb. TechCert (ArborA) EGS.Dip*

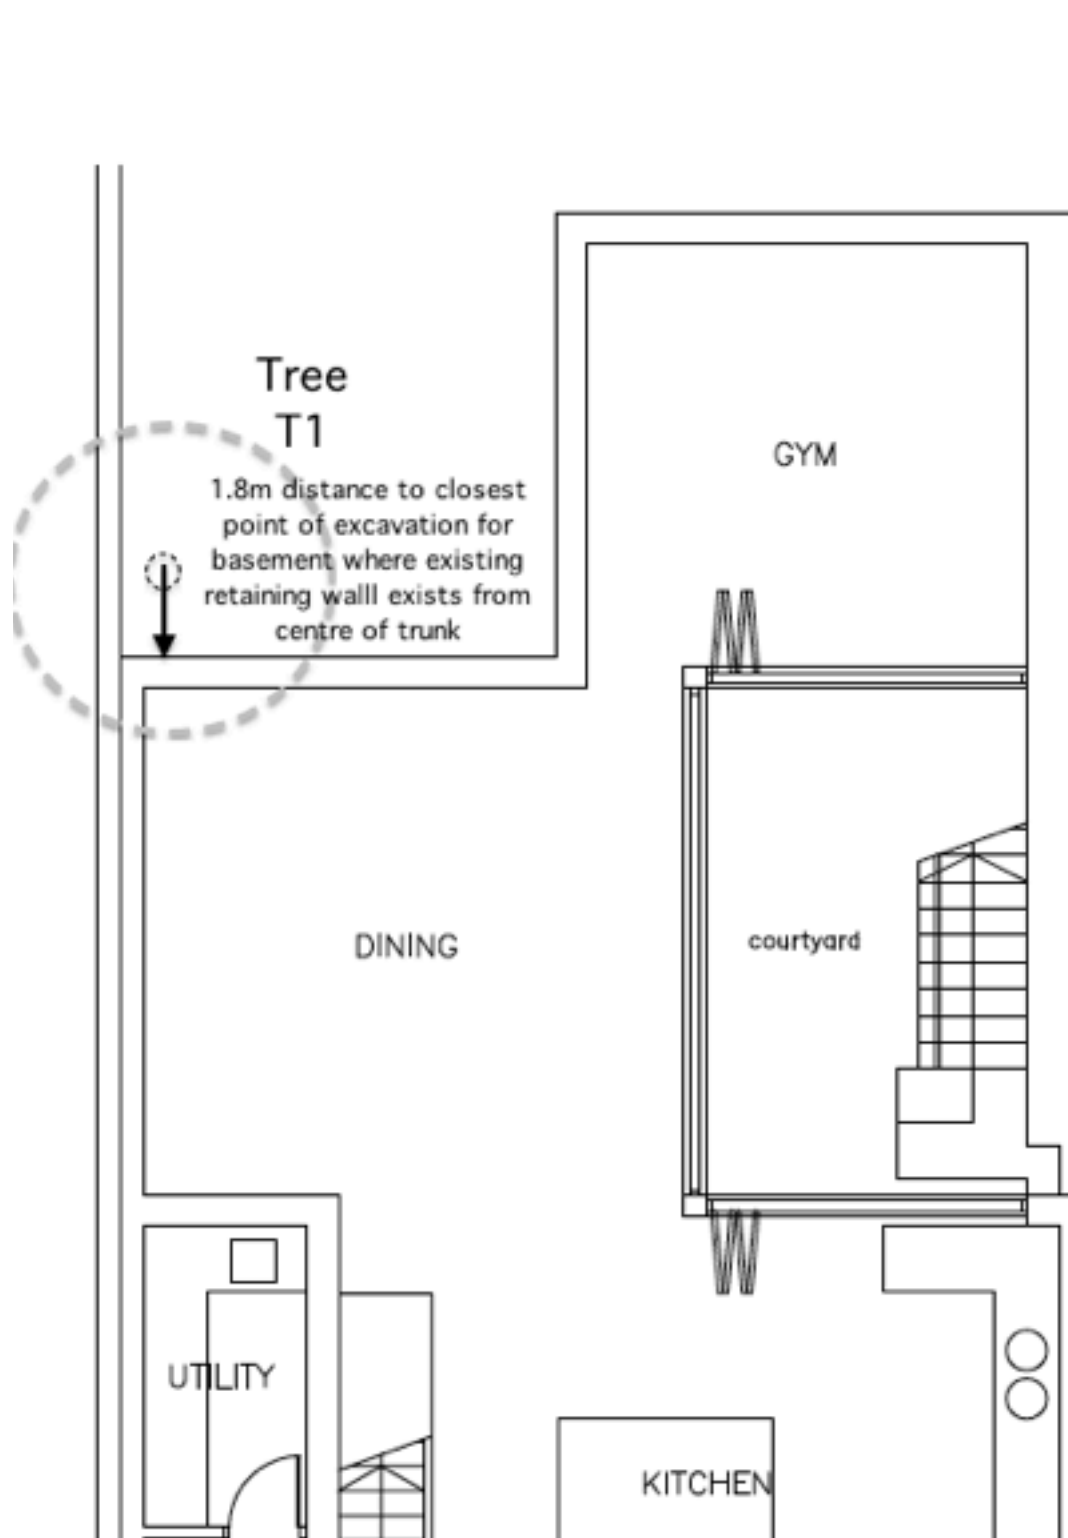
Appendix B.3 Proposed Site Plan:  
26 Dartmouth Park Avenue, London, NW5 1JN - Basement

4.18 The protection fencing that is specified for trees T2 and T3 is therefore recommended to extend across the width of the garden (see *Appendix B.3*) ensuring that full protection is provided for the entire rear garden area for this development site.
