BUILDING SURVEY

Mr and Mrs J Oliver

**4 The Grove
Highgate
London
N6 6JU**

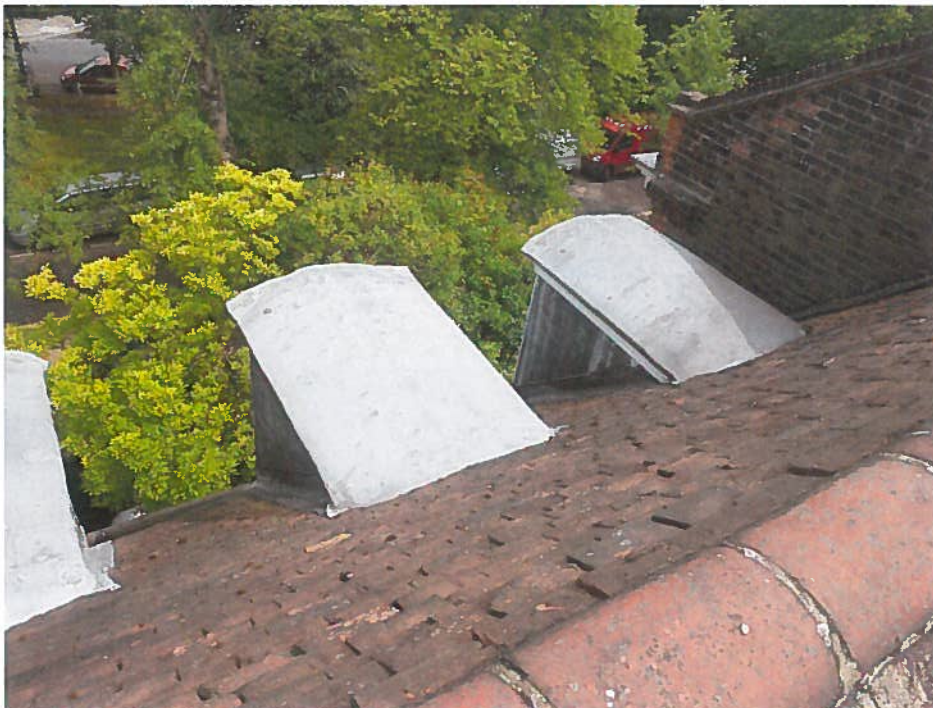
The roof over the original part of the house is arranged in a double pitch with a central valley discharging at the north end. The outer roof slopes are clad with handmade, plain clay tiles but modern concrete plain tiles have been used to retille the inner slopes (photos 4, 5 and 7). Concrete tiles have a long service life but are somewhat out of keeping on a listed building. The tiling was relaid, probably 40 or 50 years ago, and there is an underlining of reinforced bitumen felt to provide a secondary line of defence against water penetration. The tiling is generally in good condition although a minor overhaul of the clay tiling is required to replace a few broken or delaminating tiles, together with the occasional cracked ridge tile. We also noted that the mortar fillet which weathers the abutment between the rear roof slope with the south party wall has pulled away from the brickwork slightly and this should be renewed or, preferably, replaced with a lead flashing.

Photo 4 – Main roof – front slope

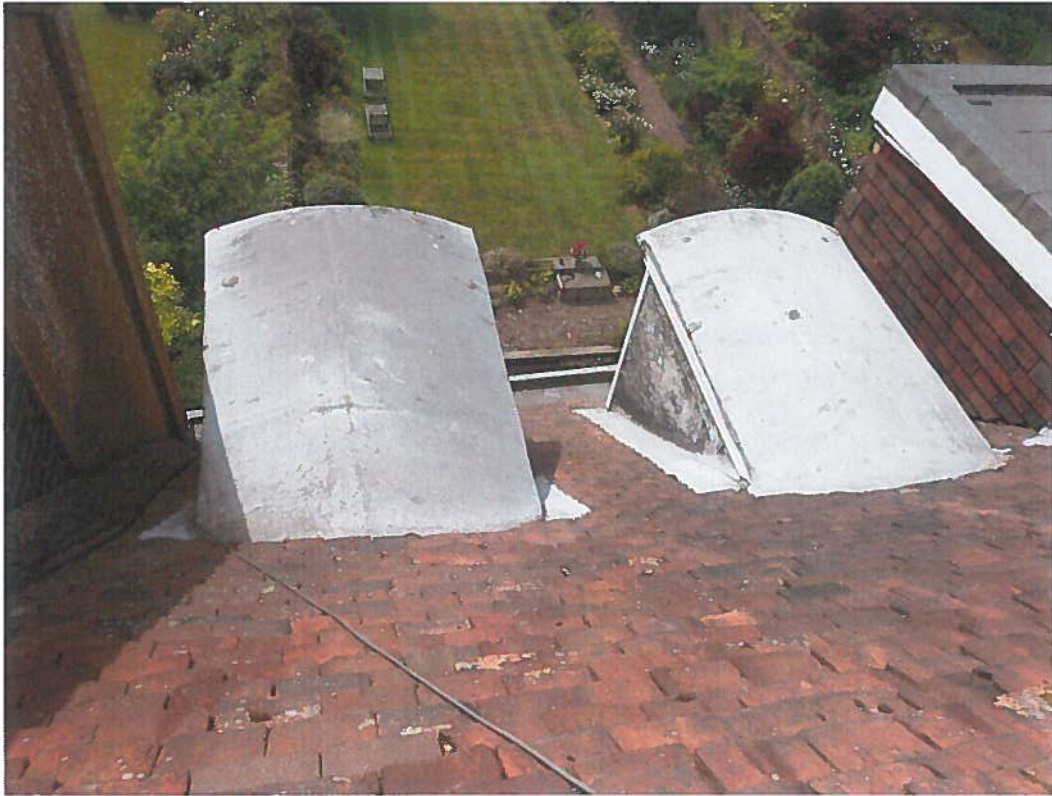
Photo 5 – Main roof – rear slope

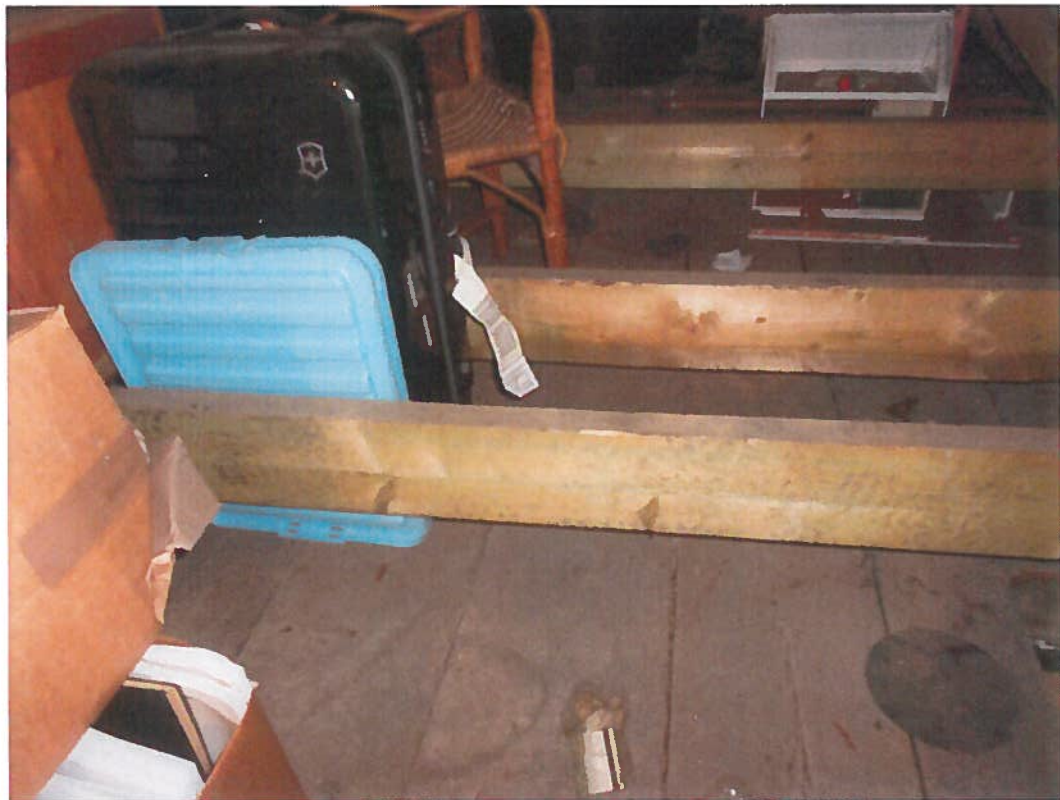
Photo 12 – New ties across rear pitch of main roof

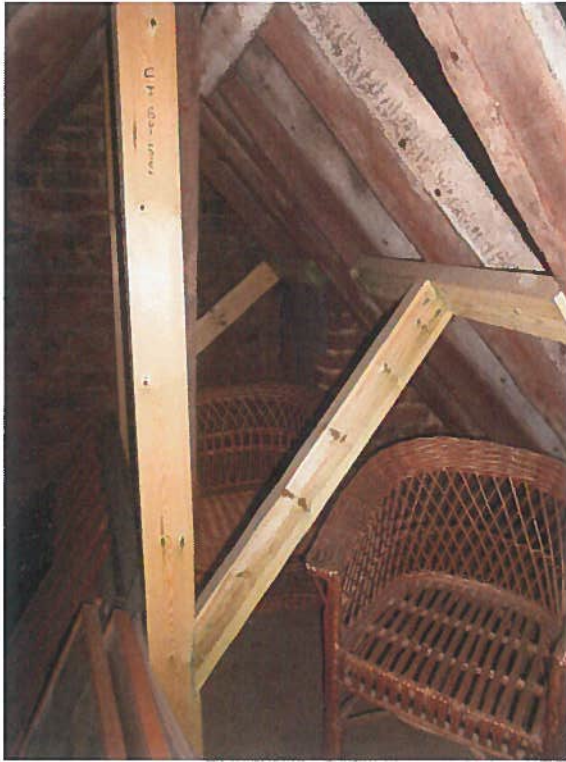
Photo 13 – New strutting to rafters of front roof pitch

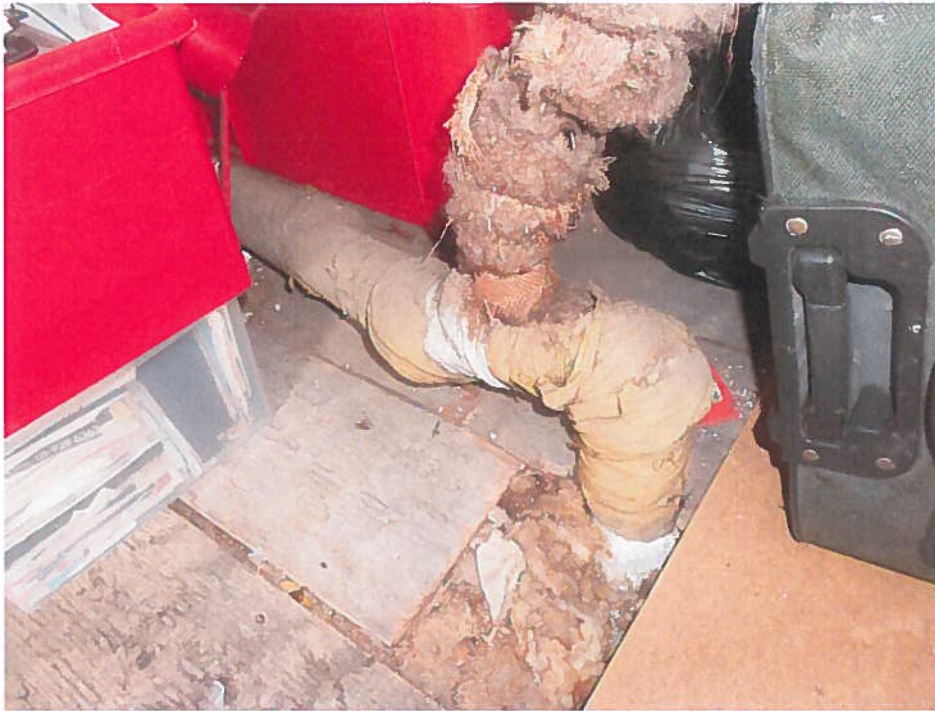
While in the front roof space, we noted that a large galvanised pipe is still insulated with asbestos which is in poor condition and will have certainly released fibres into the loft (photo 29). Specialist testing will be required to confirm that the material is asbestos based, in which case it will have to be removed under controlled conditions by a licensed contractor, who will also decontaminate the surrounding area. The pipe in question continues down through the house, without lagging where visible, but further checks should be made to ensure that none of the concealed pipework is also lagged with asbestos. At the same time, the asbestos board noted in the fireplace on the first floor should also be checked.

Photo 29 – Asbestos lagging in front roof space

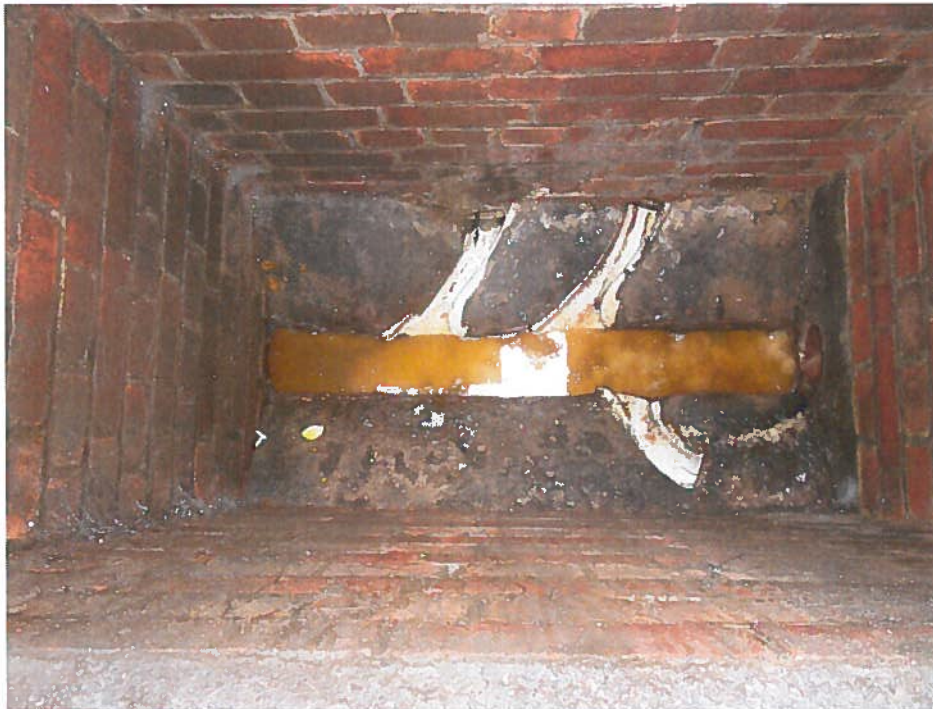
We could locate only one access manhole in the paving outside the boiler room. The manhole is of considerable depth and fitted with a heavy, cast iron cover. The drains are laid in glazed earthenware pipework, typical of the Victorian period with 150mm diameter to the main channel and 100mm branch drains. At the time of inspection, the main channel was partially blocked and this will need to be cleared by rodding or water jetting (photo 32). The condition of the drains should then be checked by means of a CCTV survey to reveal any collapses or other defects. Fortunately, most drainage defects can now be repaired by in-situ sleeving which avoids the need for excavation. In this case, any excavation would be very costly as the drains below the boiler room and front drive etc are at a very considerable depth below ground level.

Photo 32 – Blocked channel in manhole

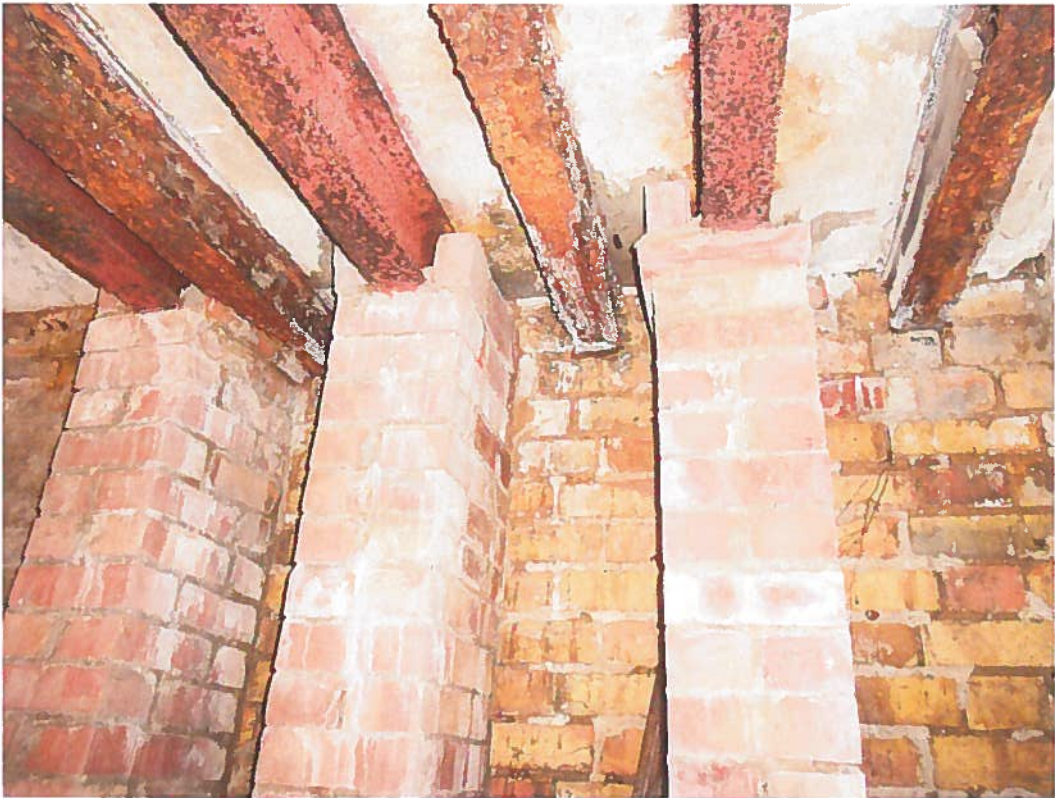
The three vaults below the upper part of the garden are constructed with arched brickwork which is in fair condition for its age. However, at the entrances to the central and southern vaults there are a series of steel beams some of which are supported on modern brick piers. The earlier beams are heavily corroded and the more recent replacements, fitted about ten years ago, are also beginning to corrode (photo 34). Further replacements must therefore be anticipated in the future and these should be galvanised to resist corrosion. As we would expect, these vaults are very damp and there is direct leakage into the north vault when it rains.

Photo 34 – Steel beams and brick piers in garden vault
