ARBORICULTURAL IMPACT ASSESSMENT REPORT:

9 Harley Road
London
NW3 3BX

Ref: SHH/9HRR/AIA/01

Date: 23rd November 2015

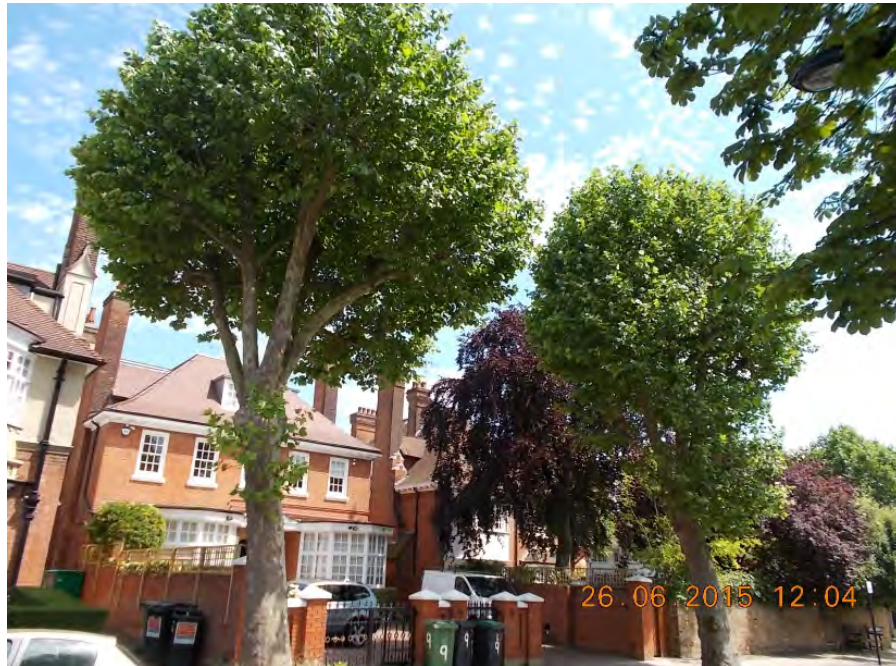
Photograph 1: 9 Harley Road, London NW3 3BX

- 3.1.1 The application site comprises a part single, part double storey, plus attic, detached house located on the north of the junction between Harley Road and Wadham Gardens. Harley Road is a predominantly residential street in the London Borough of Camden that runs in a north westerly direction between King Henry's Road and Wadham Gardens.
