ARBORICULTURAL IMPACT ASSESSMENT REPORT & OUTLINE METHOD STATEMENT:

12 Park Village West
London
NW1 4AE

Ref: CZL/12PVW/AIM/02

Date: 8th December 2015

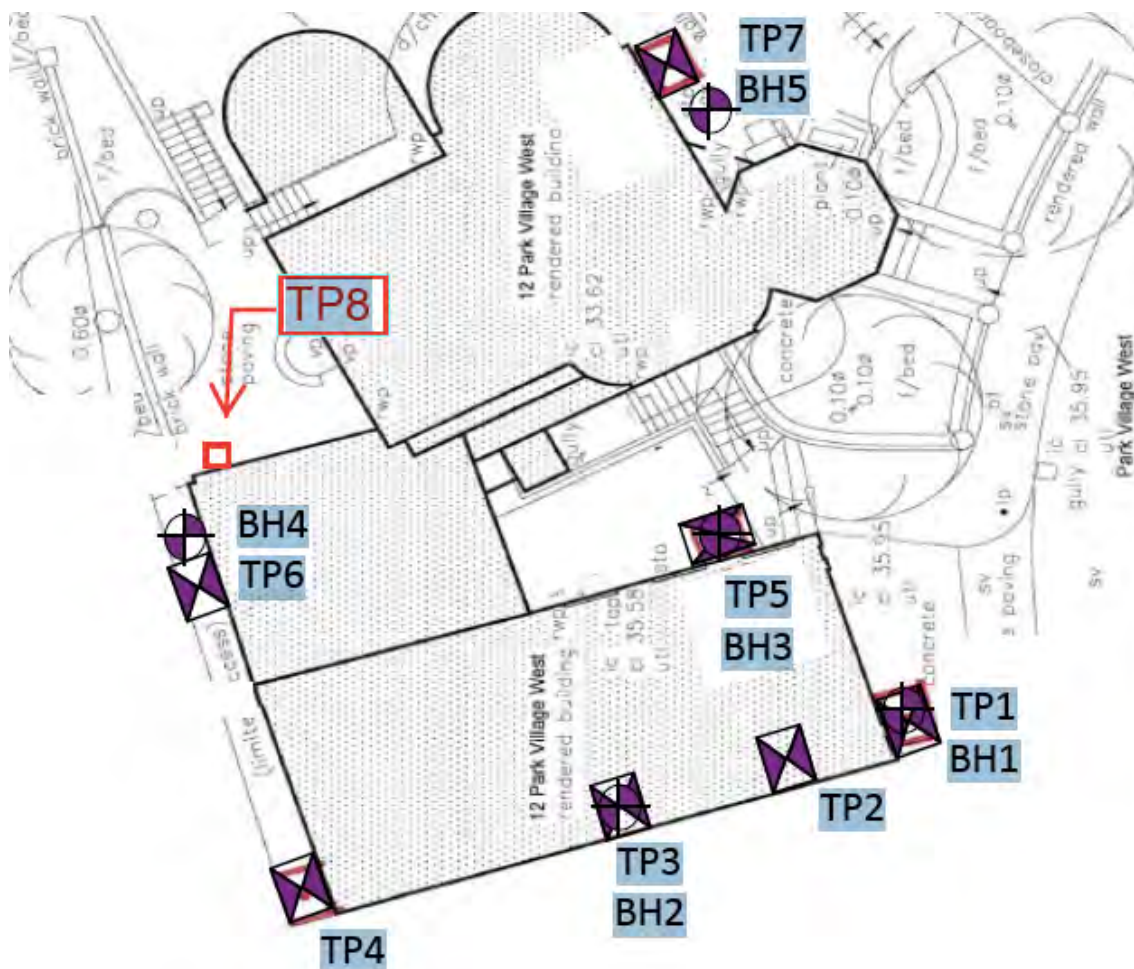
- 4.1.5 The most recent photographic trial pit evidence for trial pit 8 (see Appendix 5) has been viewed by the Tree Officer Nick Bell on the 12th August 2015. At the site meeting on the 5th of August 2015 and in a subsequent email, there is agreement between the parties that the excavations appear to be free of significant roots; the Tree Officer also noted that some of the excavations (TP8) would be best described as a holes as opposed to pits i.e. trenches. This was due to the existence of a 600mm concrete apron.

- 4.1.10 In theory, only moderate quality trees and above are significant material constraints on development. However, the findings reveal only small 'rootlets' within the proposed footprint, identified mostly as belonging to vines / creepers. Small tree roots from a London plane were found in TP6, but there is no plane within 15m of the proposals: RPA's are limited to 15m radii, though trees may root to 60m+ from their stems. Thus, these small roots are not a material constraint on development

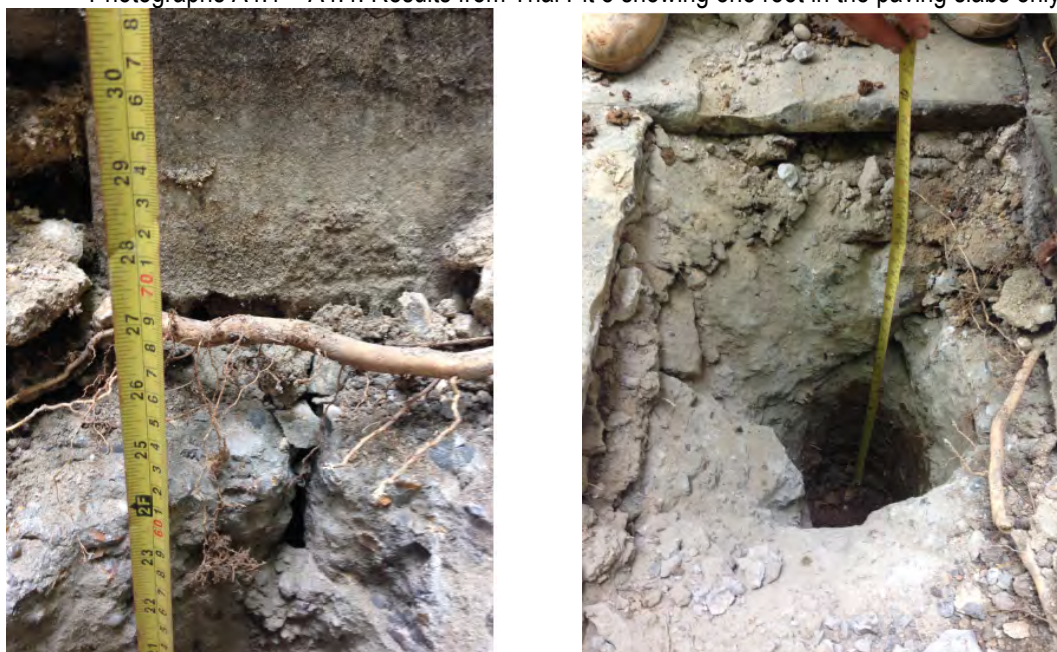
Photographs A4.1 – A4.4: Results from Trial Pit 8 showing one root in the paving slabs only

- A4.2 The roots/rootlets noted in Extract A4.1 above and Table A4 were identified by Richardson's Botanical Identifications (see letter below).
- A4.3 It has been agreed between the Tree Officer Nick Bell and Landmark Trees during the site meeting on the 5th August 2015 and subsequent emails that none of the trial pits contained significant roots. Whilst it was noted TP8 was a 'hole' rather than a trench, it was noted that the 600mm of concrete excavated to provide the trial pit evidence had clearly restricted root colonisation in this area.
