Arboricultural Consultancy for Aviva

1. Case Details

Insured	Haverstock Hill Limited	Address	96 Haverstock Hill, London, NW3 2BD		
Client	Subsidence Management Services	Contact	Emily Bogie	Claim No.	IFS-AVI-SUB-14-0052426
ES Ref	NL/0110140922/TP-REV1	Consultant	Thomas Peppiatt	Contact No.	0330 380 1036
Report Date	02/10/2015 Revised: 16/10/2015

Scope of Report: To survey the property and determine significant vegetation contributing to subsidence damage, make recommendation for remedial action and assess initial mitigation and recovery prospects. The survey does not make an assessment for decay or hazard evaluation.

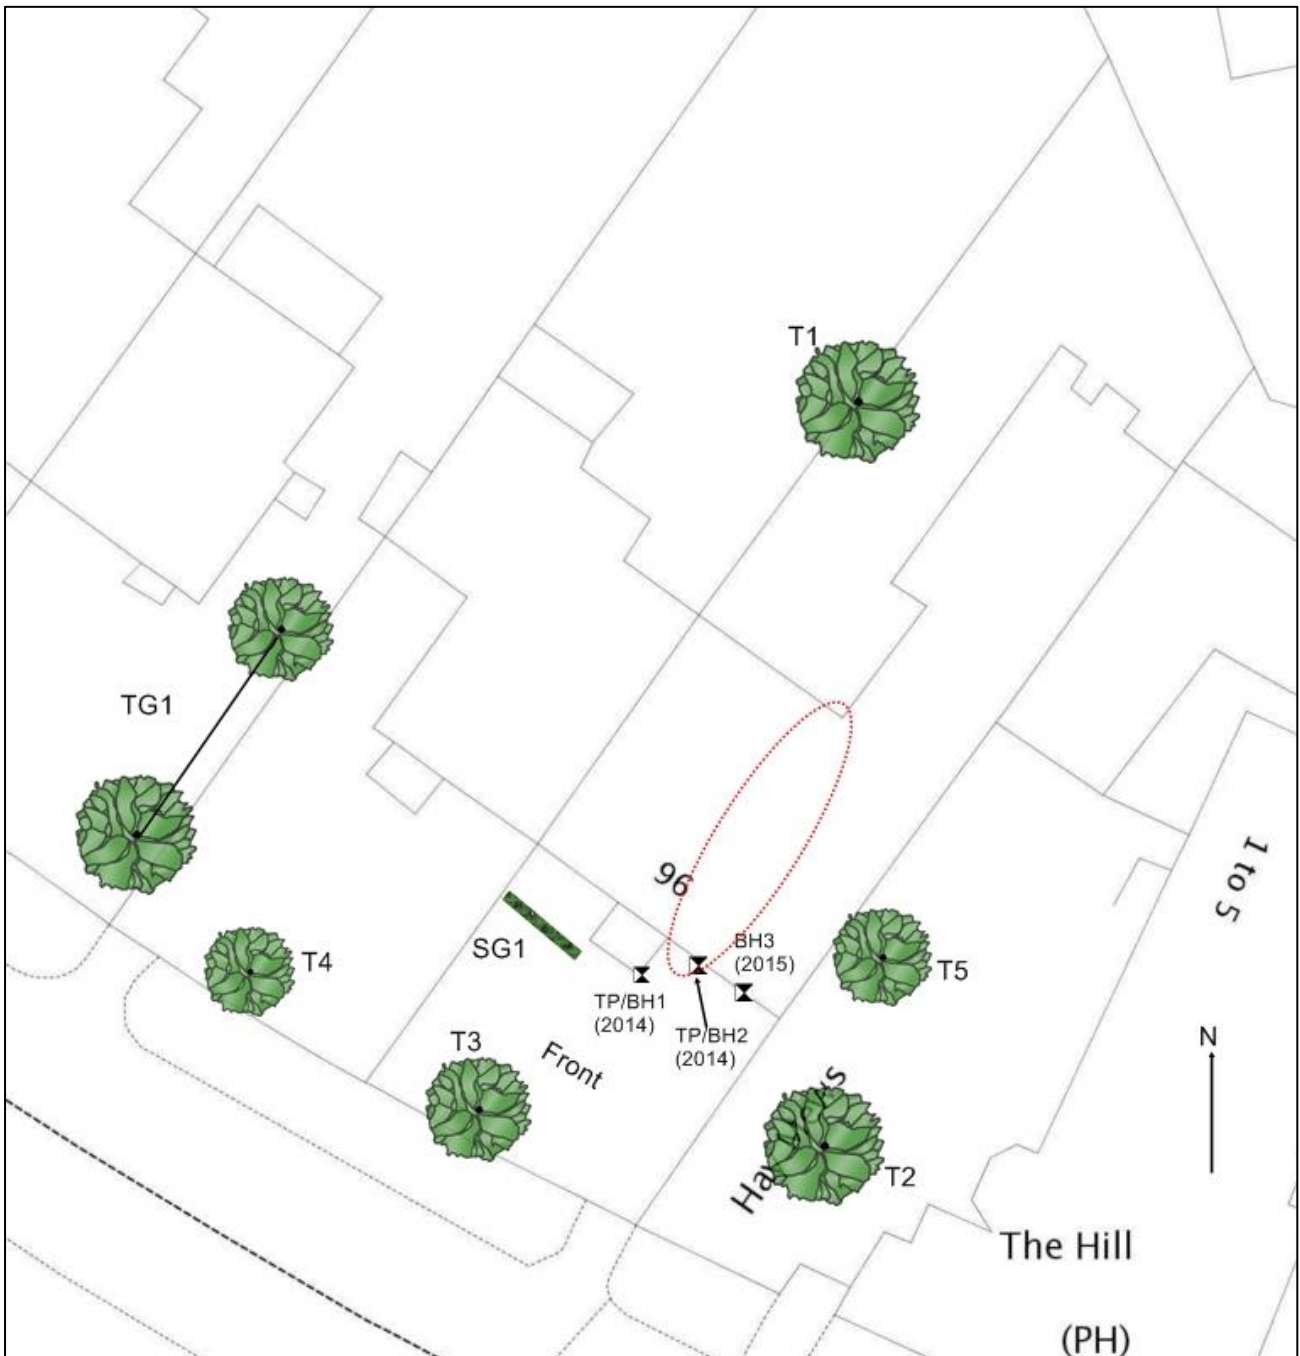
7. Site Plan

In assessing the extent of damage and the potential drying influence of the vegetation on site, T2 (Acer) and T3 (Elm) are judged to be the dominant features and accordingly we have identified them as the principal cause of the subsidence.

T5 (Pear), cannot be discounted as contributing to the overall level of soil drying proximate to the area of damage and is therefore also considered to retain a contributory influence, albeit in a limited / secondary capacity when compared to T2 (Acer) and T3 (Elm).

Please note that the footing of the subject property fall within the likely rooting zone of a further tree identified as T1 (Lime); this tree is noted to present a theoretical future risk.

In order to mitigate the current damage and allow soils beneath the property to recover to a position such that an effective engineering repair solution can be implemented we recommend a program of removals as listed by this report.
