STRATEGIC PROPOSAL FOR TREATMENT OF EXTERNAL FINISHES AT ALEXANDRA ROAD AND AINSWORTH ESTATE

Prepared by Neave Brown

04.05.04

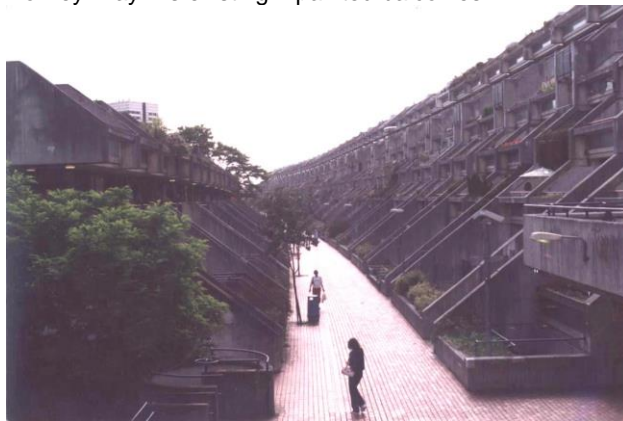
Rowley Way: Proposed – architectural unity re-instated

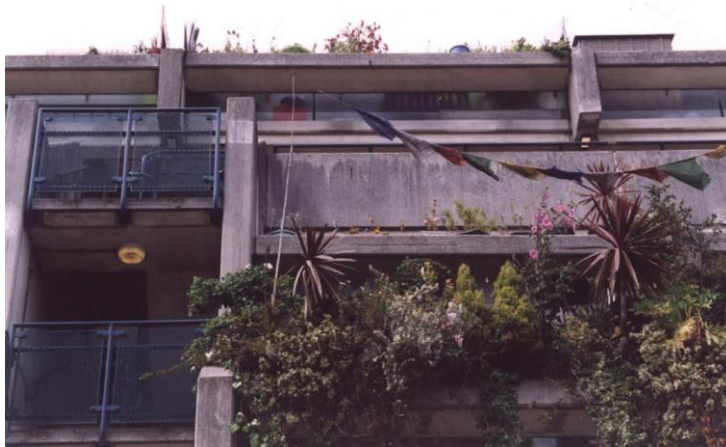
Proposed - Streaking removed

2. The narrow face of the profiled precast slab edges below the planting bays - A, B, and C Blocks which are streaked and need cleaning.
3. The face of the in situ planters between entrances, level 6 - B block north. These are very conspicuous and many badly stained with water both from above and from the planter itself, in strong contrast to the relatively clean bright concrete protected by the overhang above.
4. The surface of A Block staircase walls on the dwelling side at level 5,

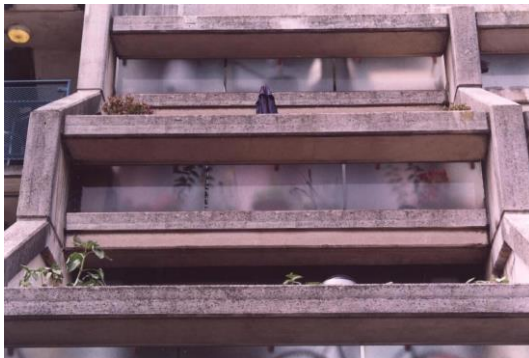
Proposed: Staining removed

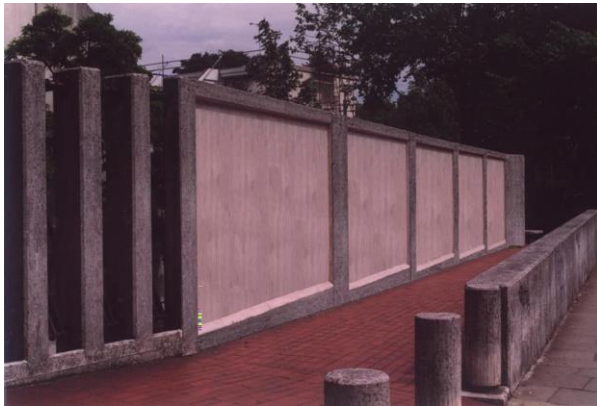
Proposed: Concrete painted within coffered.

- 11.1 It is my opinion that the painting out of the graffitied surfaces is the right method - the work of people on site doing this is already tireless and impressive. My suggestions are either in the context of, or in preparation for, the painting of rendering. In any case, it is important that the painting matches as far as possible the adjacent concrete, and intensifies rather than obscures the distinction between concrete and rendering. The two surfaces, even if adjacent, should not be painted the same colour.

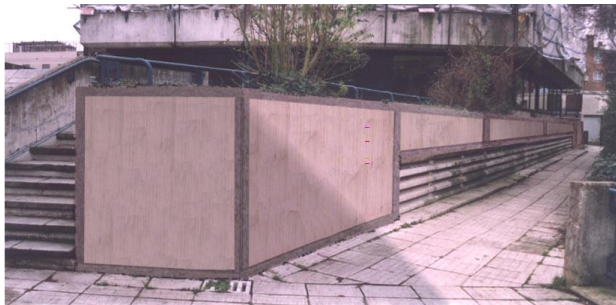
Proposed: Painted panels

- 11.4 It would be important to find a technique so that the edge for the first painting could be established, and subsequent painting to cover graffiti attacks could be easily done. An advantage would be that it would localise graffiti and over-painting could be within limits - a possible economy.
- 11.5 The continual painting out of graffiti must be a burden and needs to be as easy as possible. I realise that to suggest that more than one shade is needed is to suggest a complication. It would require a simple, clear and comprehensive visual tabulation acceptable to the people doing the job. It would have to cover every vulnerable surface.

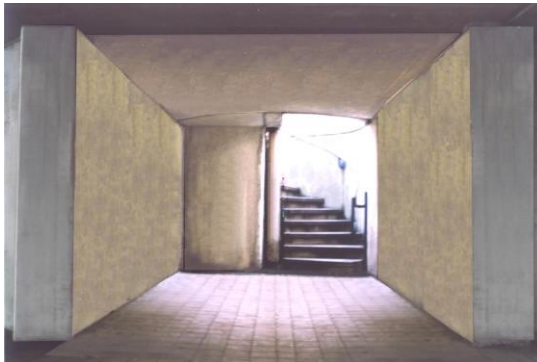
Proposed: Graffiti painted out.
