ARBORICULTURAL IMPACT ASSESSMENT REPORT:

3 Belsize Place
London
NW3 5AL

Ref: GCM/BLS/AIA/02

Date: 26th January 2016

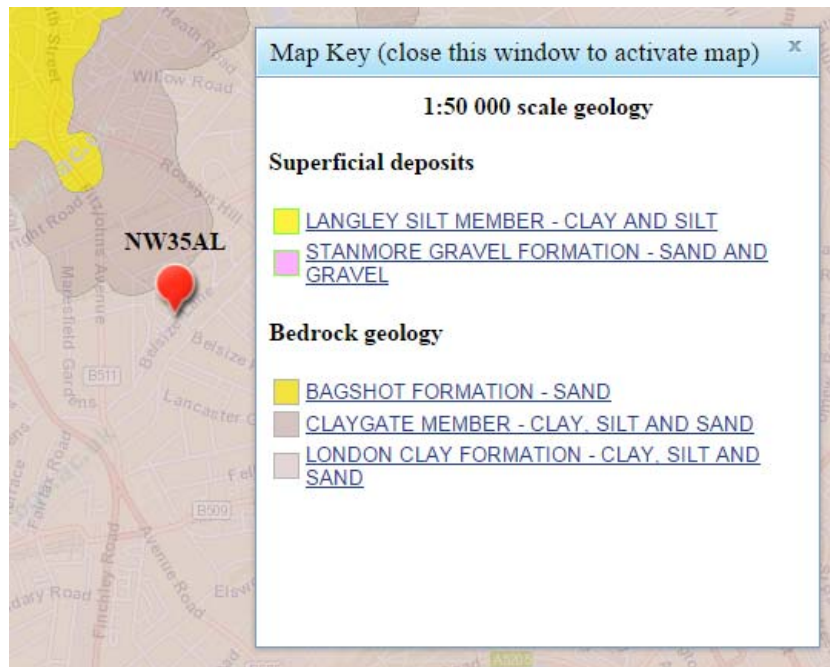
Figure 1: Extract from the BGS Geology of Britain Viewer

- 3.1.3 In terms of the British Geological Survey, the site overlies the London Clay Formation (see indicated location on Fig.1 plan extract below). The associated soils are generally, highly shrinkable clay; e.g. slowly permeable seasonally waterlogged fine loam over clay. Such highly plastic soils are prone to movement: subsidence and heave. The actual distribution of the soil series are not as clearly defined on the ground as on plan and there may be anomalies in the actual composition of clay, silt and sand content.

- 3.1.4 Clay soils are prone to compaction during development with damage to soil structure potentially having a serious impact on tree health. The design of foundations near problematic tree species will also need to take into consideration subsidence risk, given the proximity of the proposals to T2 and its capacity for large growth. Further advice from the relevant experts on the specific soil properties can be sought as necessary.

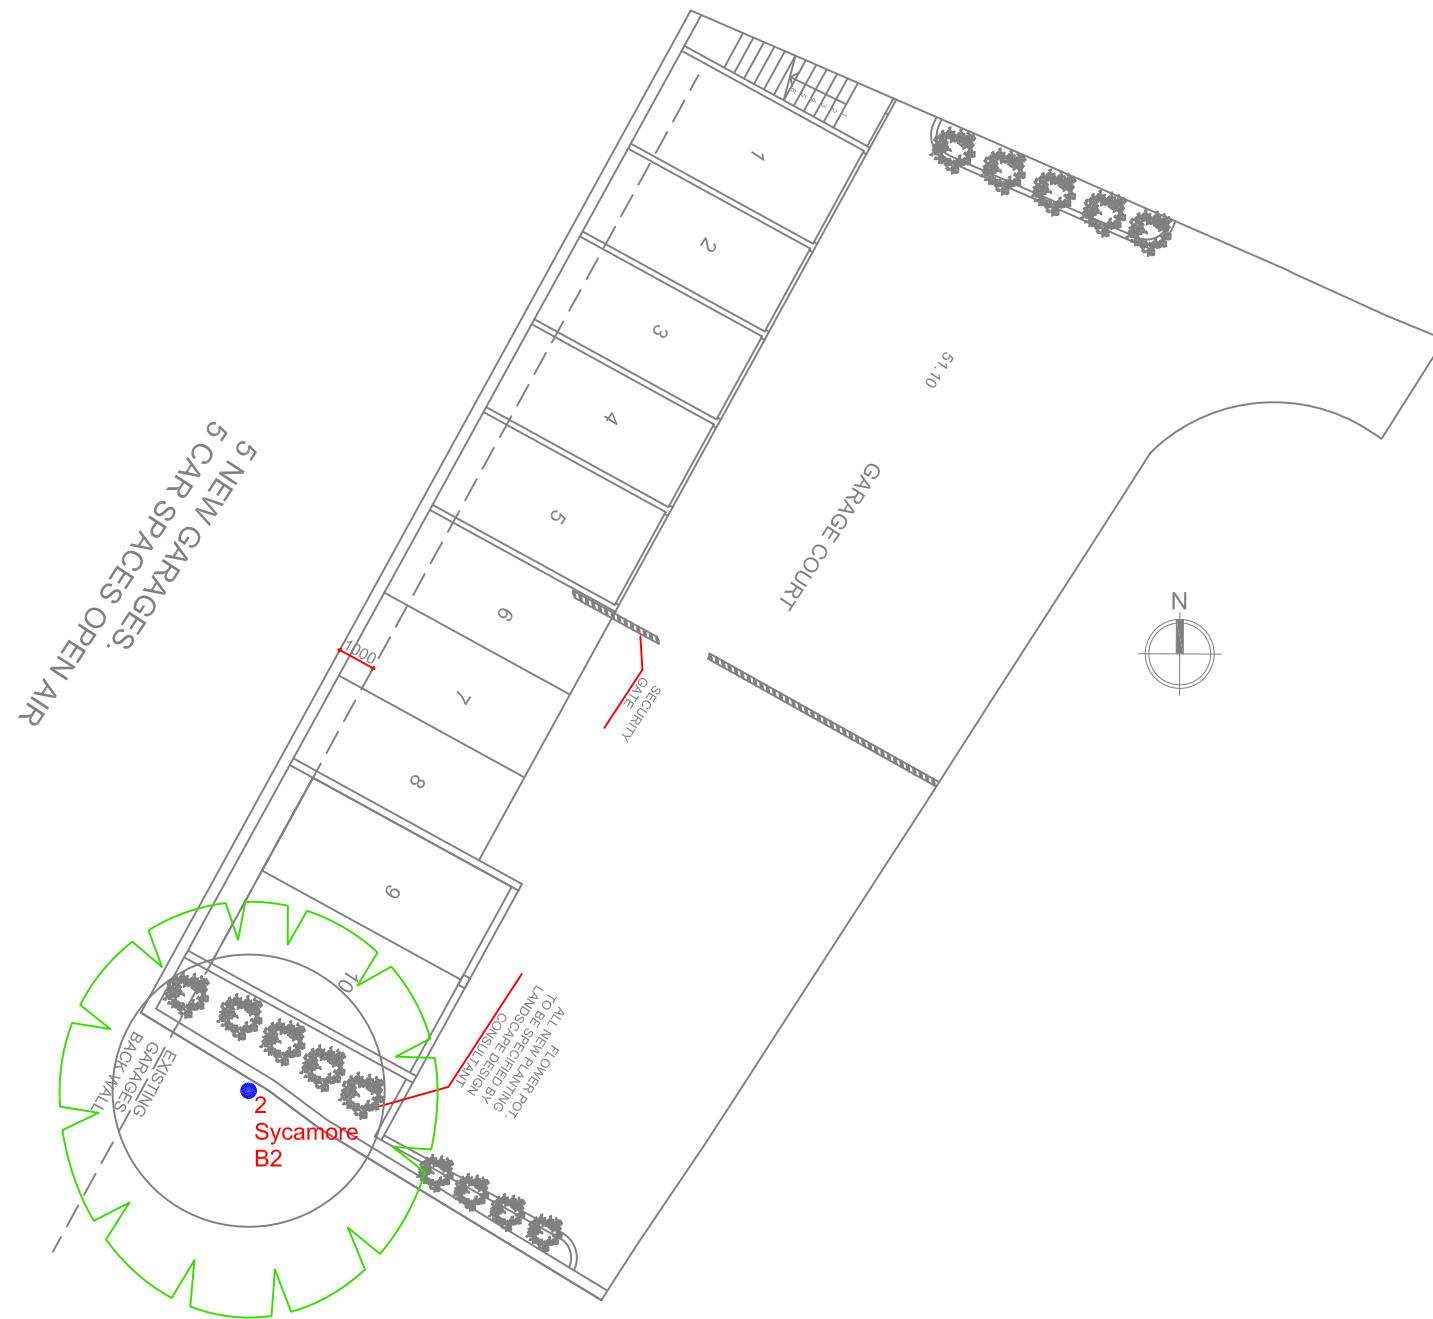
- i. Ground Floor

- 6.1.1 The primary impact of development is the location of the new garage block within the theoretical RPA of the sycamore tree, T2. Following consultation with the applicant, the footprint of the garage has been pulled back to 2m from the boundary fence leaving a theoretical encroachment of 5m² (12.3%). Two trial pits have established that there are few significant roots penetrating more than 1m into the site, and none at 2m distance. The single large buttress root entering the site was observed in TP2 to change direction approximately 1m into the site, growing straight down into the soil, with only fibrous roots found in TP1 located 2m in from the site boundary (see photographs 2 and 3 below).

- 6.1.2 Having established that no significant roots are present within the likely footprint of the redeveloped garage block (to the depth of its 600mm excavation), the founding of this structure can be supported, in the knowledge that will be no significant impact to the low quality tree or its roots. The impact of the proposal is therefore rated as low.

8.1.1 Excavation and construction impacts within the RPA's of trees identified in Table 1 above, will need to be controlled by method statements specifying mitigation methods suggested in para 6.3 above and by consultant supervision as necessary. These method statements can be provided as part of the discharge of conditions.
