13 Kemplay Road, Hampstead

Tree Survey Report

1st March 2016

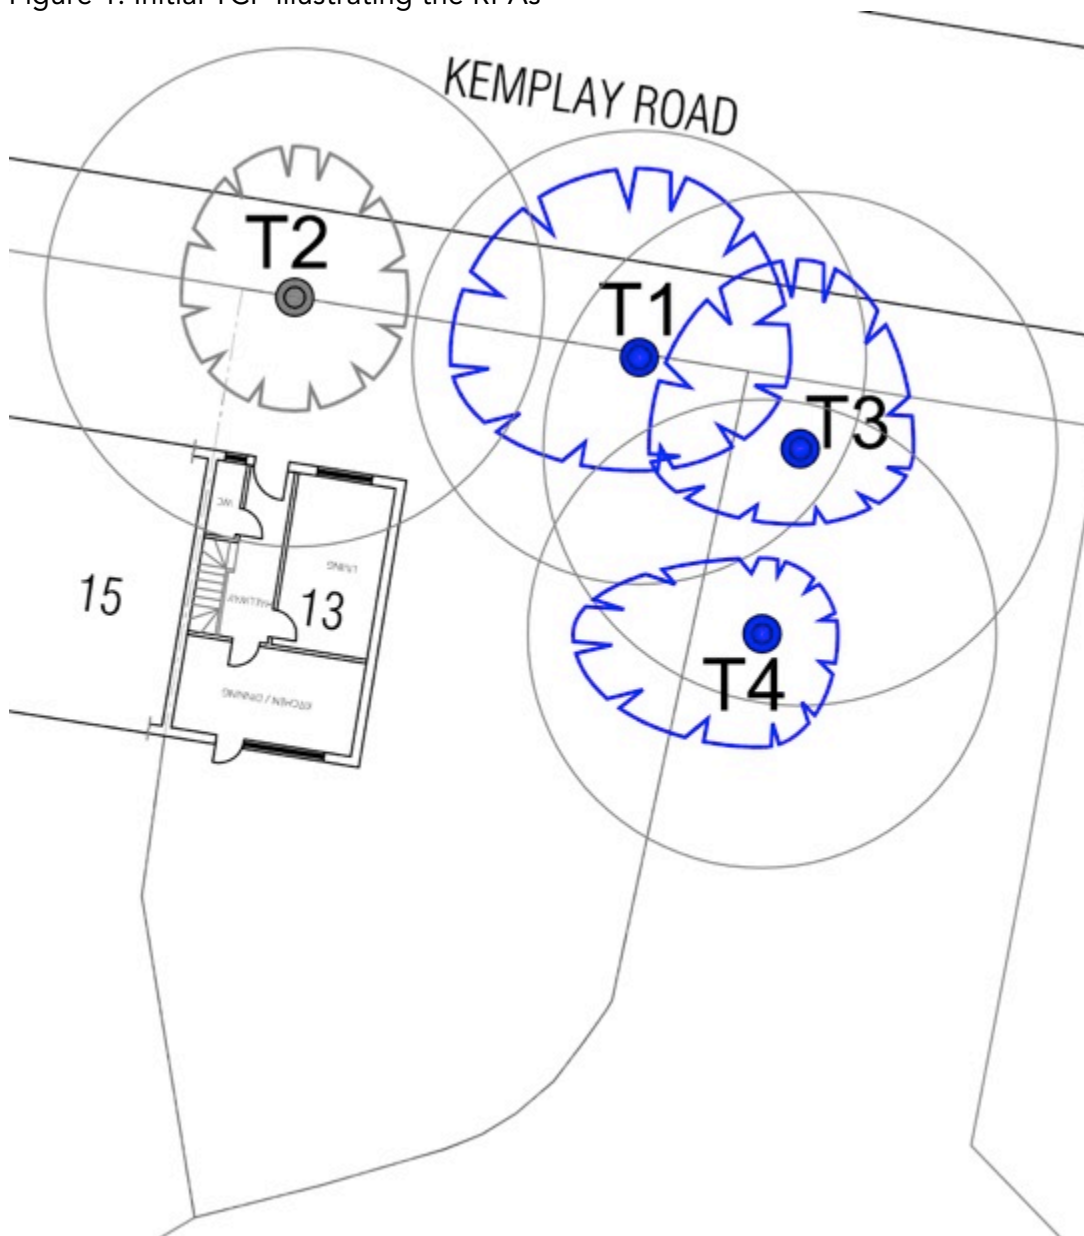
Figure 1: Initial TCP illustrating the RPAs

- T1 – on-site sycamore "B"
- T2 – on-site sycamore "C" (significant decay)
- T3 – off-site lime "B"
- T4 – off-site lime "B"

The initial Tree Constraints Plan (TCP) produced as a result of the initial survey is provided below in Figure 1 and as a separate document ref: 16_1206_TCP_NT that accompanies this report.
