Condition Report

Prepared On Behalf of:
City and Provincial Properties PLC

Of the Property:
20-21 King's Mews London WC1N 2JB

Job Ref:
DK/mh/P1585

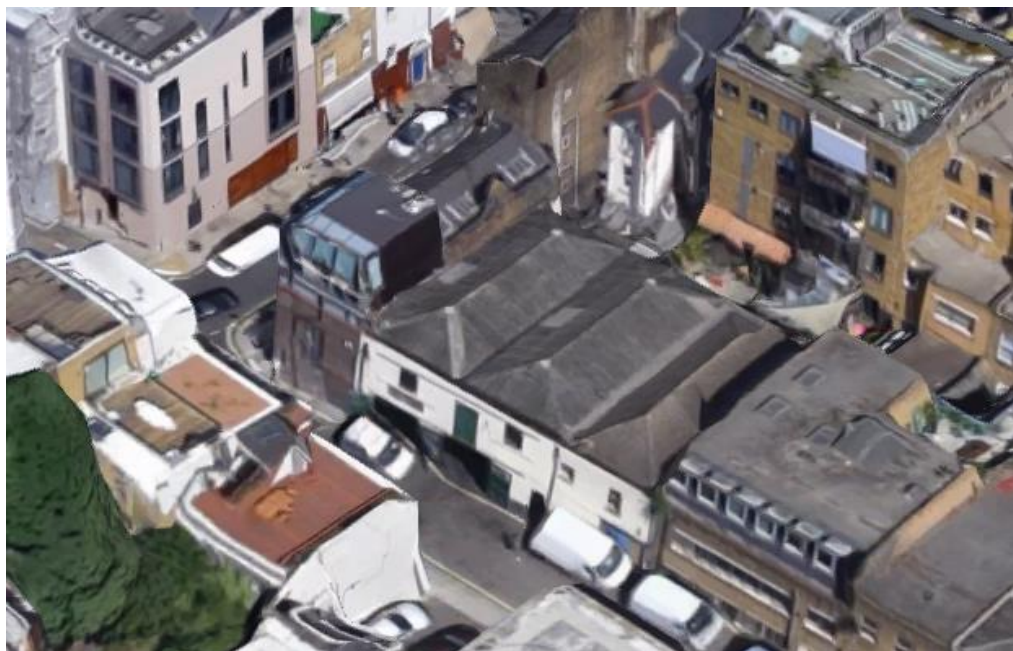
4. The mid terraced unit is of solid masonry construction surmounted by a metal framed roof clad with profiled sheeting. A mezzanine floor covers the majority of the building accessed via a small staircase from the front of the building. The building is currently used as a vehicle servicing/repair centre with access via large doors at the front of the building facing on to Kings Mews.

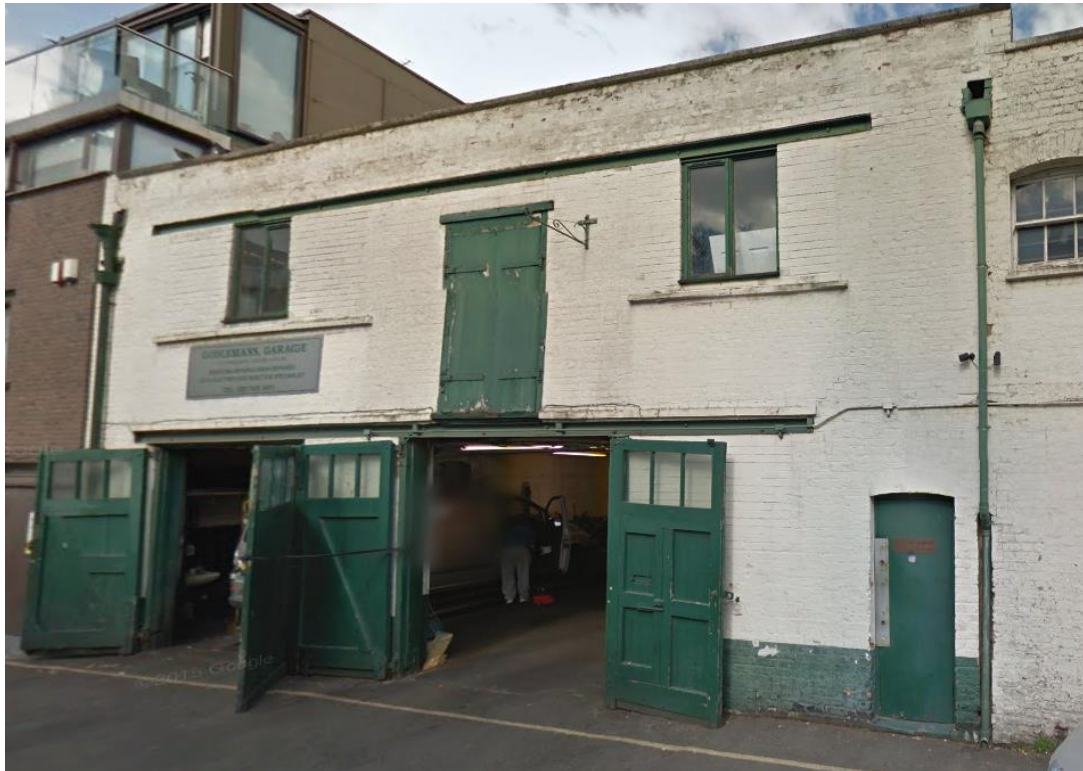
5. The building has had little repair or ongoing maintenance in recent years and does not meet current regulations in terms of structural performance and a number of deficiencies are considered to be significant and in particular we note:
 - 5.1 The walls to the building are inadequately restrained either at floor or roof level and there is a noticeable bowing outwards of the front wall at approximately mid-height position.
 - 5.2 Stepped cracking is visible to the front elevation masonry to the right hand end elevation and to the return party wall shows evidence of ongoing lateral movement.

- 5.3 Further cracking to left and right party walls has previously been repaired but since re-opened indicating ongoing movement.
- 5.4 The first floor is of timber construction supported by timber beams and posts. There is a significant fall in the level of the floor joists from the centre to the front of the building and, as noted above, there is no evidence of strapping or other forms of mechanical fixing to the perimeter walls.
