**FURTHER STRUCTURAL APPRAISAL**

**ONE SEVEN ONE  
171A FINCHLEY ROAD  
LONDON  
NW3 6LB**

**JAMES ANDREWS RSW**

**Project N° 2411  
October 2015**

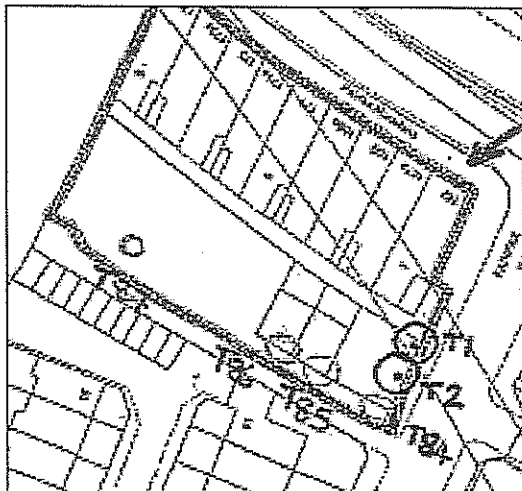
Sketch plan excerpt (left) from Camden document supplied showing TPO trees and certain hand-written information on trees.

T1 – not identified in TPO info supplied  
T2 - sycamore  
T84 – not identified in TPO info supplied (gone)  
T85 – not identified in TPO info supplied  
T86 - sycamore  
T87 – cherry (gone)
