TECHNICAL REPORT ON A SUBSIDENCE CLAIM

Crawford Reference: SU1504550

37 Greville Road
London
NW6 5JB

SUBSIDENCE CLAIM

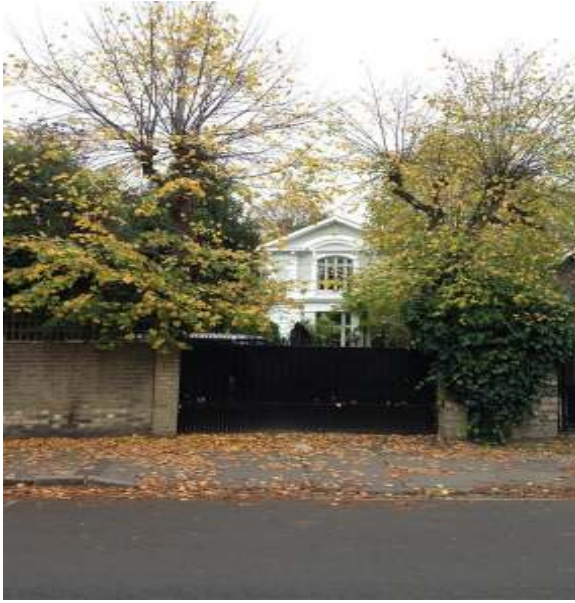
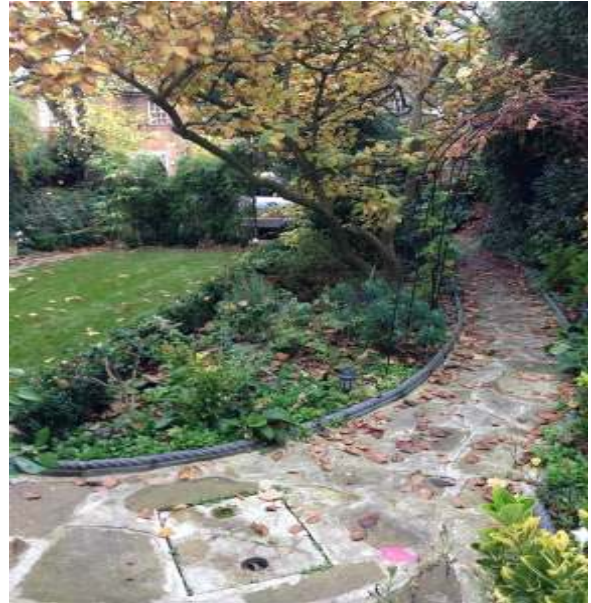
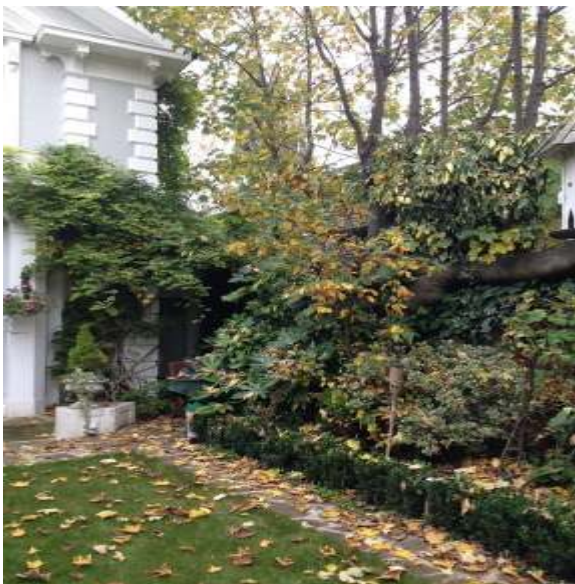
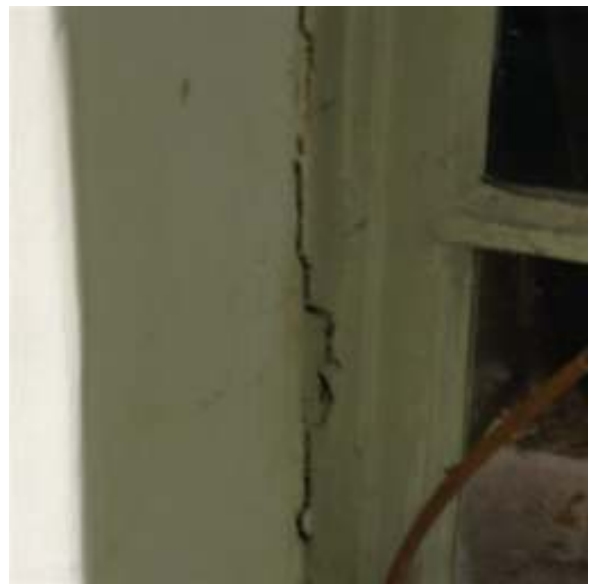
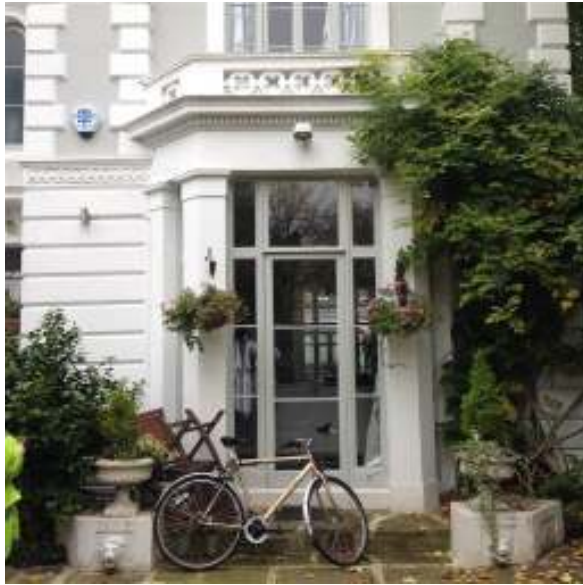
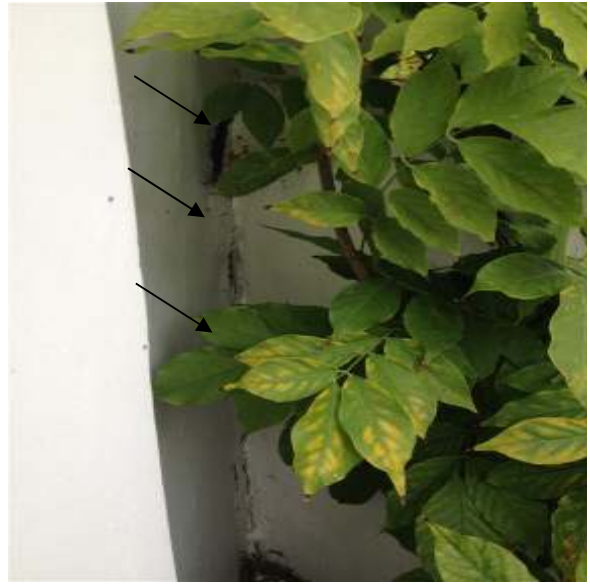
Vertical tapering crack at either side of abutment up to 15mm wide.
 Separation between right hand bay pier and window frames up to 2mm wide.
 Various 1mm diagonal cracks above left hand window head.

In structural terms the damage falls into Category 3 of Table 1, Building Research Establishment⁶ Digest 251, which describes it as **“moderate”**.

The pattern and nature of the cracks is indicative of an episode of subsidence. The cause of movement appears to be clay shrinkage.

The timing of the event, the presence of shrinkable clay beneath the foundations and the proximity of vegetation where there is damage indicates the shrinkage to be root induced. This is a commonly encountered problem and probably accounts for around 70% of subsidence claims notified to insurers.

Although the cause of the movement needs to be dealt with, we note the vegetation is subject to a Preservation Order. Unfortunately, current legislation requires certain investigations to be carried out to support an application for the tree works.
