Express Drainage Solutions

CCTV Survey Report

Foul & Surface Water

**Re: CCTV Survey Foul & Surface Water Systems
Site: Premier Basements, 12 Elsworthy Road, London, NW3 3DJ**

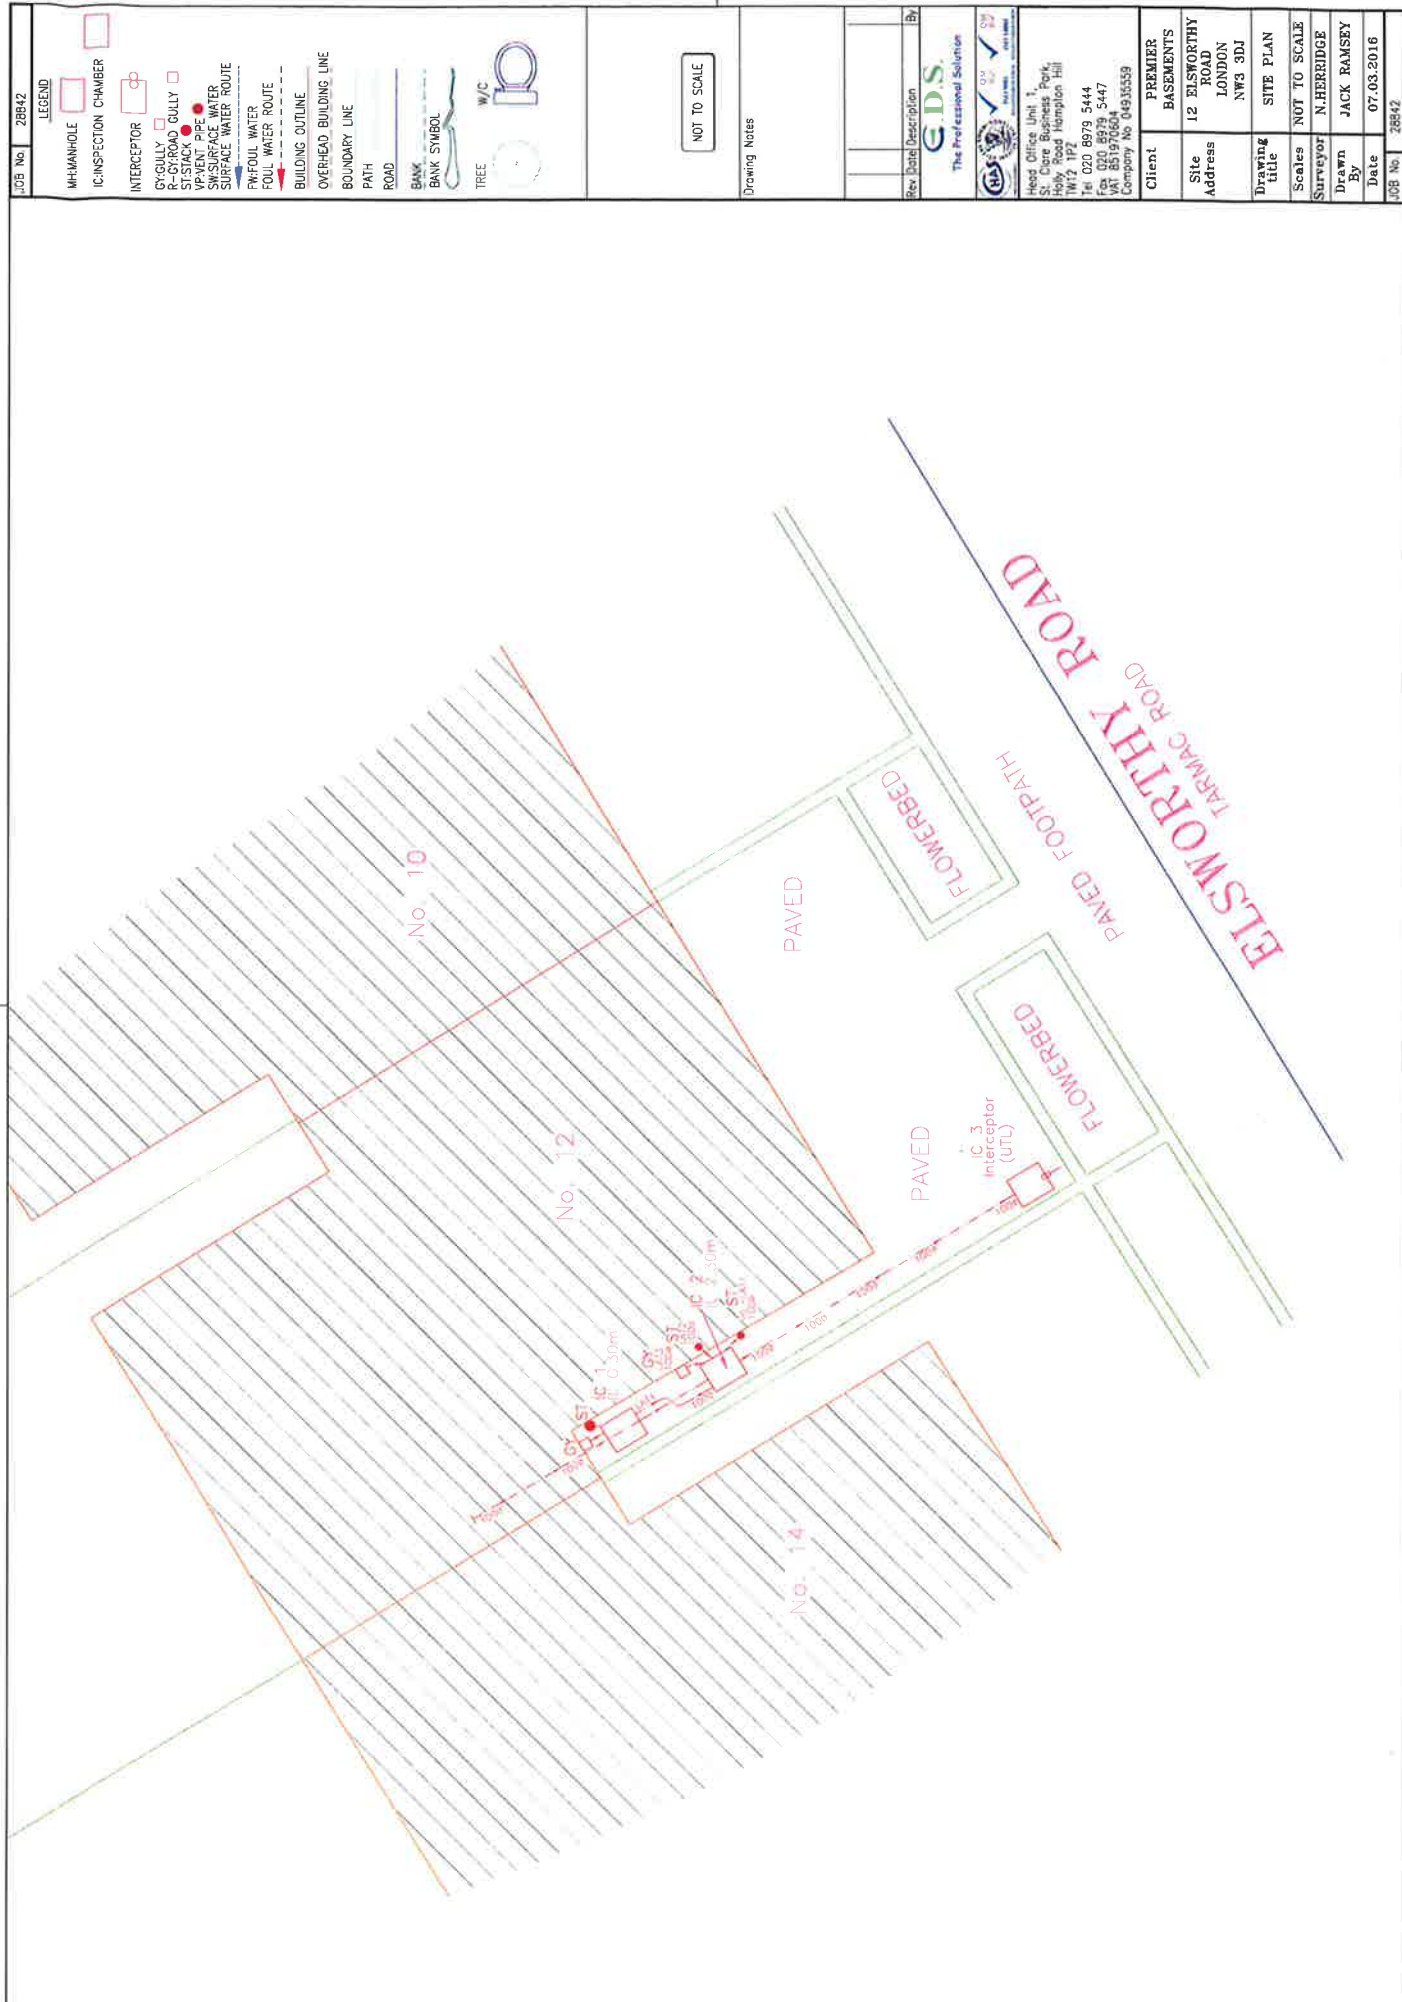
Sheet No:	Drainage Section (Surface or Foul Water)	Abbreviated Recommendations	Scale 1-4	Net Cost	Further Works
IC Condition Report Page	IC 3	1) Remove all Roots from Cover & Frame 2) Expose IC & Re-CCTV	3	£250.00	Yes
1:	IC 1 – IC 2	Excavate & Replace Approx 3m of drainage run & connection into IC 2	3	£1,650.00	Yes
2:	IC 2 – Lateral 2 (Stack)	High Pressure Water Jet & Re-Line Approx 1m (Super Sleeve – 100mm)	3	£750.00	Yes
3:	IC 2 – Lateral 3 (Gully)	No Recommendations	4	-	No
4:	IC 2 – IC 3	1) High Pressure Water Jet 2) Excavate & Remove Interceptor 3) Re-Line Approx 1m (Super Sleeve – 100mm) 4) install a 4 inch stainless steel rat blocker	3	£1,700.00	Yes
5:	IC 2 – High Level Lateral 1 (Stack)	No Recommendations	4	-	No
6:	IC 2 – Upstream	High Pressure Water Jet with Chain Flail & Re-CCTV	2	£225.00	Yes
			Net Cost:	£4,575.00
