ARBORICULTURAL IMPACT ASSESSMENT REPORT:

73-75 Avenue Road
London
NW8 6JD

Ref: BWR/75AVR/AIA/01b

Date: 22nd March 2016

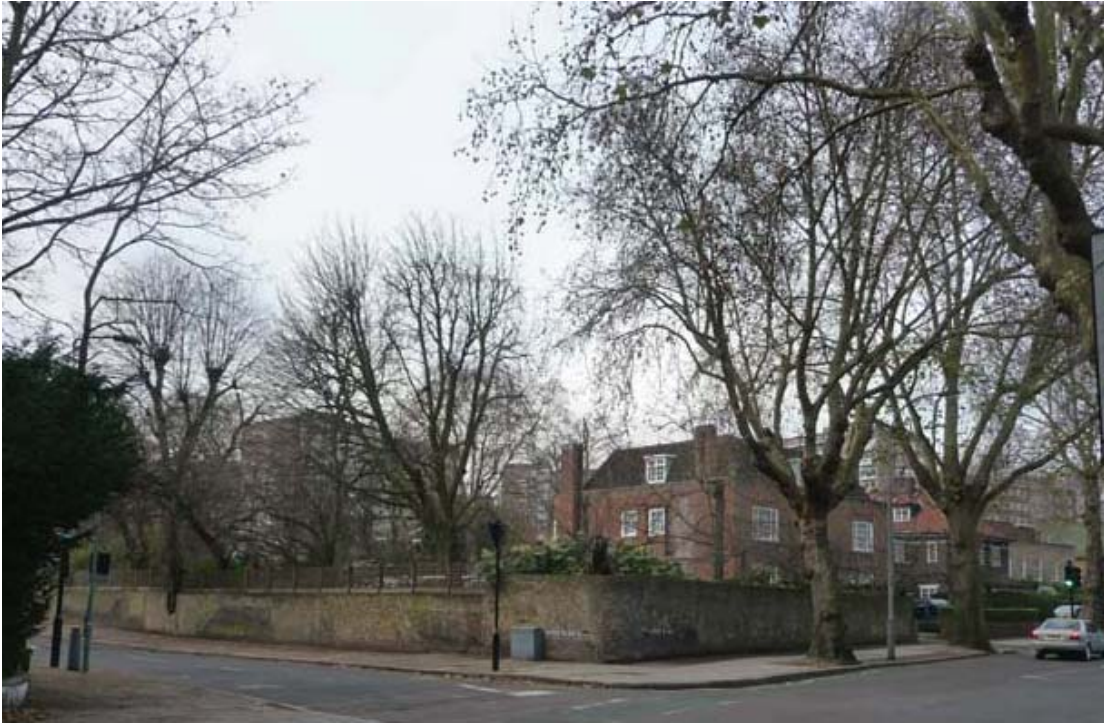
Photograph 1: View of existing dwelling from Avenue Road and Queen's Grove Junction

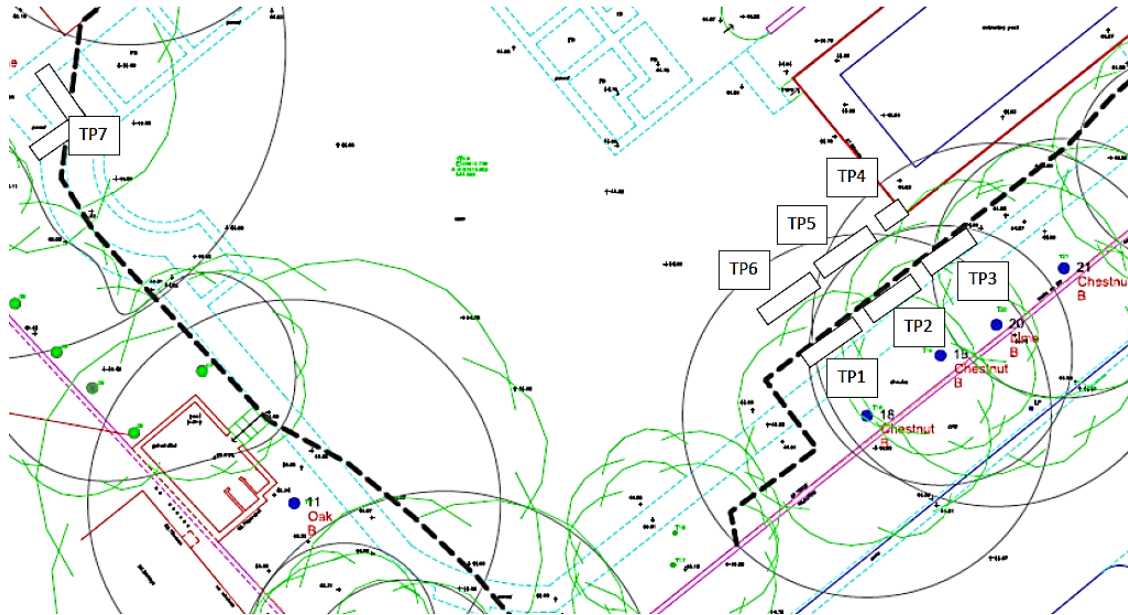
Plan Extract Showing Location of Trial Pits

Trial Pit 1	1.5m Long, 40cm Wide, 12cm Deep. 1x60mm root Number of fibrous roots
Trial Pit 2	1.5m Long, 40cm wide 18cm Deep. 1x 50mm Root
Trial Pit 3	1.5m long, 35cm wide, 13cm Deep 1x45mm root 1x50mm root
Trial Pit 4	90cm long, 40cm wide, 12cm deep 2x30mm roots 1x25mm root
Trial Pit 5	1.5m long plot containing 2x 40mm roots, Chased this back into the lawn to determine point that roots reduce <25mm. 2.5m out from initial plot (11m from boundary wall) roots are still 30mm in diameter.
Trial Pit 6	1.5m long, 40cm wide, 20cm deep 1x45mm root 1x30mm root
Trial Pit 7	1.5m longx1.5m long "L", 40cm wide, 70cm deep No Roots

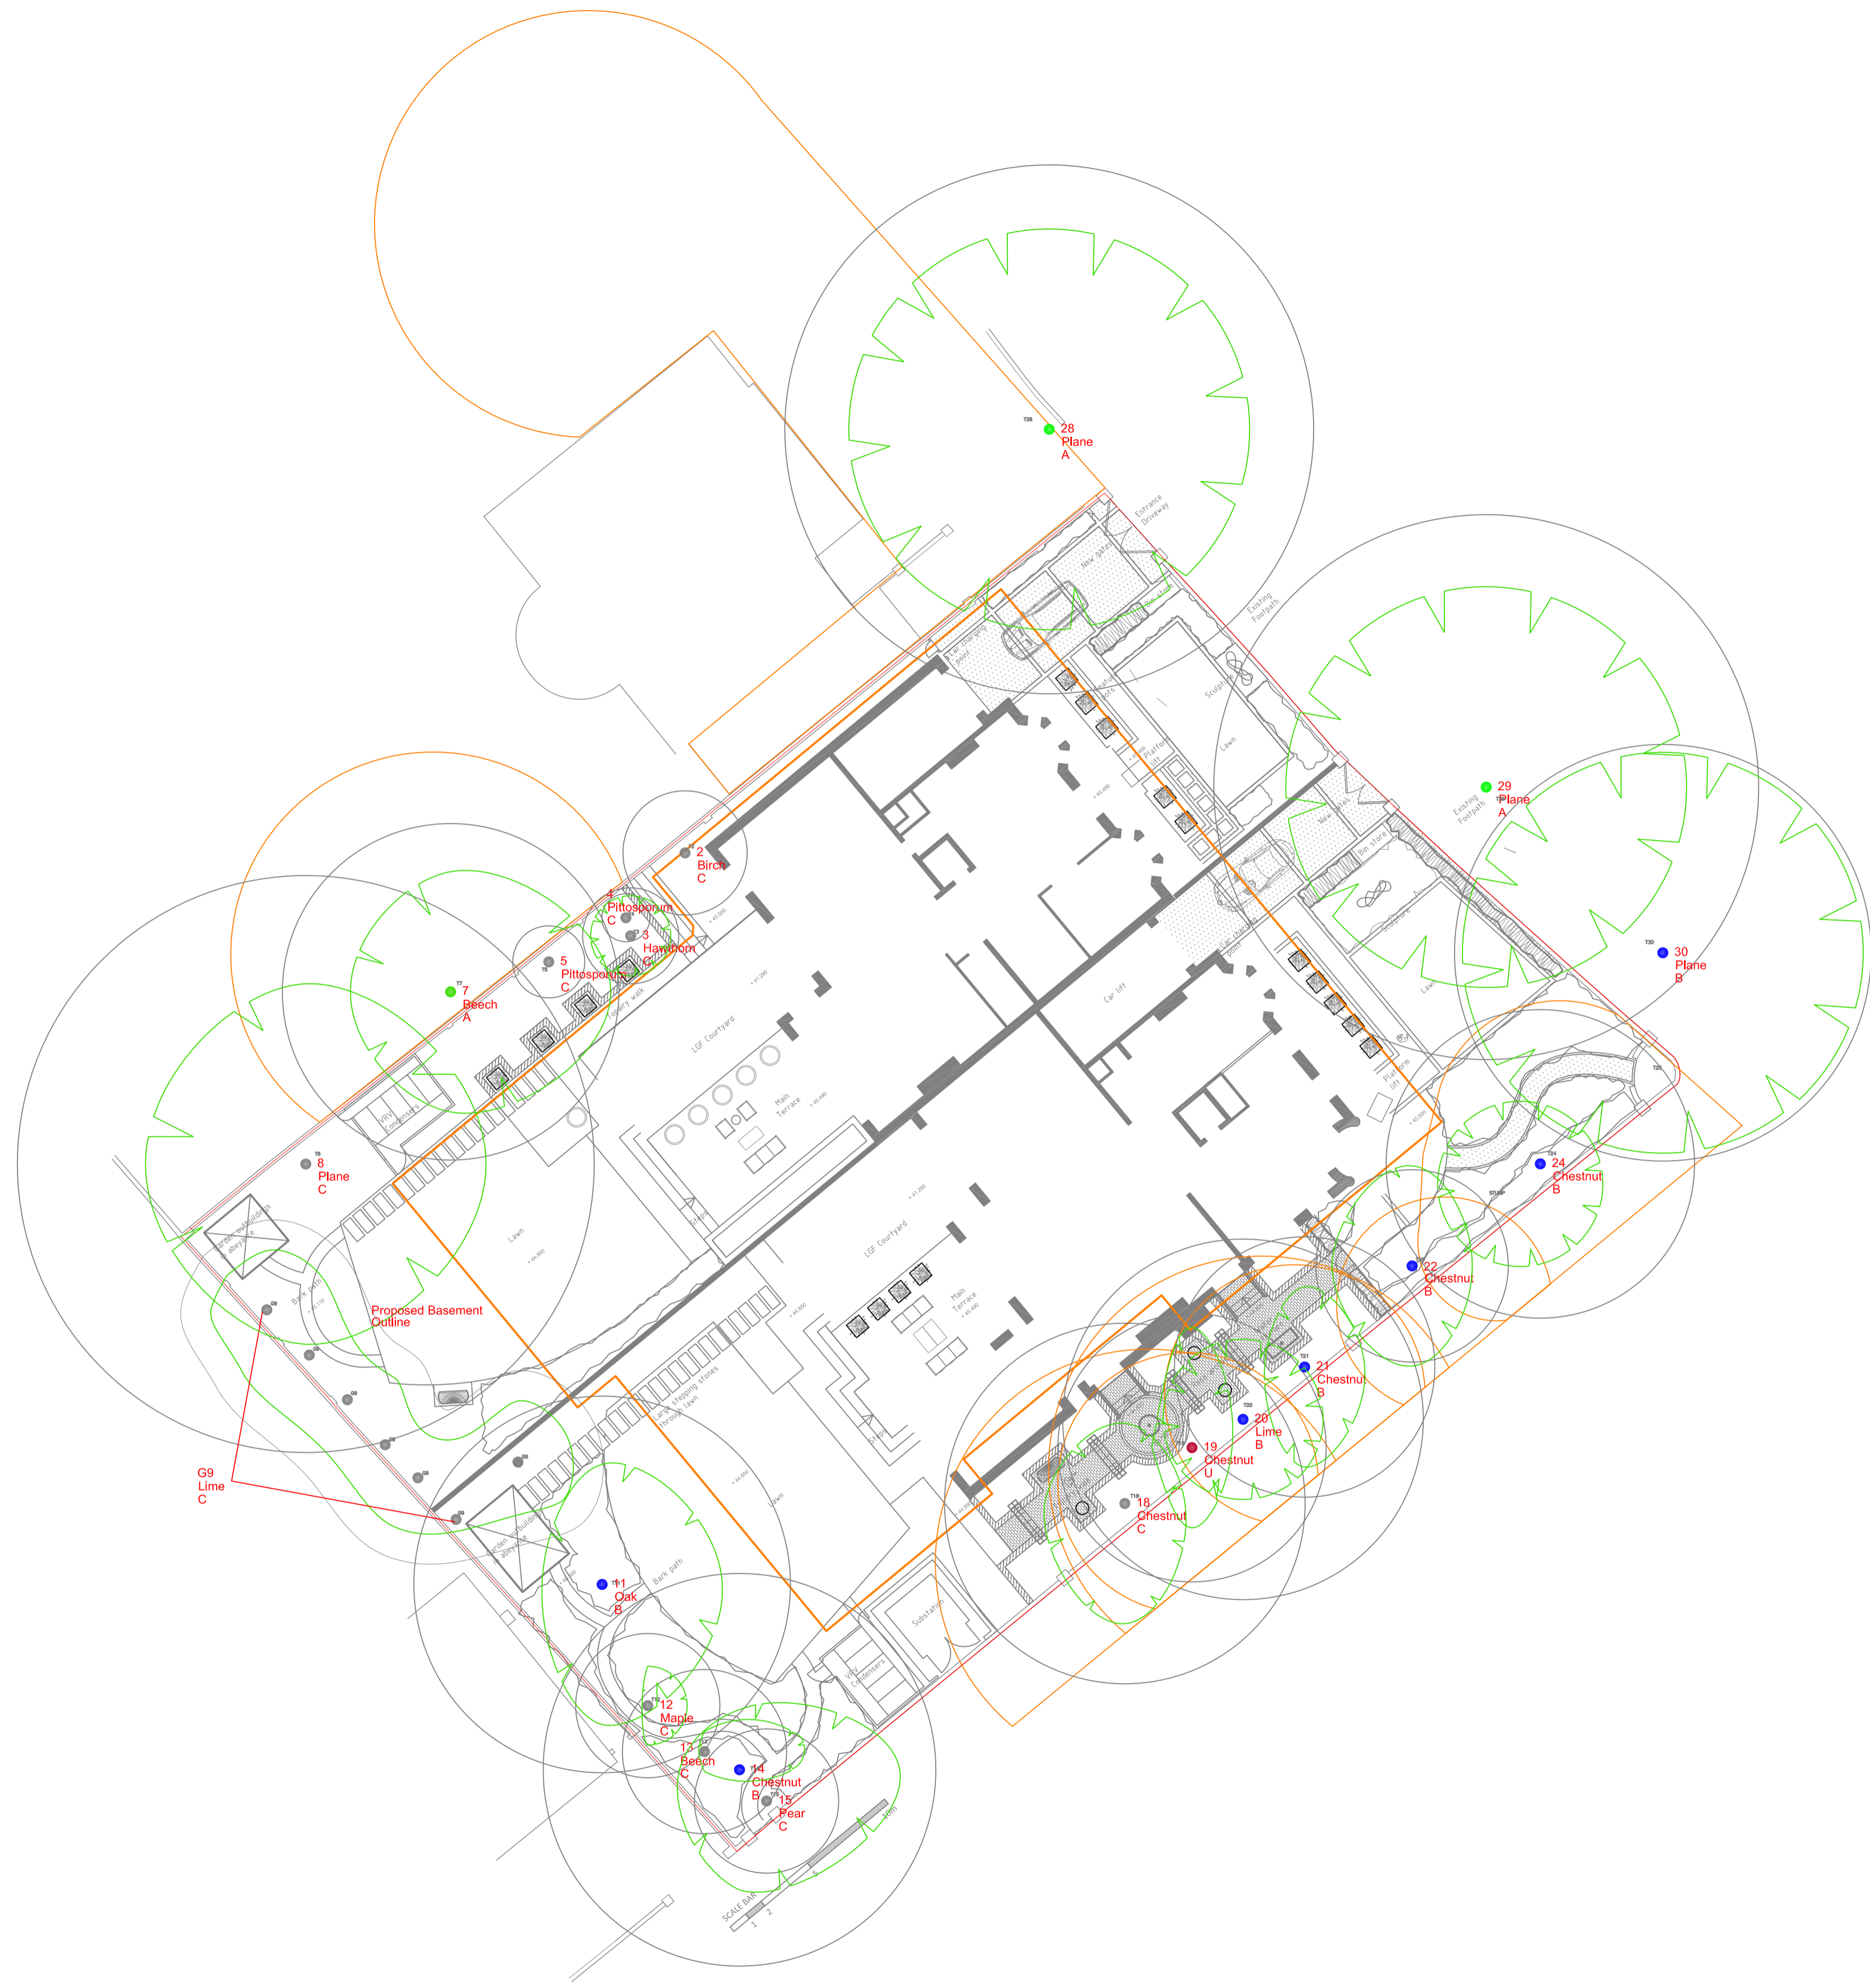
Proposed Lower Ground Floor Plan

- 6.1.5 The substation and adjacent condenser enclosure encroach within the RPAs of T18 (2.8%) and T14 (4.6%) respectively. Whilst these encroachments are rated as a very low impact, the potential for a more significant cumulative impact to T18 in particular exists and therefore, similar mitigation of manual excavation of the limits of the foundations with pre-emptive root pruning is proposed. The adoption of this mitigation will ensure the impacts remain very low overall. The condenser enclosure can be sited on a concrete raft installed using a no-dig method meaning it is of negligible impact to T14 overall.
