HIGHGATE CEMETERY: REPAIRS TO THE COLONNADE

Planning issue, May 2016

PART 1A: DESIGN STATEMENT

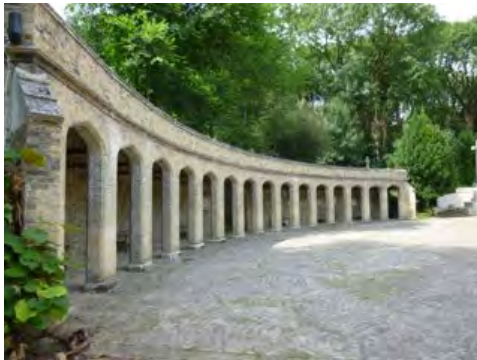
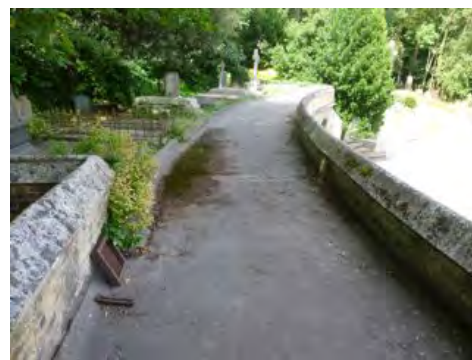
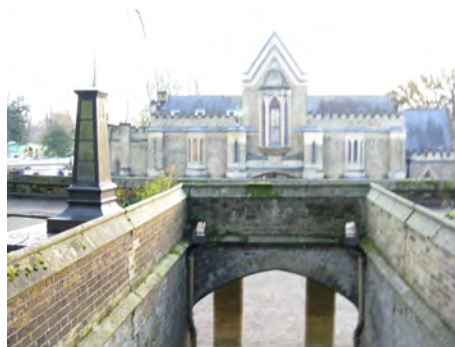
The Colonnade was constructed in 1838, and comprises a curved open loggia with vaults behind, and a flight of steps on the central axis rising some 4m to an upper ground level. Listing description attributes it to Stephen Geary, but it is widely held to be by architect J B Bunning. It is listed Grade II, Historic England ID 478234.
