HISTORIC ENGLAND
CIVIL & STRUCTURAL ENGINEERING TEAM
INTERNAL MEMO

Subject: St Stephens, Rosslyn Hill, Hampstead, London

To: Ian Harper (HE, London Office) **cc:**
From: Bridget Drake-Wilkes **Tel:** 07747 743 081
(Senior Engineer)
Date: 9th September 2015

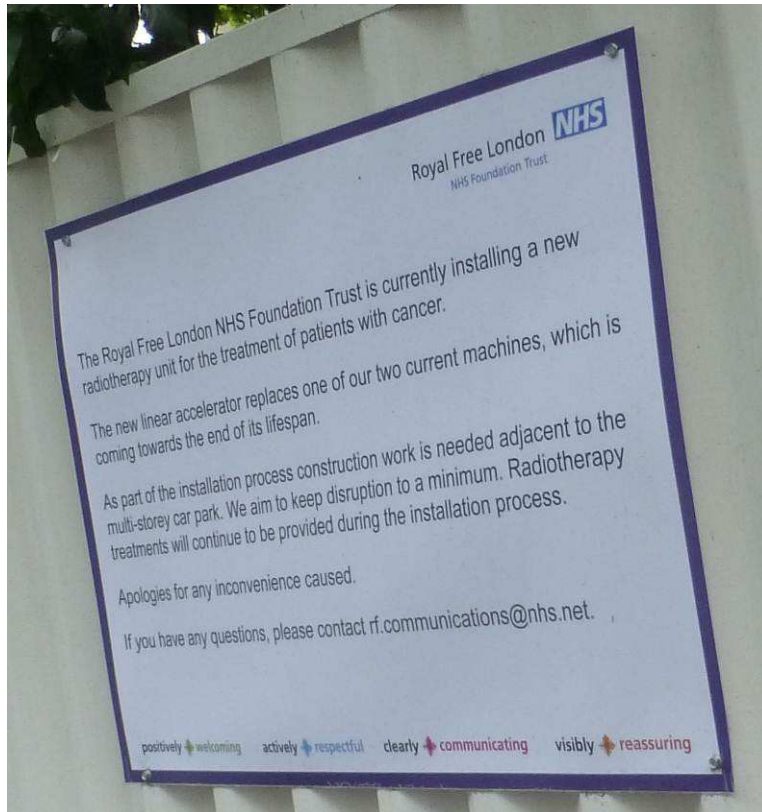
Photo 12. Signage on Royal Free Construction Site

5.2.1 Included in the planning application is a construction management plan, on p.26 it notes *"that there is sensitive medical equipment located adjacent to level 00 (basement level) that may be susceptible to vibration caused by demolition and construction activity and so care must be taken to avoid any disruption to this. Previously vibration monitoring has been carried out during piling operations and no issues were encountered but suitable precautions and continued monitoring should still be undertaken during the forthcoming works. To this end, enabling works to separate the current car park from the hospital building to minimise any vibration transmission are being considered."*

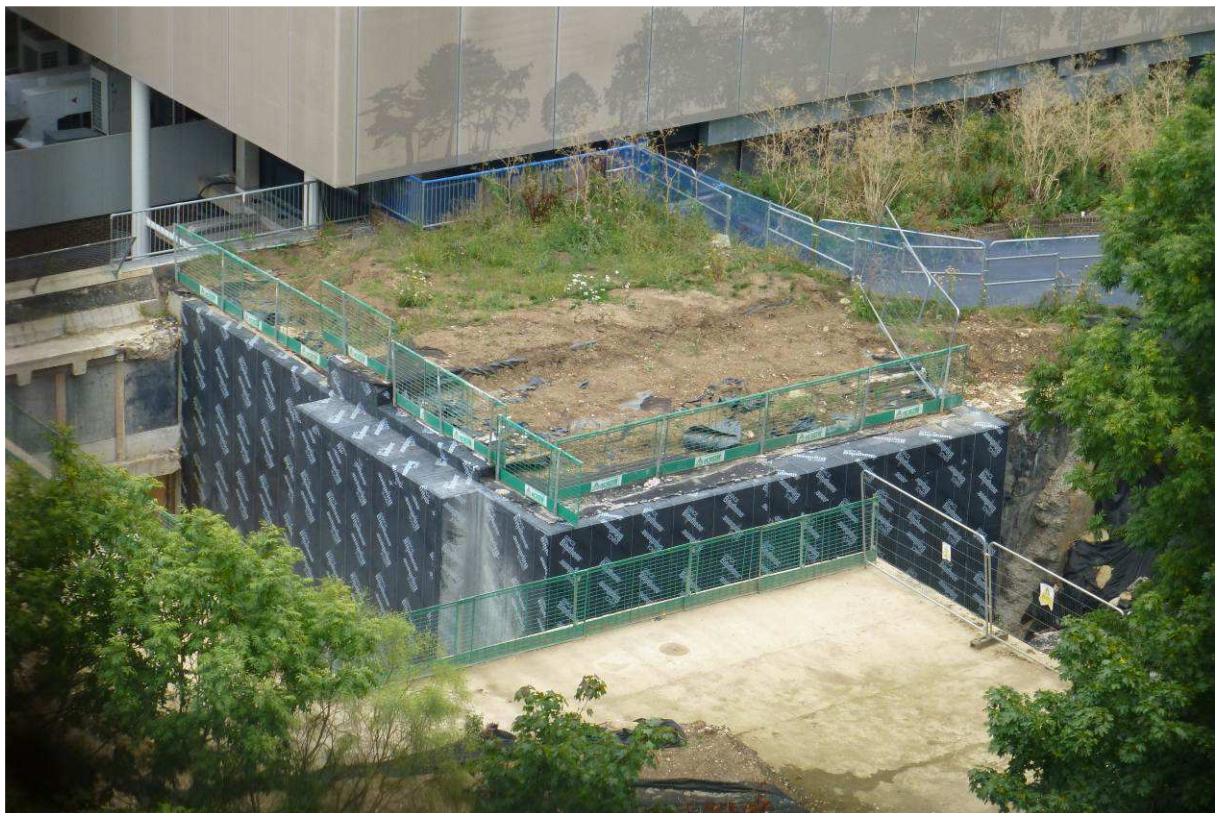
- 4.3 On returning to the office and observing drawing A/RFMR/0002 Existing Level 00 plan on Camden Council's planning application [2014/6845/P](#) this confirms the walls to the linear accelerator are approximately 900mm thick. This also identified that the nearest point of visible breaking out (observed from the tower) was approximately 58m from St Stephens.

Photo 13. View from St Stephens Tower of north end of linear accelerator.
