13 Mornington Crescent

Report on condition of the upper facade and recommendations for repairs.

Nicholas Weedon, AABC
HMDW Architects Ltd.

26 April 2015

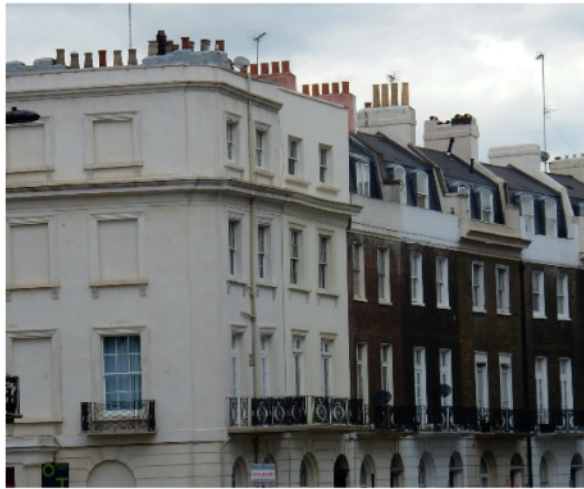
Fig 9. Corner of Mornington Place (No. 25)

3.3 At 25 Mornington Crescent (analogous to No13), a coping is visible on the parapet, projecting cornice at the base of the parapet, and projecting cornices to front and side. At No. 12, opposite No.13, the cornices are of a flatter profile, the mid-height one being similar to the flatter profile behind the GRP one on No.13. There is no easy correlation between the three buildings that can lead to an immediate conclusion that one represents the original of a more 'correct' configuration. Decorative details are often sacrificed over time when repairs take place, particularly so during the early to mid 20th century, when the relative decline of the social class of the population in the area would have led to more austere maintenance methods, with very little interest in conservation. The historical records from mapping also indicate that although similar, No's 25, 13 and 12 were built in different phases of development between 1821 and 1824 at the earliest, with some maps suggesting No.12 being later still. This means that the buildings clearly form a unified set, they may well have differed in detail.

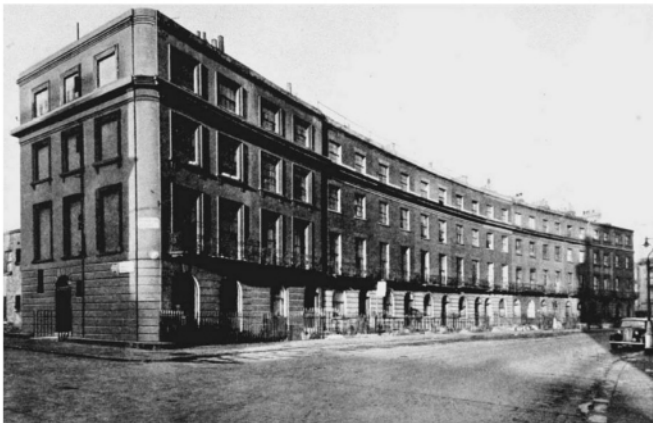
Fig.11 The terrace in the 1950's

3.2 The cornices at parapet level were applied to plain stucco, which appears to have previously replaced any original render cornices. It is assumed that there were originally projecting cornices at this level by comparing with the neighbouring buildings and photograph from the 1950's.

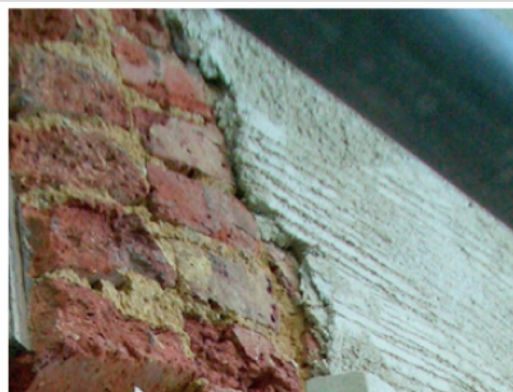
First coat up to 10mm thick

The rough face of the existing brick will be advantageous for forming a key for the render. Any pockets and irregularities should be daubed out in lime mortar of the same specification as above, in layers up to 15mm, which should be allowed to set before adding a further layer. The substrate should be sprayed in water before applying the mortar to avoid over-rapid drying out and cracking. Once the surface consistent to 10-15mm to the face, then the first 'scratch' coat of lime render can be applied. **First coat mix: 1 part NHL 3.5 lime to 2 parts sharp sand.**

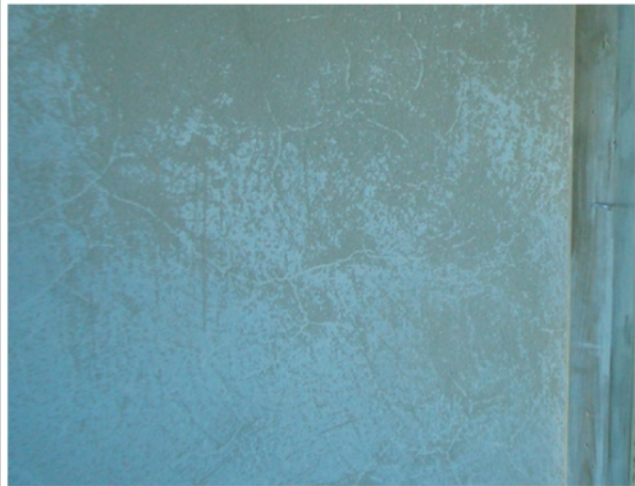
The example illustrated here happens to show one of the advantageous properties of the lime mix: that in the case of minor cracking or crazing, the newly exposed lime carbonates and fills the crack. The material is also vapour permeable, allowing for latent moisture within the wall to evaporate out, which dictates the recommendation for the most compatible paint.

Finish coats 5-8mm thick.

After sufficient curing of the first coat, apply a **'float' coat to the same mix**, followed by a **finish coat in mix: 1 part NHL 3.5 lime to 2.5 parts sharp sand**.
