Design and Access & Heritage Statement
Application for Full Planning & Listed Building Consent
8 Rothwell Street, NW1 8YH

Updated 13.06.16

8 Rothwell Street

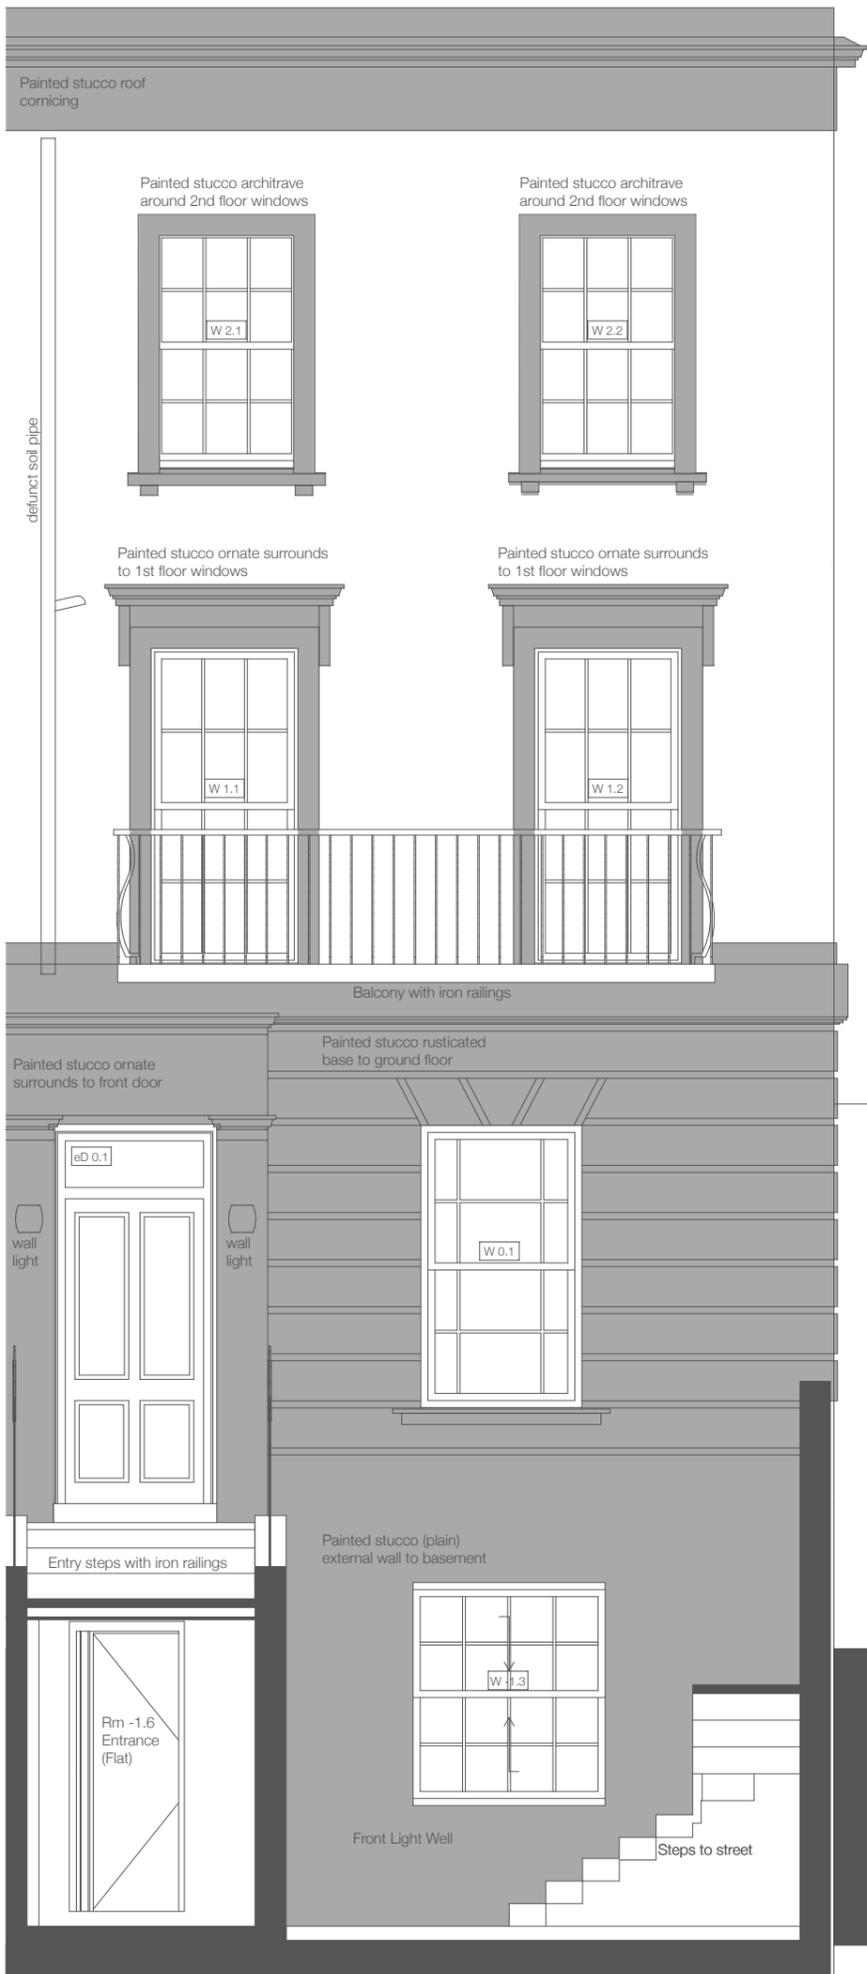
A.1 Front (South) elevation through basement light well

Original condition front façade of London stock brickwork and painted stucco detailing including a rusticated ground level and ornate surrounds to window and door openings and a roof cornice. London stock brickwork is visible on the two upper floors of the building and appears sound and the mortar pointing also generally appears sound. The render coatings to the wall on the two lower floor levels and around the projecting stone features to the upper windows and the cornice at roof level require minor repair and redecoration. The top section of the rendered parapet wall which rises above the main roof and the projecting cornice below is missing lead cappings. The balcony, which projects from the front wall at first floor level, has been historically reconstructed with a cast concrete slab. The original iron railings to the balcony appear to have been refitted as these match the other buildings in the terrace. The concrete structure balcony is in reasonable condition but has no waterproof finish over the top surface of the balcony which may pose a risk of moisture ingress to the metal reinforcement in the concrete balcony structure. The windows are covered with years of paint, both to the interior and exterior surfaces. A pair of modern wall lights are located either side of the front door on the pilasters. A defunct soil pipe runs above the entrance across the 1st and 2nd floor that is likely to have served a former bathroom to the front of the property. Original cast iron railings with urn finials to the entry stair, street perimeter and 1st floor balcony appear in good structural condition but poor decorative condition.

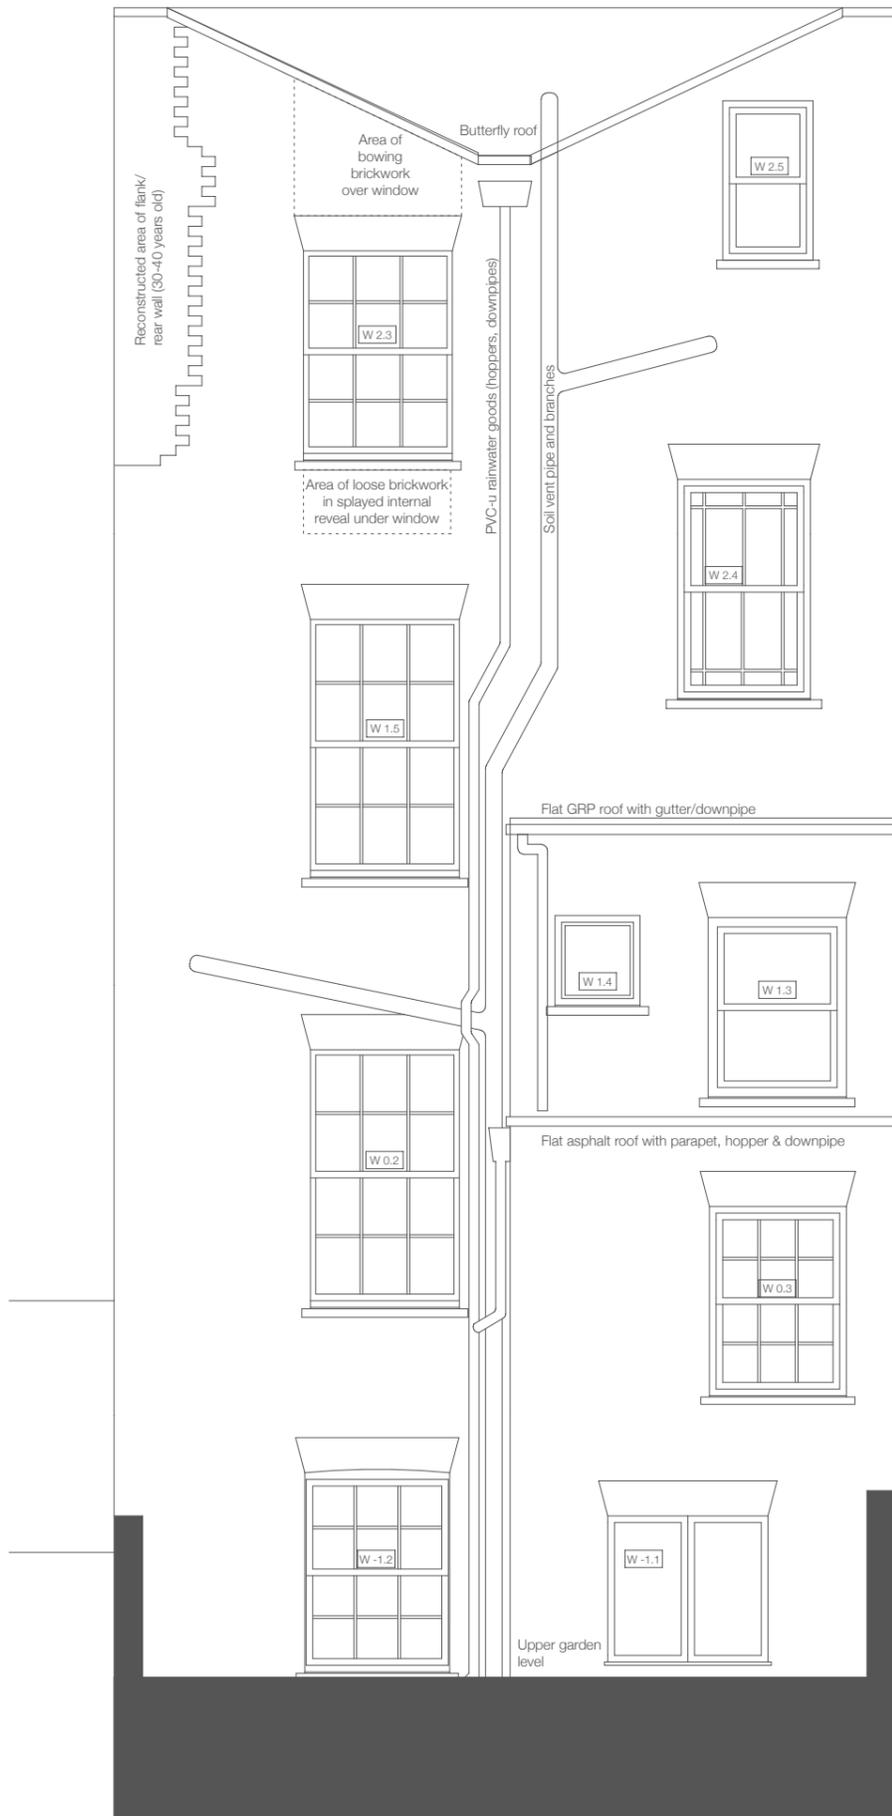
B.1 Rear (North) elevation through upper garden level

The rear wall of the building has a traditional 'V' shaped parapet to the butterfly roof line. The upper section of this parapet wall coping is quite weathered and the pointing to the upper sections of the wall below eroded. There is also some missing pointing to the walls of the rear addition structure, most notably the rear wall of the addition at basement and ground floor levels. The top section of the flank wall (not shown) also has some missing and eroded pointing. An area of brickwork at 2nd floor level has been reconstructed at the rear and flank walls (around 30-40 years ago) with a visible joint between the old and new brickwork on the rear corner of the building. The joint which is visible to the top of the rear wall is slightly open and there is some minor cracking visible internally in the top rear bedroom. This indicates slight separation of the new and old sections of masonry. In addition an area of brickwork over window W 2.3 is bowing toward the roof and the one brick thick wall under the same window's splayed reveal is loose. The windows are covered with years of paint, both to the interior and exterior surfaces. Rainwater disposal from the main roof is to the rear of the building via the central valley gutter which drains to a PVC hopper mounted on the rear wall. The connecting PVC rainwater pipe passes down to ground level but simply spills onto the floor at the base of the wall. This will increase the risk of damp penetrating into the base of the wall and causing internal damp problems. There is also evidence of leakage of the rainwater pipe serving the rear addition roof causing water saturation and staining of the exterior brickwork to the side of the kitchen door below. The arrangement of the PVC rainwater and drainage pipework to the rear wall has become convoluted and messy due to historic reconfiguration of the property.
