CONSULTING STRUCTURAL ENGINEERS

**Basement Impact Assessment  
Stages 1 and 2  
15 Park Village West  
London**

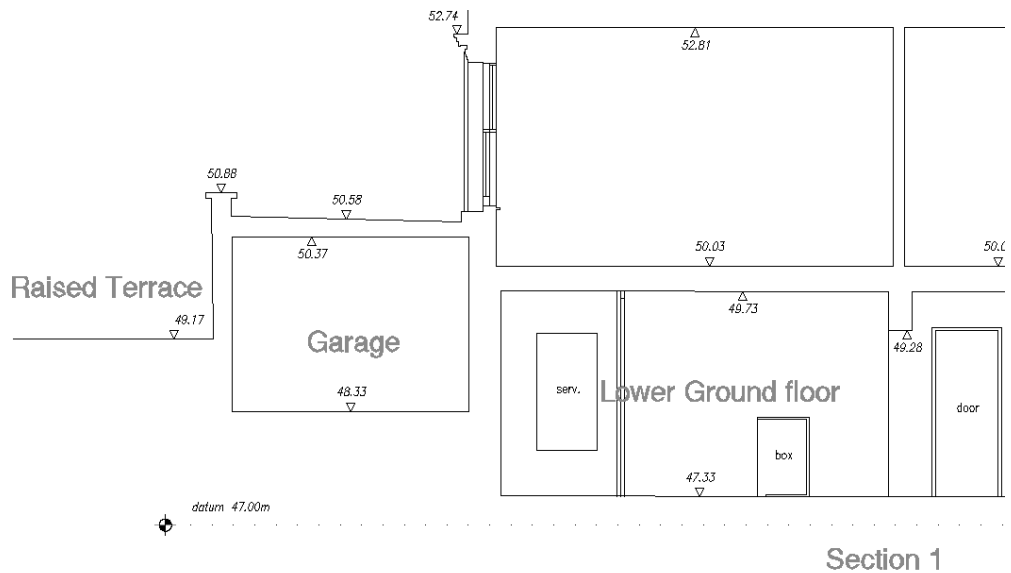
Photograph No.2

On the western side there is a raised terrace area where the level of the terrace is 0.84m above the garage floor level and at the rear southern side the terrace steps up so that it is 1.29m above. It should also be noted that the lower ground floor level of the main house is 1.0m below the garage floor and there is a set of internal steps to gain access. The cross section below, taken from the Cadplan survey drawing 8454-08, shows the relevant levels. A view of the raised terrace is shown on photograph No. 2
