9.1 Demolition Asbestos Survey, Vezey Wing (2015)

Demolition Asbestos Survey

National Temperance Hospital (Vezey-Strong Wing)
London NW1

RSK Report Number: 415000-2 (00)

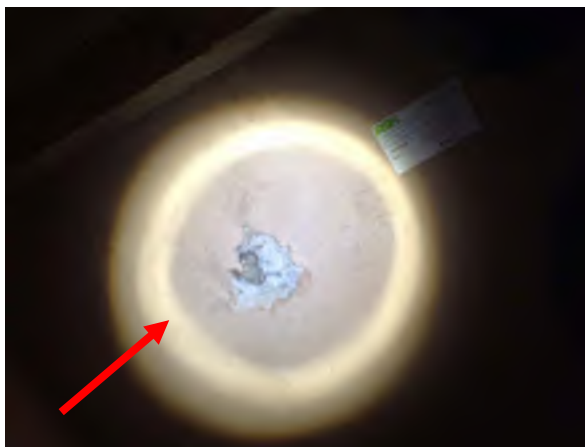
Building	Vezey-Strong wing
Floor	Basement
Room	311
Item Description	Insulation ceiling panel
Material Type	Insulating Board
Sample Number	27077
Asbestos Type	Amosite

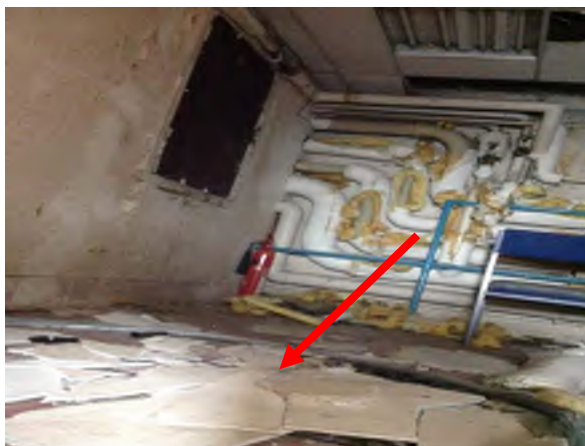
Building	Vezey-Strong wing
Floor	Basement
Room	314
Item Description	Board debris to floor and rear of duct door
Material Type	Insulating Board
Sample Number	27082
Asbestos Type	Chrysotile / Amosite

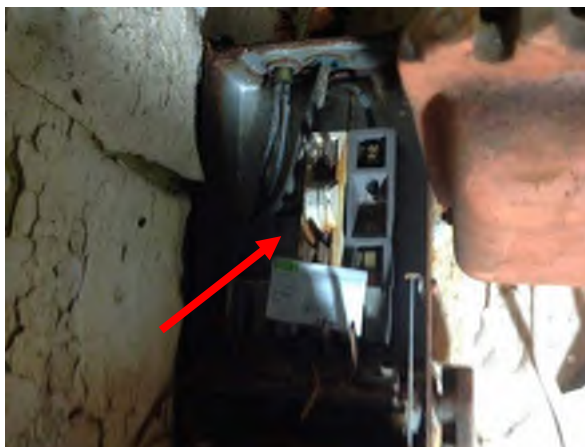
Building	Vezey-Strong wing
Floor	Basement
Room	314
Item Description	Textile flash guard
Material Type	Textiles/Cloth
Sample Number	27083
Asbestos Type	Chrysotile

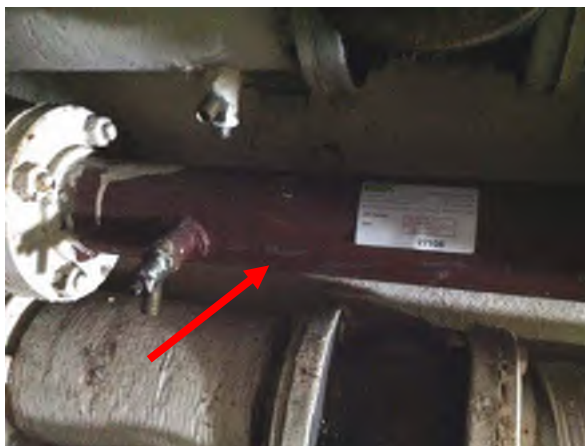
Building	Vezey-Strong wing
Floor	Basement
Room	314
Item Description	Residue to pipework
Material Type	Dust/Debris
Sample Number	27108
Asbestos Type	Chrysotile

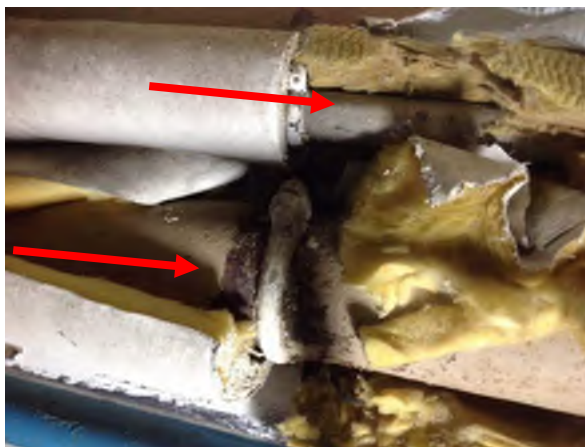
Building	Vezey-Strong wing
Floor	Basement
Room	314
Item Description	Residue to pipework
Material Type	Dust/Debris
Sample Number	27109
Asbestos Type	Chrysotile

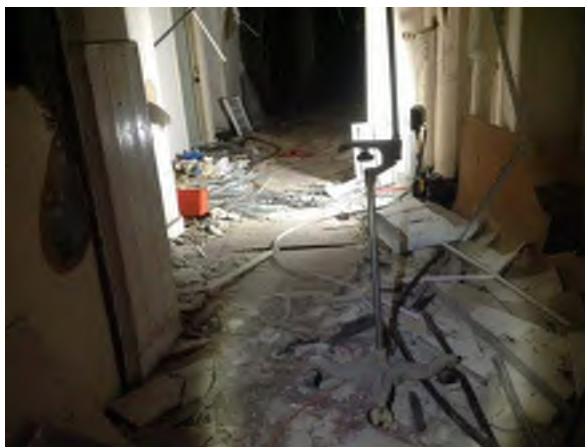
Building	Vezey-Strong wing
Floor	Basement
Room	314
Item Description	Floor ducts
Material Type	-
Sample Number	-
Asbestos Type	Default Presumption

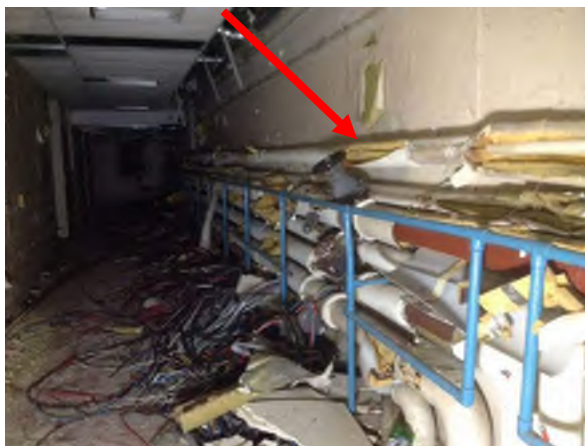
Building	Vezey-Strong wing
Floor	Basement
Room	314
Item Description	Residue to pipework
Material Type	Dust/Debris
Sample Number	Similar to 27110
Asbestos Type	Sp Chrysotile / Amosite

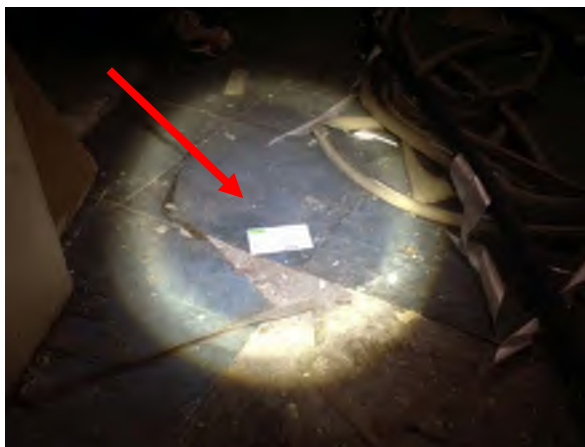
Building	Vezey-Strong wing
Floor	Basement
Room	318
Item Description	Blue vinyl floor tile
Material Type	Floor Tile / Vinyl
Sample Number	27078
Asbestos Type	Chrysotile (Floor Tile & Mastic)

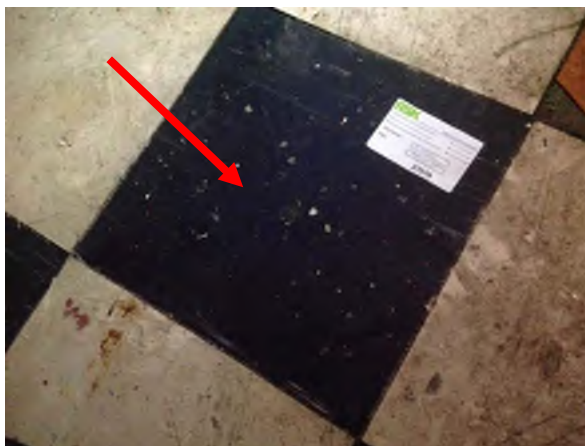
Building	Vezey-Strong wing
Floor	Basement
Room	320
Item Description	Black vinyl floor tile
Material Type	Floor Tile / Vinyl
Sample Number	27079
Asbestos Type	Chrysotile (Floor Tile Only)

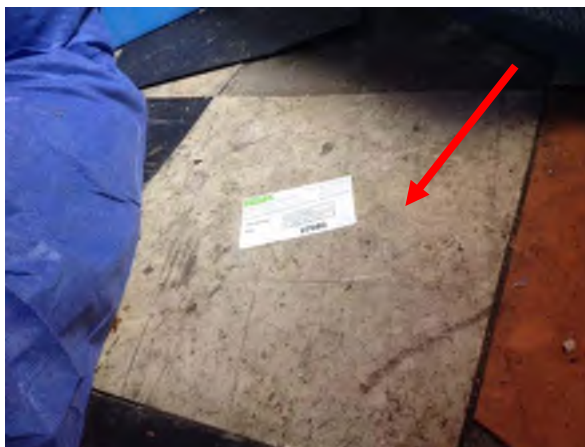
Building	Vezey-Strong wing
Floor	Basement
Room	320
Item Description	White vinyl floor tile
Material Type	Floor Tile / Vinyl
Sample Number	27080
Asbestos Type	Chrysotile (Floor Tile Only)

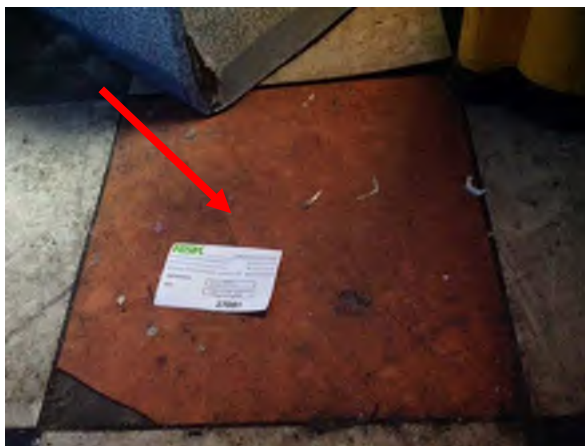
Building	Vezey-Strong wing
Floor	Basement
Room	320
Item Description	Orange vinyl floor tile
Material Type	Floor Tile / Vinyl
Sample Number	27081
Asbestos Type	Chrysotile (Floor Tile Only)

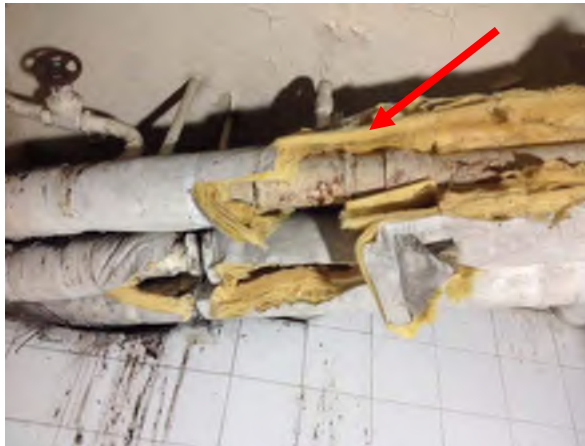
Building	Vezey-Strong wing
Floor	Basement
Room	322
Item Description	Pipe insulation residue
Material Type	Dust/Debris
Sample Number	27085
Asbestos Type	Chrysotile

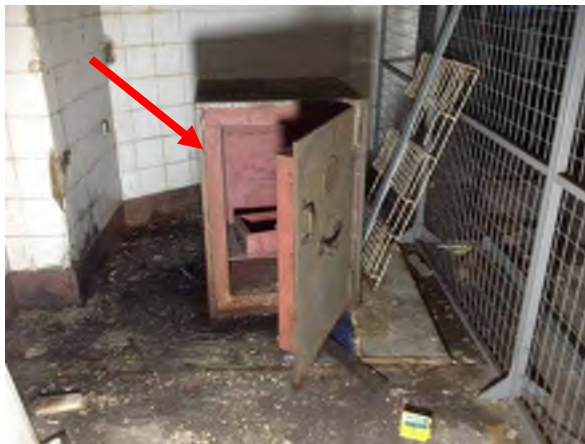
Building	Vezey-Strong wing
Floor	Basement
Room	322
Item Description	Safe
Material Type	-
Sample Number	-
Asbestos Type	Default Presumption

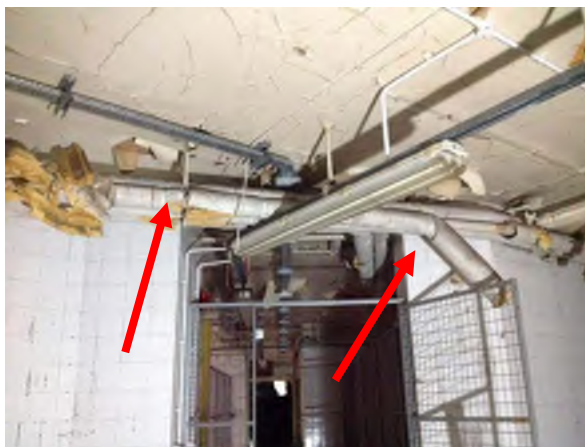
Building	Vezey-Strong wing
Floor	Basement
Room	322
Item Description	Pipe insulation residue
Material Type	Dust/Debris
Sample Number	Similar to 27085
Asbestos Type	Sp Chrysotile

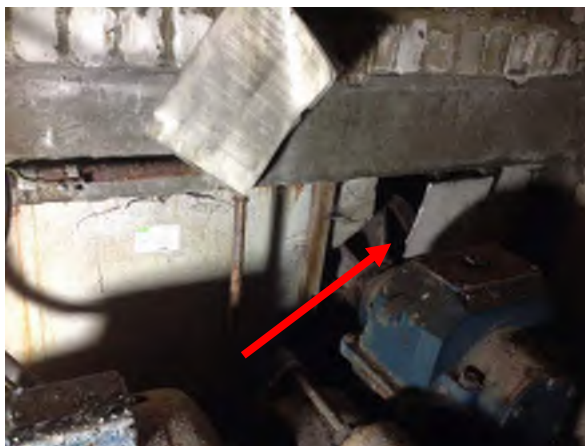
Building	Vezey-Strong wing
Floor	Basement
Room	326
Item Description	Insulating board panels
Material Type	Insulating Board
Sample Number	27086
Asbestos Type	Amosite

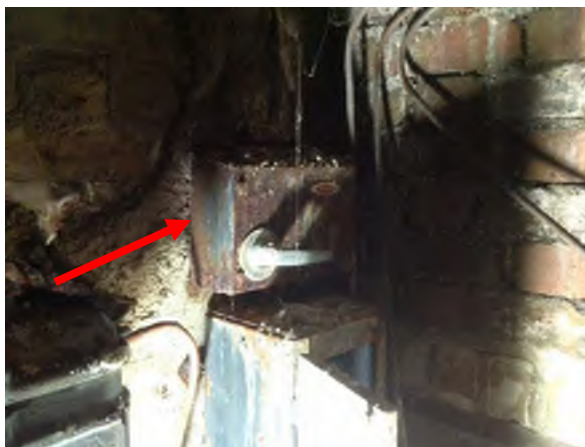
Building	Vezey-Strong wing
Floor	Basement
Room	326
Item Description	Electrics
Material Type	-
Sample Number	-
Asbestos Type	Default Presumption

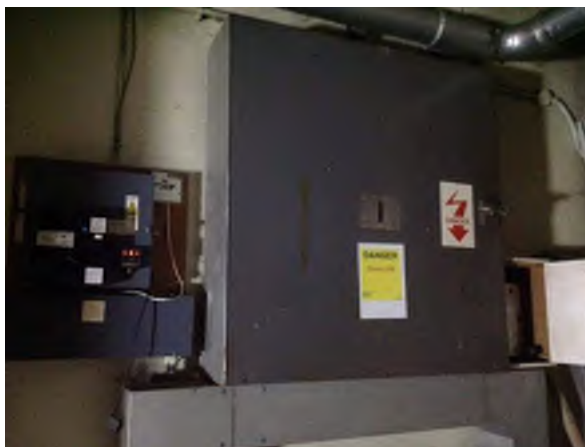
Building	Vezey-Strong wing
Floor	Basement
Room	340
Item Description	Live electrics
Material Type	-
Sample Number	-
Asbestos Type	Default Presumption

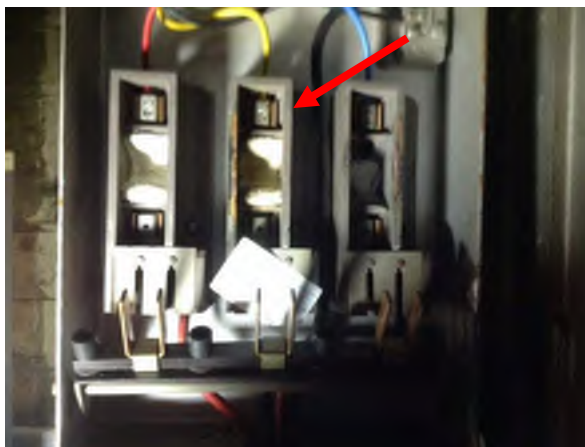
Building	Vezey-Strong wing
Floor	Basement
Room	342
Item Description	Flash guard to large fuse box
Material Type	Textiles/Cloth
Sample Number	27093
Asbestos Type	Chrysotile

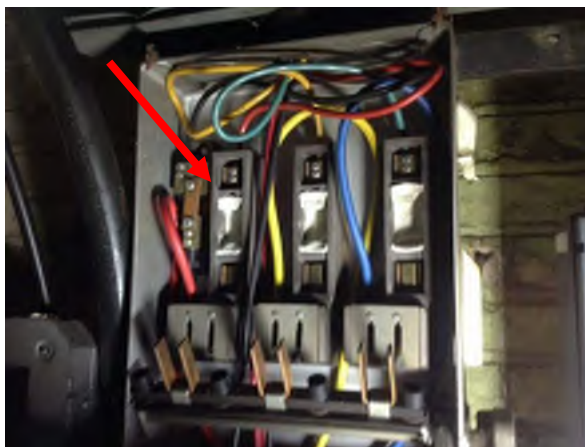
Building	Vezey-Strong wing
Floor	Basement
Room	342
Item Description	Flash guard to large fuse box
Material Type	Textiles/Cloth
Sample Number	Similar to 27093
Asbestos Type	Chrysotile

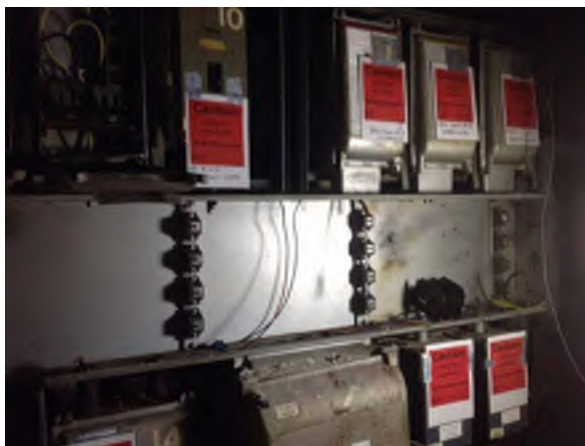
Building	Vezey-Strong wing
Floor	Basement
Room	342
Item Description	Flash guard debris
Material Type	Dust/Debris
Sample Number	Similar to 27095
Asbestos Type	Sp Chrysotile

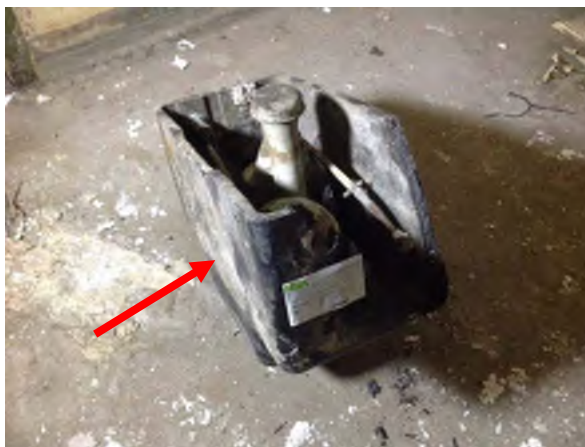
Building	Vezey-Strong wing
Floor	Basement
Room	351
Item Description	Toilet cistern
Material Type	Composite
Sample Number	27098
Asbestos Type	Amosite

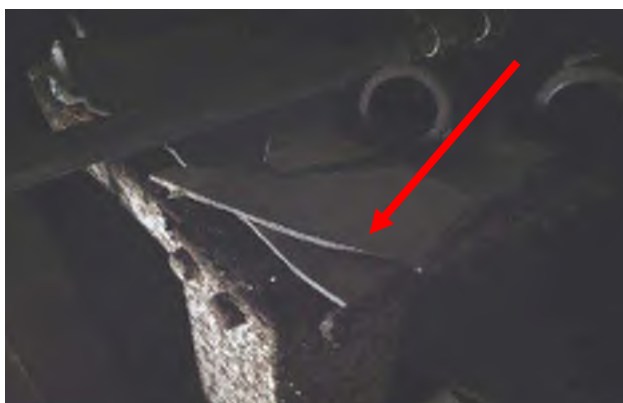
Building	Vezey-Strong wing
Floor	Basement
Room	352
Item Description	Cement panel debris
Material Type	Cement
Sample Number	27097
Asbestos Type	Chrysotile

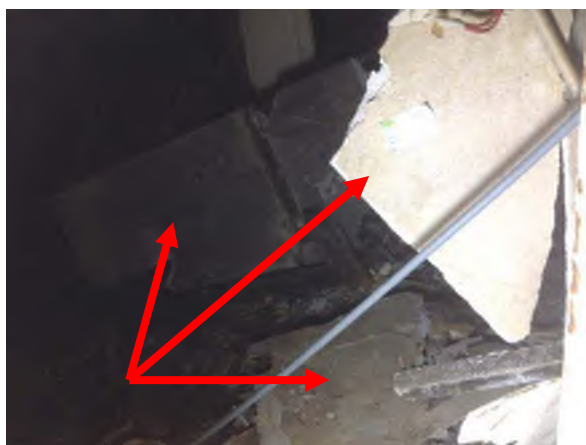
Building	Vezey-Strong wing
Floor	Basement
Room	374
Item Description	Insulation board debris
Material Type	Insulating Board
Sample Number	27099
Asbestos Type	Chrysotile / Amosite

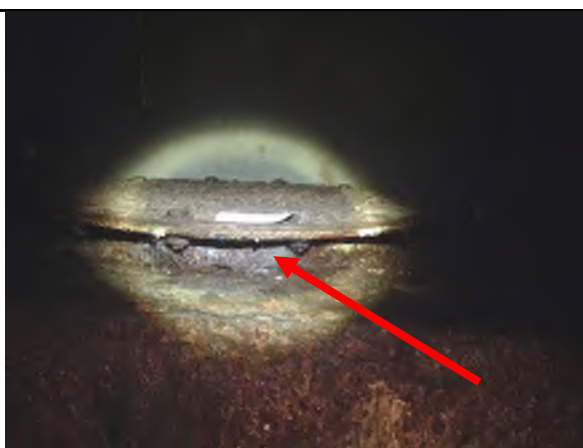
Building	Vezey-Strong wing
Floor	Basement
Room	381
Item Description	Gasket to top of fuel tank
Material Type	Gaskets/Washers
Sample Number	27101
Asbestos Type	Chrysotile

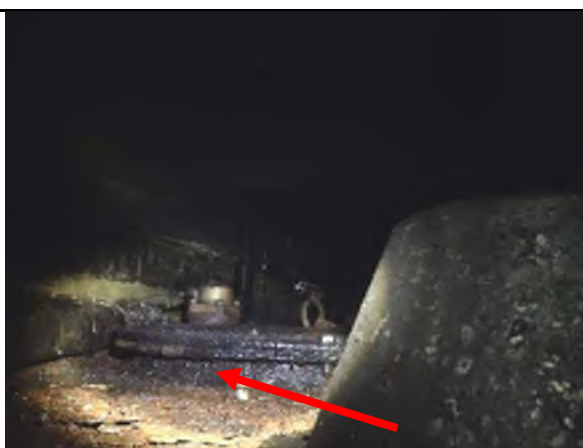
Building	Vezey-Strong wing
Floor	Basement
Room	386
Item Description	Gasket to top of fuel tank
Material Type	Gaskets/Washers
Sample Number	Similar to 27101
Asbestos Type	Sp Chrysotile

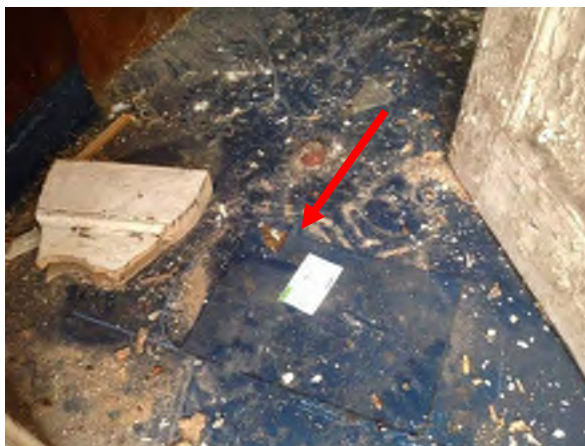
Building	Vezey-Strong wing
Floor	Basement
Room	390
Item Description	Blue vinyl floor tile
Material Type	Floor Tile / Vinyl
Sample Number	27105
Asbestos Type	Chrysotile

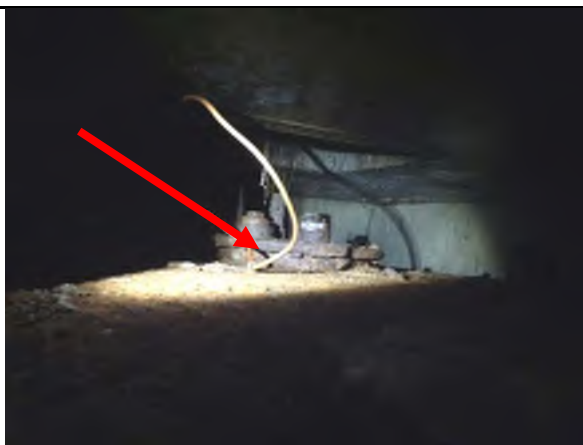
Building	Vezey-Strong wing
Floor	Basement
Room	391
Item Description	Gasket to top of fuel tank
Material Type	Gaskets/Washers
Sample Number	Similar to 27101
Asbestos Type	Sp Chrysotile

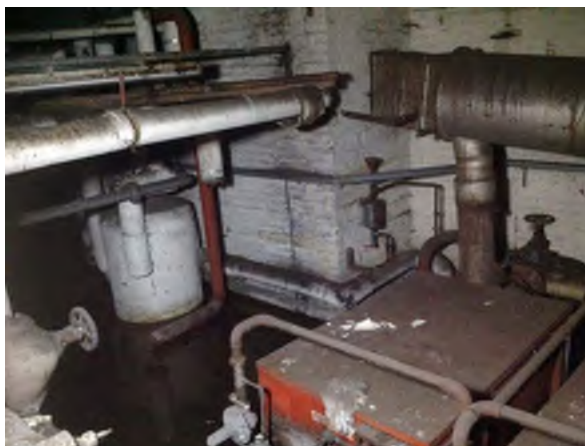
Building	Vezey-Strong wing
Floor	Basement
Room	Boiler room - FLOODED no access
Item Description	Boiler room
Material Type	-
Sample Number	-
Asbestos Type	Default Presumption

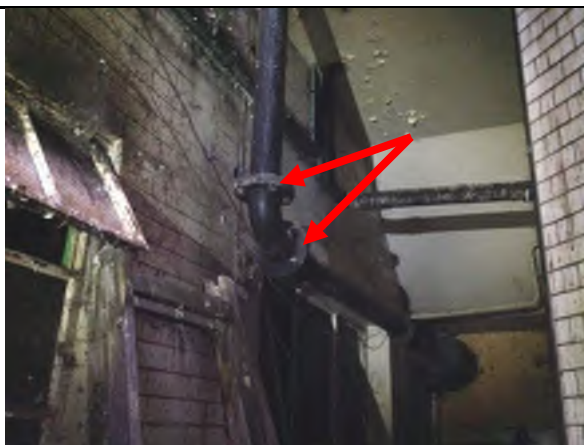
Building	Vezey-Strong wing
Floor	Basement
Room	Exterior
Item Description	Gasket to pipe flanges
Material Type	Gaskets/Washers
Sample Number	Similar to 27102
Asbestos Type	Sp Chrysotile

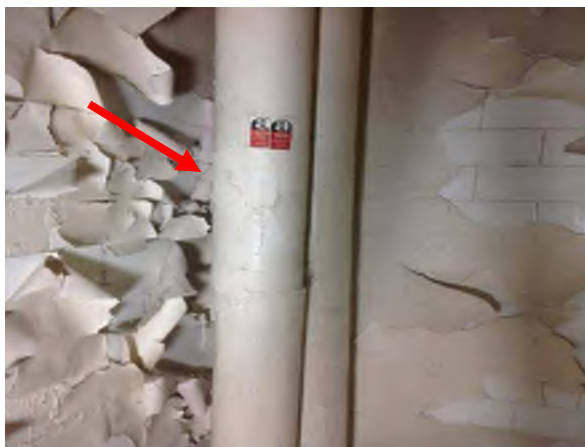
Building	Vezey-Strong wing
Floor	Ground
Room	274
Item Description	Pipe insulation
Material Type	Thermal Insulation/Lagging
Sample Number	27070
Asbestos Type	Chrysotile

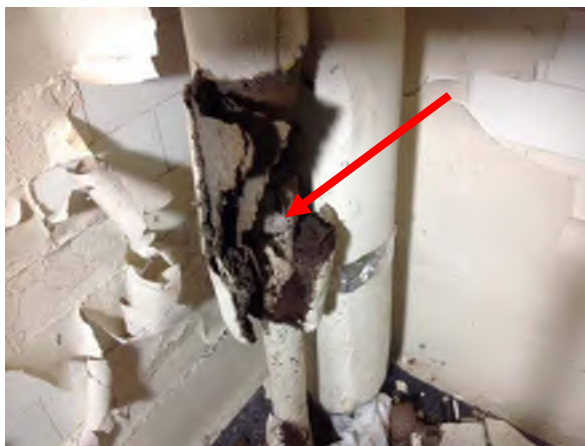
Building	Vezey-Strong wing
Floor	Ground
Room	274
Item Description	Paper lining to insulation
Material Type	Paper
Sample Number	27071
Asbestos Type	Chrysotile

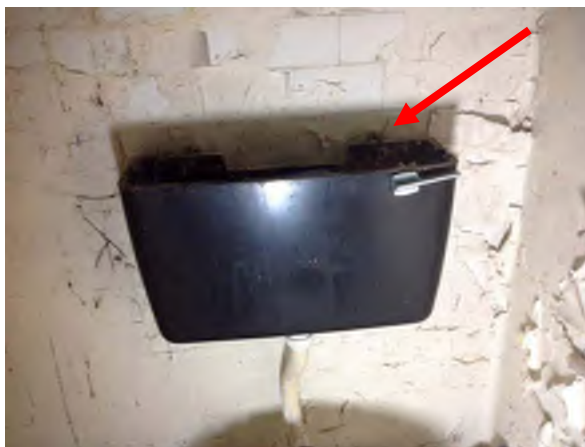
Building	Vezey-Strong wing
Floor	Ground
Room	274
Item Description	Toilet cistern
Material Type	Composite
Sample Number	Similar to 27068
Asbestos Type	Sp Amosite

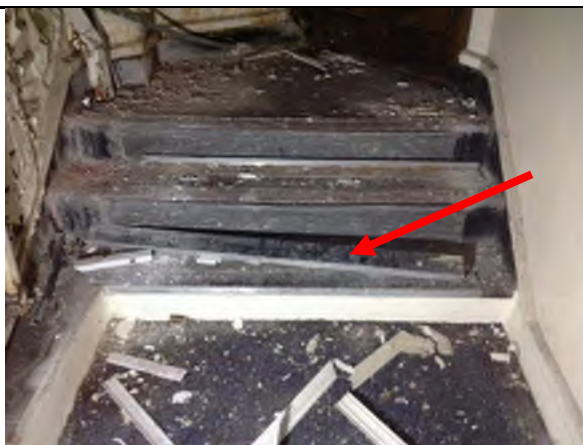
Building	Vezey-Strong wing
Floor	Ground
Room	275
Item Description	Stair nosing
Material Type	Composite
Sample Number	27074
Asbestos Type	Chrysotile

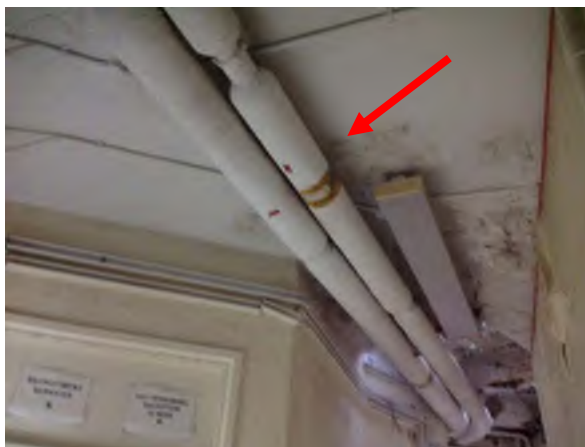
Building	Vezey-Strong wing
Floor	Ground
Room	275
Item Description	Pipe insulation
Material Type	Thermal Insulation/Lagging
Sample Number	Similar to 27070
Asbestos Type	Pr Chrysotile

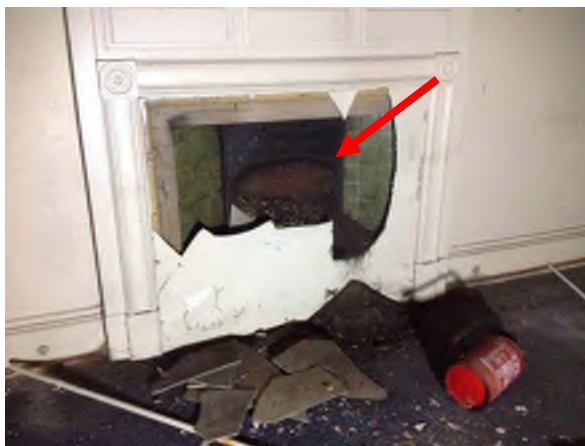
Building	Vezey-Strong wing
Floor	Ground
Room	276
Item Description	Cement panel to fireplace
Material Type	Cement
Sample Number	27073
Asbestos Type	Chrysotile

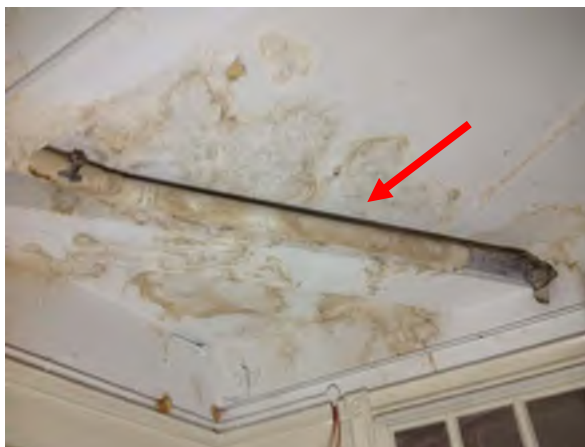
Building	Vezey-Strong wing
Floor	Ground
Room	276
Item Description	Paper lining to insulation
Material Type	Paper
Sample Number	Similar to 27071
Asbestos Type	Sp Chrysotile

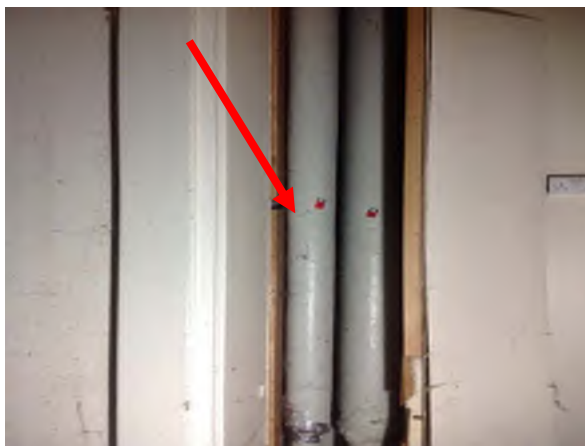
Building	Vezey-Strong wing
Floor	Ground
Room	278
Item Description	Pipe insulation
Material Type	Thermal Insulation/Lagging
Sample Number	Similar to 27070
Asbestos Type	Sp Chrysotile

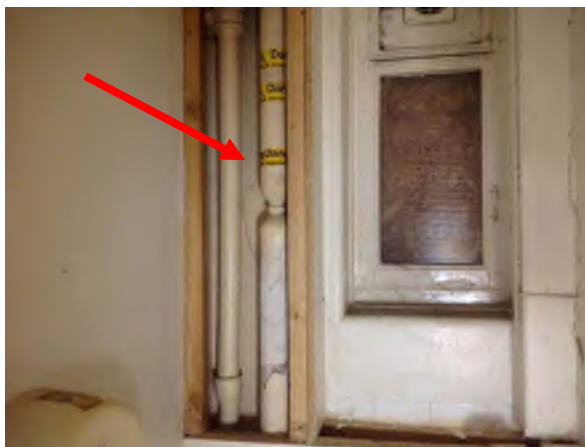
Building	Vezey-Strong wing
Floor	Ground
Room	281
Item Description	Pipe insulation
Material Type	Thermal Insulation/Lagging
Sample Number	Similar to 27070
Asbestos Type	Sp Chrysotile

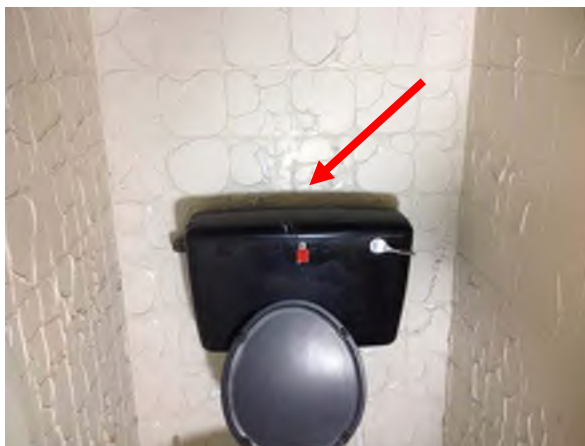
Building	Vezey-Strong wing
Floor	Ground
Room	292
Item Description	Toilet cistern
Material Type	Composite
Sample Number	Similar to 27068
Asbestos Type	Sp Amosite

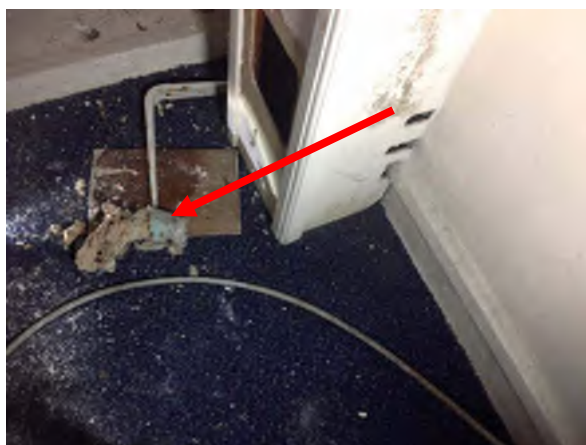
Building	Vezey-Strong wing
Floor	First
Room	178
Item Description	Pipe insulation
Material Type	Thermal Insulation/Lagging
Sample Number	Similar to 27057
Asbestos Type	Sp Chrysotile

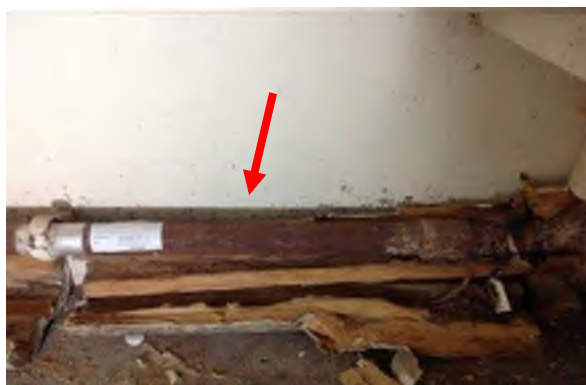
Building	Vezey-Strong wing
Floor	First
Room	179
Item Description	Pipe insulation debris
Material Type	Thermal Insulation/Lagging
Sample Number	27057
Asbestos Type	Chrysotile

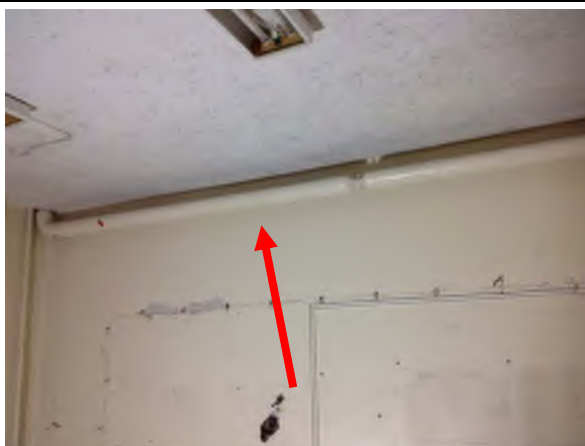
Building	Vezey-Strong wing
Floor	First
Room	187
Item Description	Pipe insulation
Material Type	Thermal Insulation/Lagging
Sample Number	Similar to 27057
Asbestos Type	Sp Chrysotile

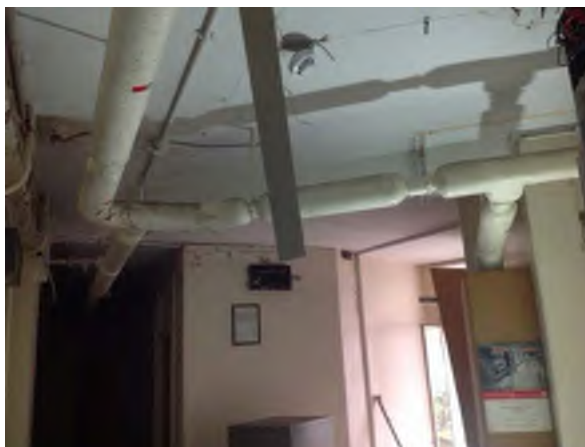
Building	Vezey-Strong wing
Floor	First
Room	188
Item Description	Pipe insulation
Material Type	Thermal Insulation/Lagging
Sample Number	Similar to 27057
Asbestos Type	Sp Chrysotile

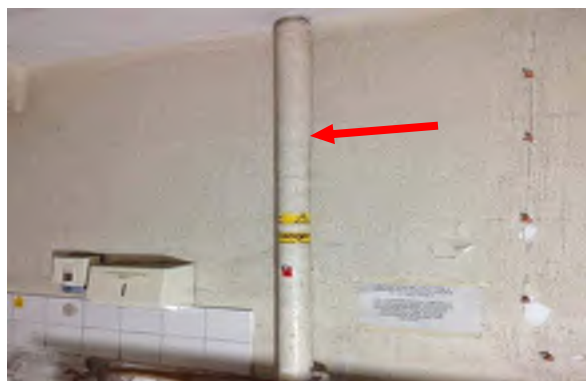
Building	Vezey-Strong wing
Floor	First
Room	190
Item Description	Pipe insulation
Material Type	Thermal Insulation/Lagging
Sample Number	Similar to 27057
Asbestos Type	Sp Chrysotile

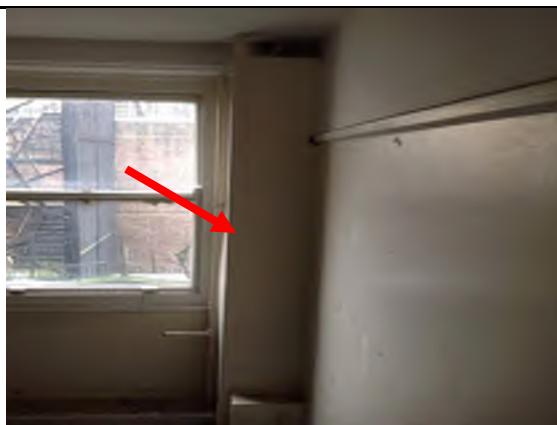
Building	Vezey-Strong wing
Floor	2 nd floor Mezzanine
Room	211
Item Description	Pipe insulation
Material Type	Thermal Insulation/Lagging
Sample Number	27063
Asbestos Type	Chrysotile

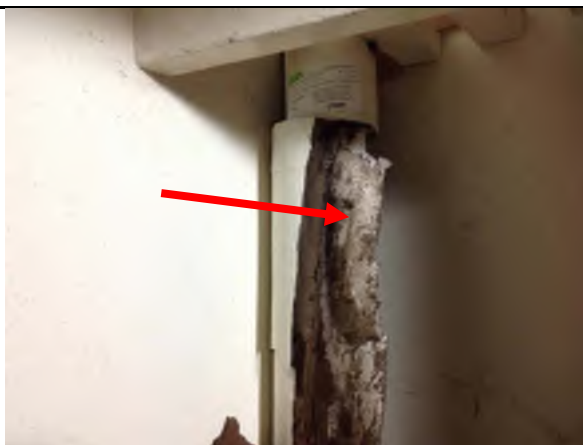
Building	Vezey-Strong wing
Floor	2 nd floor Mezzanine
Room	216
Item Description	Pipe insulation
Material Type	Thermal Insulation/Lagging
Sample Number	Similar to 27063
Asbestos Type	SpChrysotile

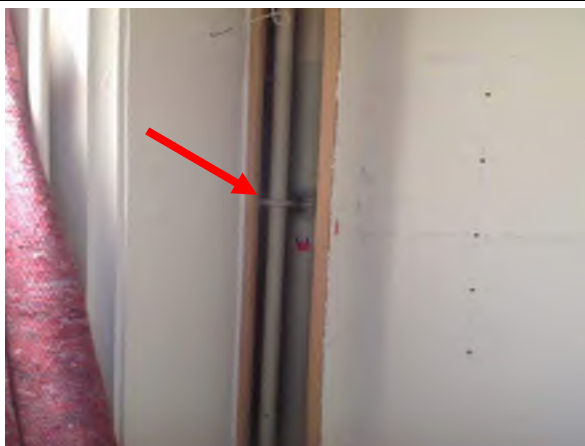
Building	Vezey-Strong wing
Floor	2 nd floor Mezzanine
Room	222
Item Description	Pipe insulation
Material Type	Thermal Insulation/Lagging
Sample Number	Similar to 27063
Asbestos Type	Sp Chrysotile

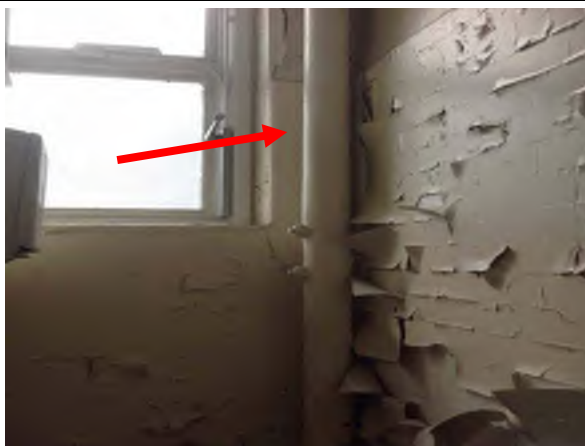
Building	Vezey-Strong wing
Floor	Second
Room	074
Item Description	Pipe lagging
Material Type	Thermal Insulation/Lagging
Sample Number	Similar to 25273
Asbestos Type	Sp Chrysotile

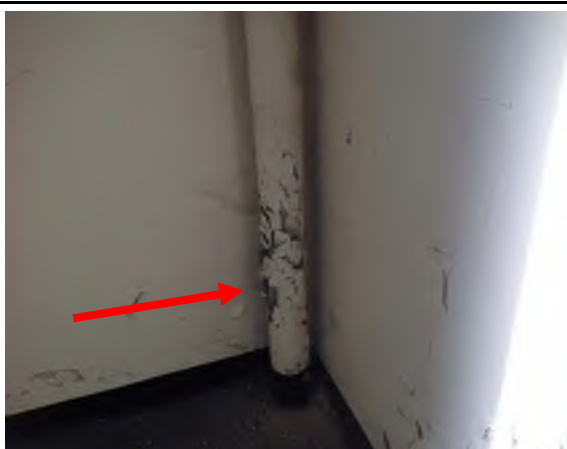
Building	Vezey-Strong wing
Floor	Second
Room	074
Item Description	Pipe lagging
Material Type	Thermal Insulation/Lagging
Sample Number	Similar to 25273
Asbestos Type	Sp Chrysotile

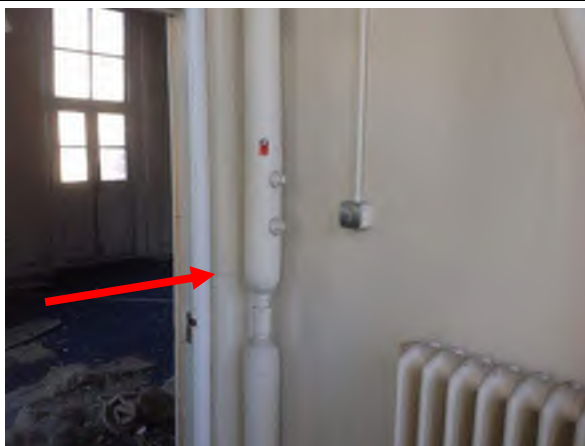
Building	Vezey-Strong wing
Floor	Second
Room	079
Item Description	Pipe lagging
Material Type	Thermal Insulation/Lagging
Sample Number	Similar to 25273
Asbestos Type	Sp Chrysotile

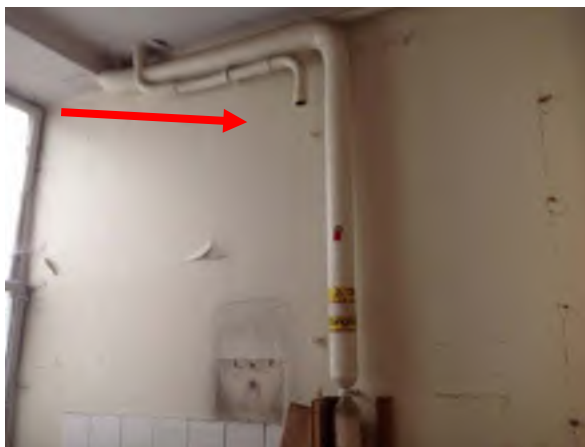
Building	Vezey-Strong wing
Floor	Second
Room	087
Item Description	Pipe insulation
Material Type	Thermal Insulation/Lagging
Sample Number	25277
Asbestos Type	Chrysotile

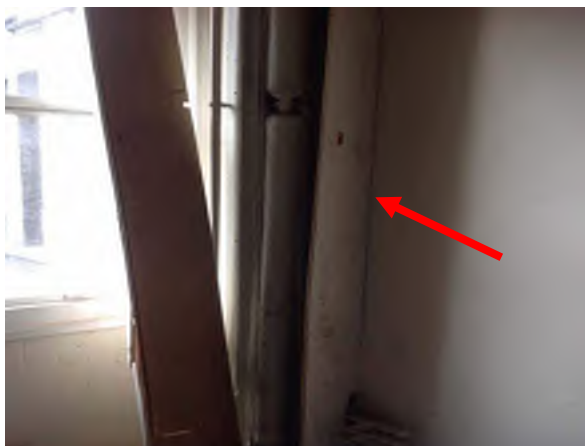
Building	Vezey-Strong wing
Floor	Second
Room	101
Item Description	Pipe insulation
Material Type	Thermal Insulation/Lagging
Sample Number	Similar to 25277
Asbestos Type	Sp Chrysotile

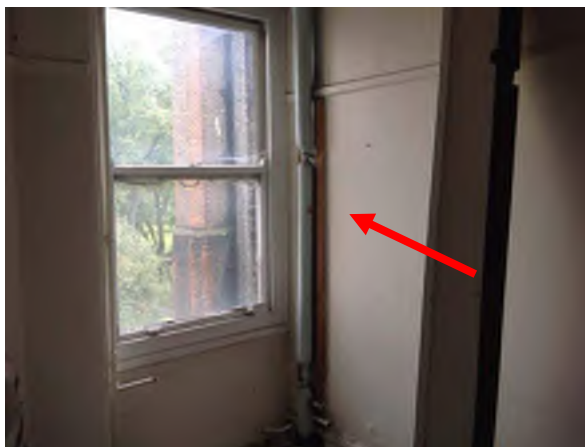
Building	Vezey-Strong wing
Floor	Second
Room	102
Item Description	Pipe insulation
Material Type	Thermal Insulation/Lagging
Sample Number	Similar to 25277
Asbestos Type	Sp Chrysotile

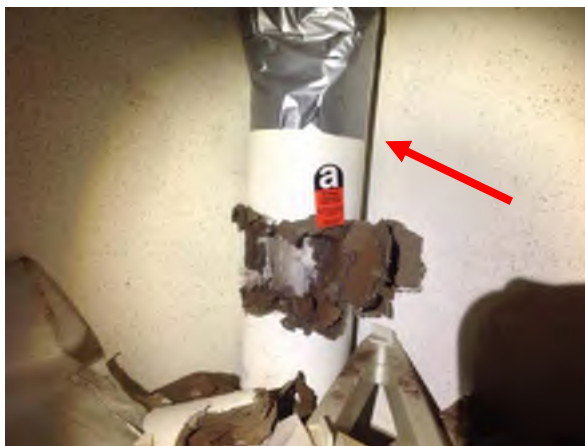
Building	Vezey-Strong wing
Floor	Second
Room	106
Item Description	Pipe insulation
Material Type	Thermal Insulation/Lagging
Sample Number	Similar to 25277
Asbestos Type	Sp Chrysotile

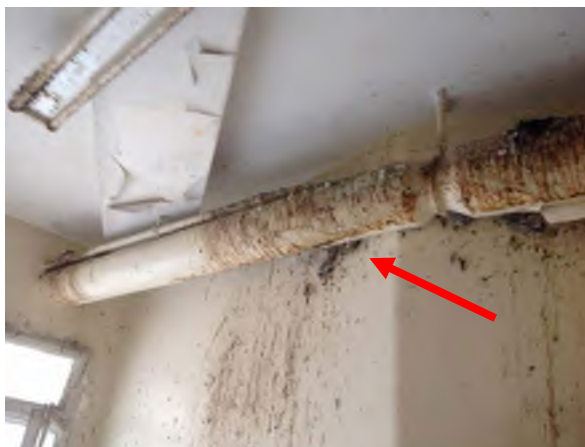
Building	Vezey-Strong wing
Floor	Second
Room	107
Item Description	Paper lining to insulation sleeve
Material Type	Paper
Sample Number	25283
Asbestos Type	Chrysotile

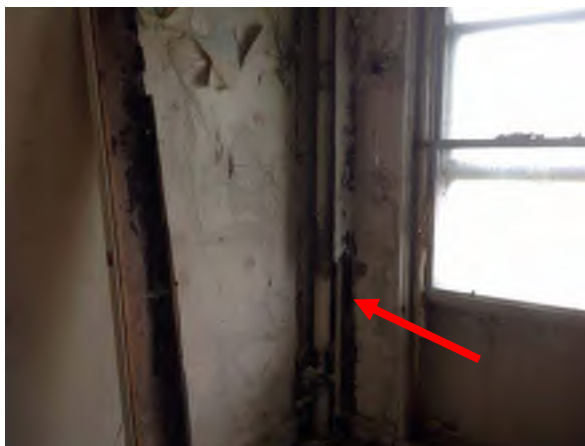
Building	Vezey-Strong wing
Floor	Second
Room	108
Item Description	Pipe insulation
Material Type	Thermal Insulation/Lagging
Sample Number	Similar to 25277
Asbestos Type	Sp Chrysotile

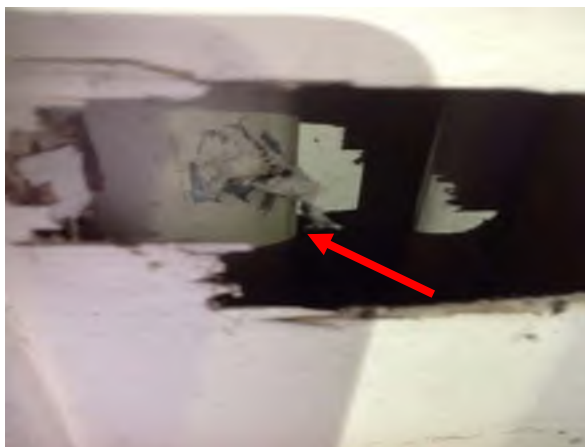
Building	Vezey-Strong wing
Floor	Second
Room	113
Item Description	Pipe insulation
Material Type	Thermal Insulation/Lagging
Sample Number	Similar to 25277
Asbestos Type	Sp Chrysotile

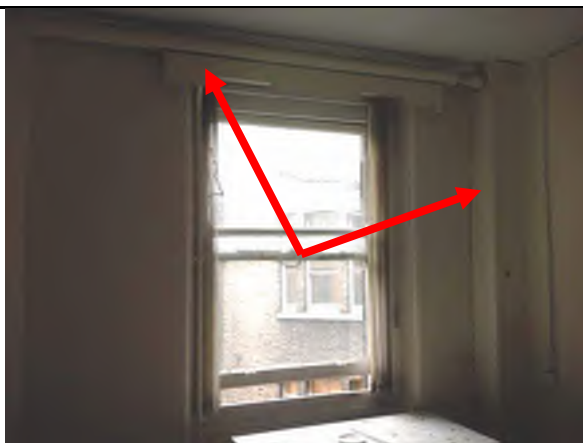
Building	Vezey-Strong wing
Floor	Second
Room	115
Item Description	Pipe insulation
Material Type	Thermal Insulation/Lagging
Sample Number	Similar to 25277
Asbestos Type	Sp Chrysotile

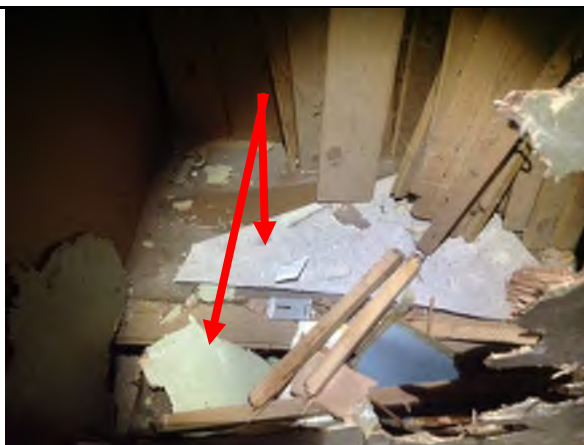
Building	Vezey-Strong wing
Floor	Second
Room	116
Item Description	Pipe insulation
Material Type	Thermal Insulation/Lagging
Sample Number	Similar to 25277
Asbestos Type	Sp Chrysotile

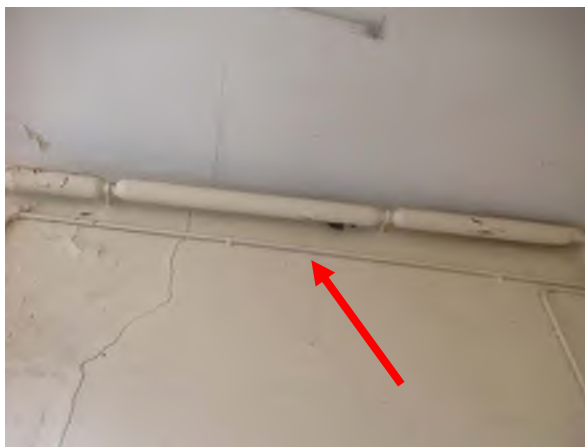
Building	Vezey-Strong wing
Floor	Second
Room	124
Item Description	Pipe insulation
Material Type	Thermal Insulation/Lagging
Sample Number	Similar to 25277
Asbestos Type	Sp Chrysotile

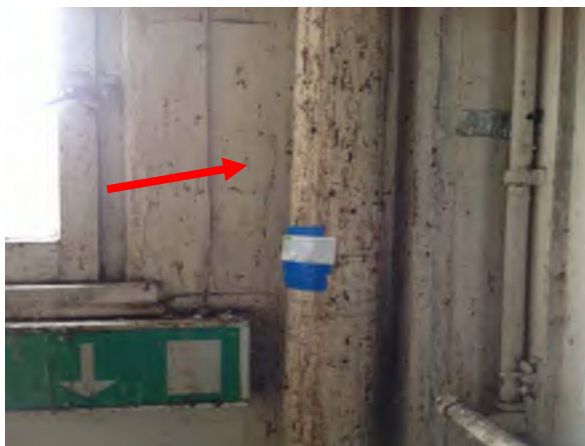
Building	Vezey-Strong wing
Floor	Second
Room	125
Item Description	Pipe insulation
Material Type	Thermal Insulation/Lagging
Sample Number	Similar to 25277
Asbestos Type	Sp Chrysotile

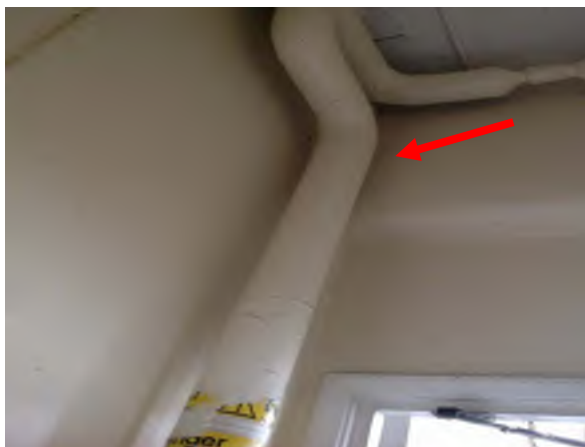
Building	Vezey-Strong wing
Floor	Third
Room	002
Item Description	Pipe insulation
Material Type	Thermal Insulation/Lagging
Sample Number	25227
Asbestos Type	Chrysotile

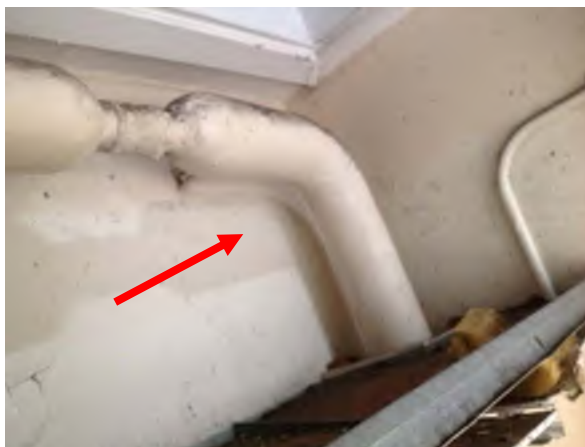
Building	Vezey-Strong wing
Floor	Third
Room	006
Item Description	Pipe insulation
Material Type	Thermal Insulation/Lagging
Sample Number	Similar to 25227
Asbestos Type	Sp Chrysotile

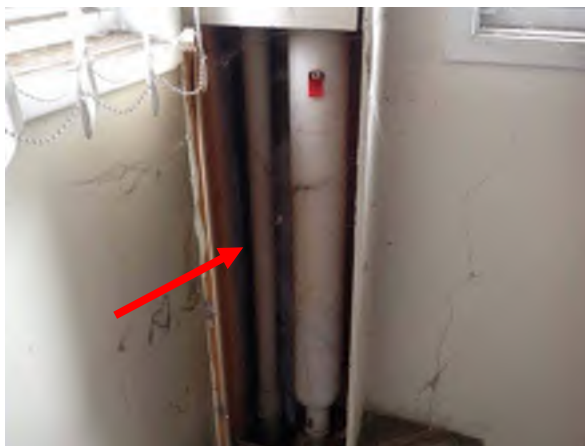
Building	Vezey-Strong wing
Floor	Third
Room	022
Item Description	Pipe insulation
Material Type	Thermal Insulation/Lagging
Sample Number	Similar to 25227
Asbestos Type	Sp Chrysotile

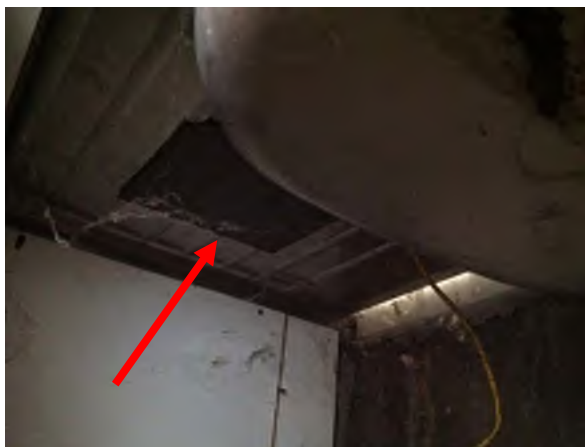
Building	Vezey-Strong wing
Floor	Third
Room	022
Item Description	Pipe insulation
Material Type	Thermal Insulation/Lagging
Sample Number	Similar to 25227
Asbestos Type	Sp Chrysotile

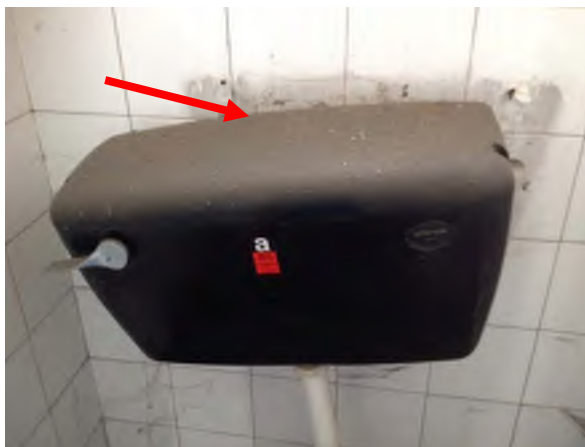
Building	Vezey-Strong wing
Floor	Third
Room	025
Item Description	Toilet cistern
Material Type	Composite
Sample Number	25247
Asbestos Type	Amosite

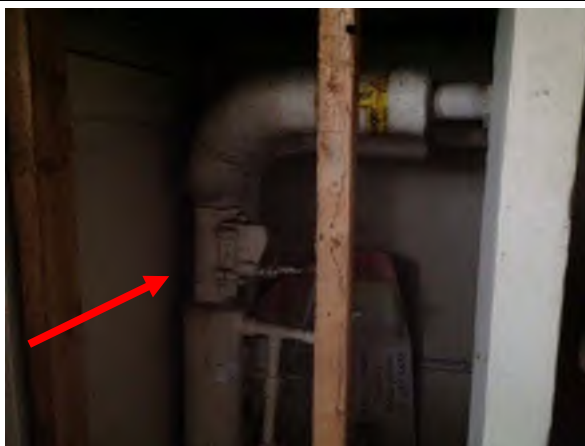
Building	Vezey-Strong wing
Floor	Third
Room	032
Item Description	Residue on old calorifier
Material Type	Thermal Insulation/Lagging
Sample Number	25249
Asbestos Type	Chrysotile

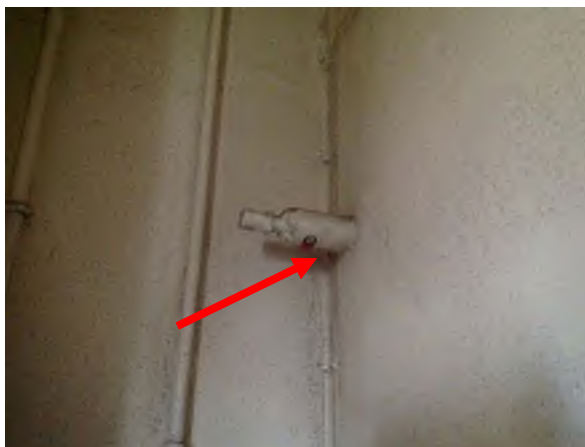
Building	Vezey-Strong wing
Floor	Third
Room	032
Item Description	Pipe insulation
Material Type	Thermal Insulation/Lagging
Sample Number	25250
Asbestos Type	Chrysotile

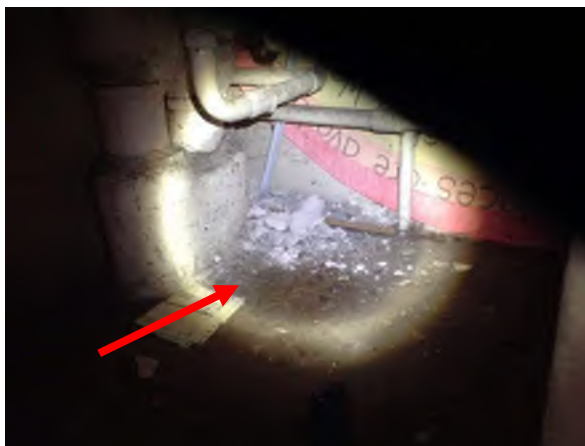
Building	Vezey-Strong wing
Floor	Third
Room	032
Item Description	Pipe insulation
Material Type	Thermal Insulation/Lagging
Sample Number	Similar to 25248
Asbestos Type	Sp Chrysotile

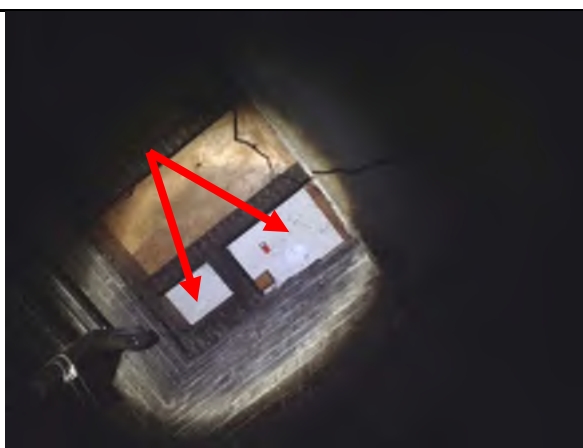
Building	Vezey-Strong wing
Floor	Third
Room	032
Item Description	Pipe insulation debris
Material Type	Thermal Insulation/Lagging
Sample Number	Similar to 25250
Asbestos Type	Sp Chrysotile

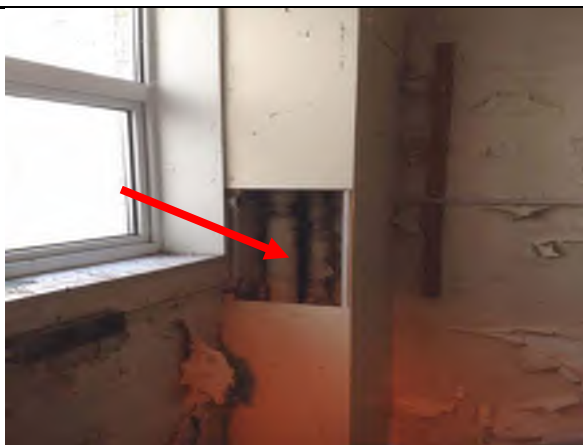
Building	Vezey-Strong wing
Floor	Third
Room	043
Item Description	Pipe insulation
Material Type	Thermal Insulation/Lagging
Sample Number	Similar to 25250
Asbestos Type	Sp Chrysotile

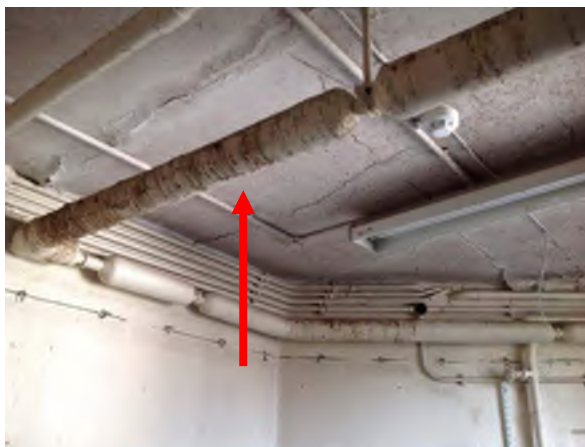
Building	Vezey-Strong wing
Floor	Third
Room	045
Item Description	Pipe insulation
Material Type	Thermal Insulation/Lagging
Sample Number	Similar to 25250
Asbestos Type	Sp Chrysotile

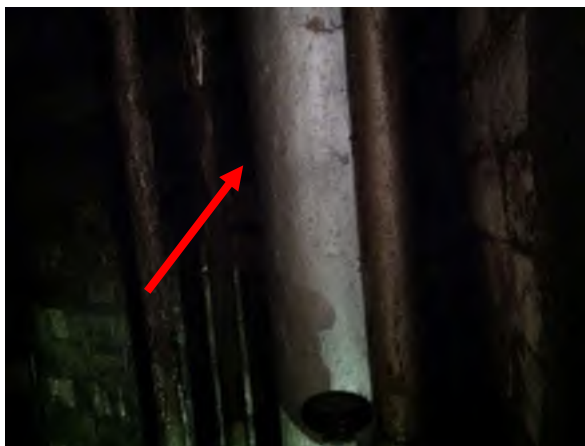
Building	Vezey-Strong wing
Floor	Third
Room	046
Item Description	Pipe insulation
Material Type	Thermal Insulation/Lagging
Sample Number	Similar to 25250
Asbestos Type	Sp Chrysotile

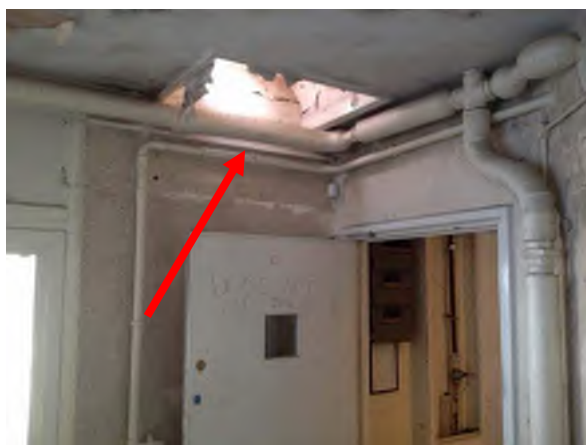
Building	Vezey-Strong wing
Floor	Third
Room	047
Item Description	Pipe insulation
Material Type	Thermal Insulation/Lagging
Sample Number	Similar to 25250
Asbestos Type	Sp Chrysotile
